# Aviation Investigation Factual Report

<b>Location:</b>	Tuckers Crossing, Mississippi	<b>Accident Number:</b>	CEN21LA102
<b>Date &amp; Time:</b>	December 29, 2020, 08:35 Local	<b>Registration:</b>	N103SU
<b>Aircraft:</b>	Hughes 369D	<b>Aircraft Damage:</b>	Destroyed
<b>Defining Event:</b>	Off-field or emergency landing	<b>Injuries:</b>	1 Fatal
<b>Flight Conducted Under:</b>	Part 133: Rotorcraft ext. load

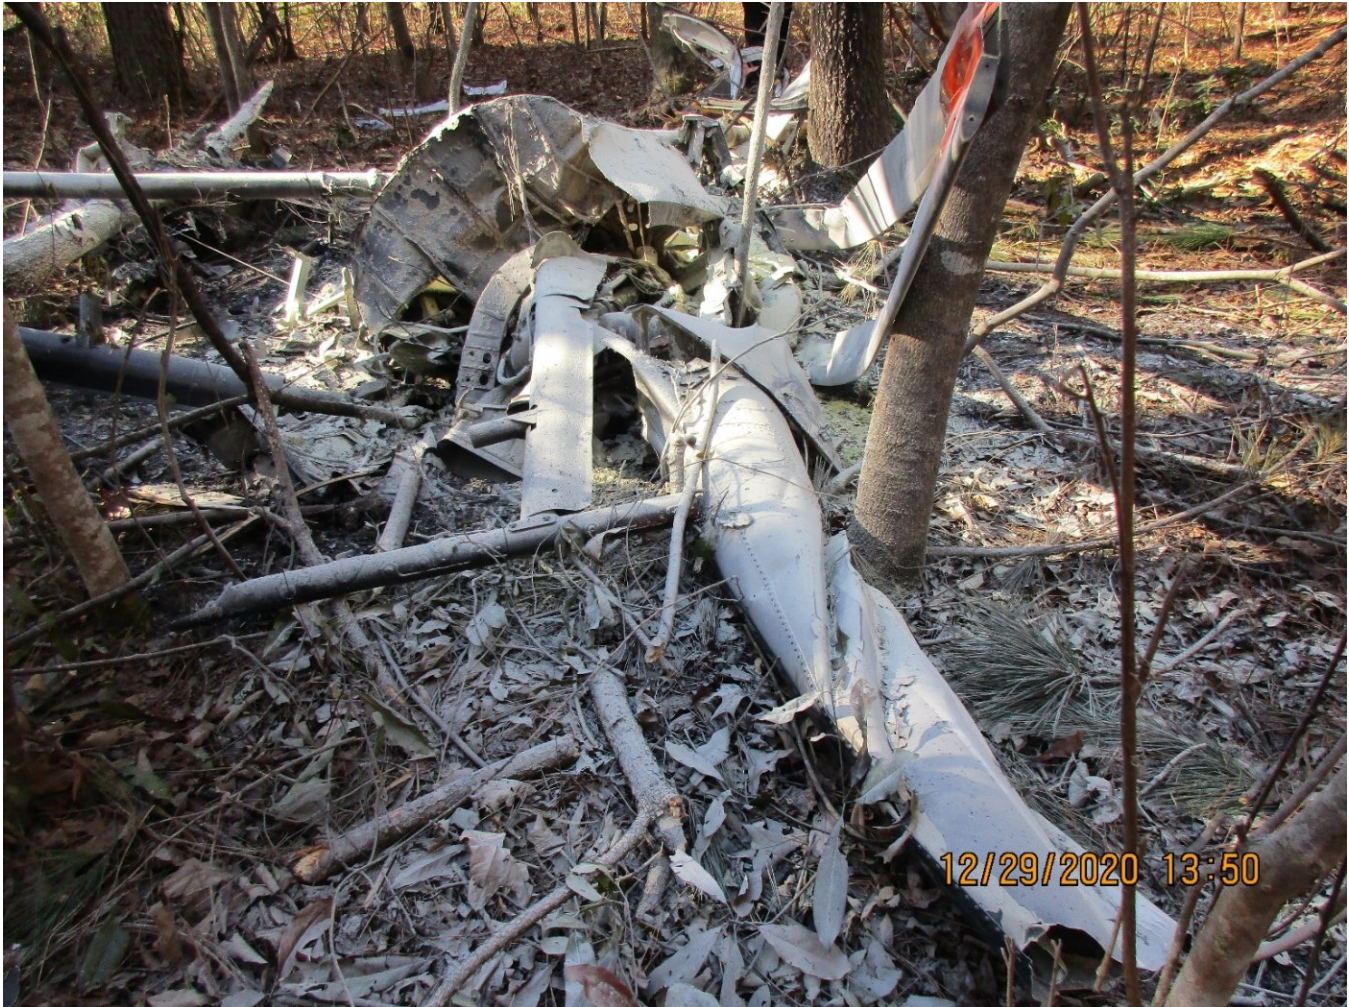
Figure 1. Main wreckage (Source: Federal Aviation Administration).

The accident site was located in wooded terrain to the east of the transmission line (see figure 1). The external saw assembly was found connected to the helicopter's trapeze assembly and entangled in the trees.

The main wreckage, which consisted of the fuselage, engine, main transmission, and rotor assembly, was consumed by the postimpact fire. The tail rotor assembly had separated from the tailboom near the tail rotor gearbox and was found adjacent to the main wreckage.

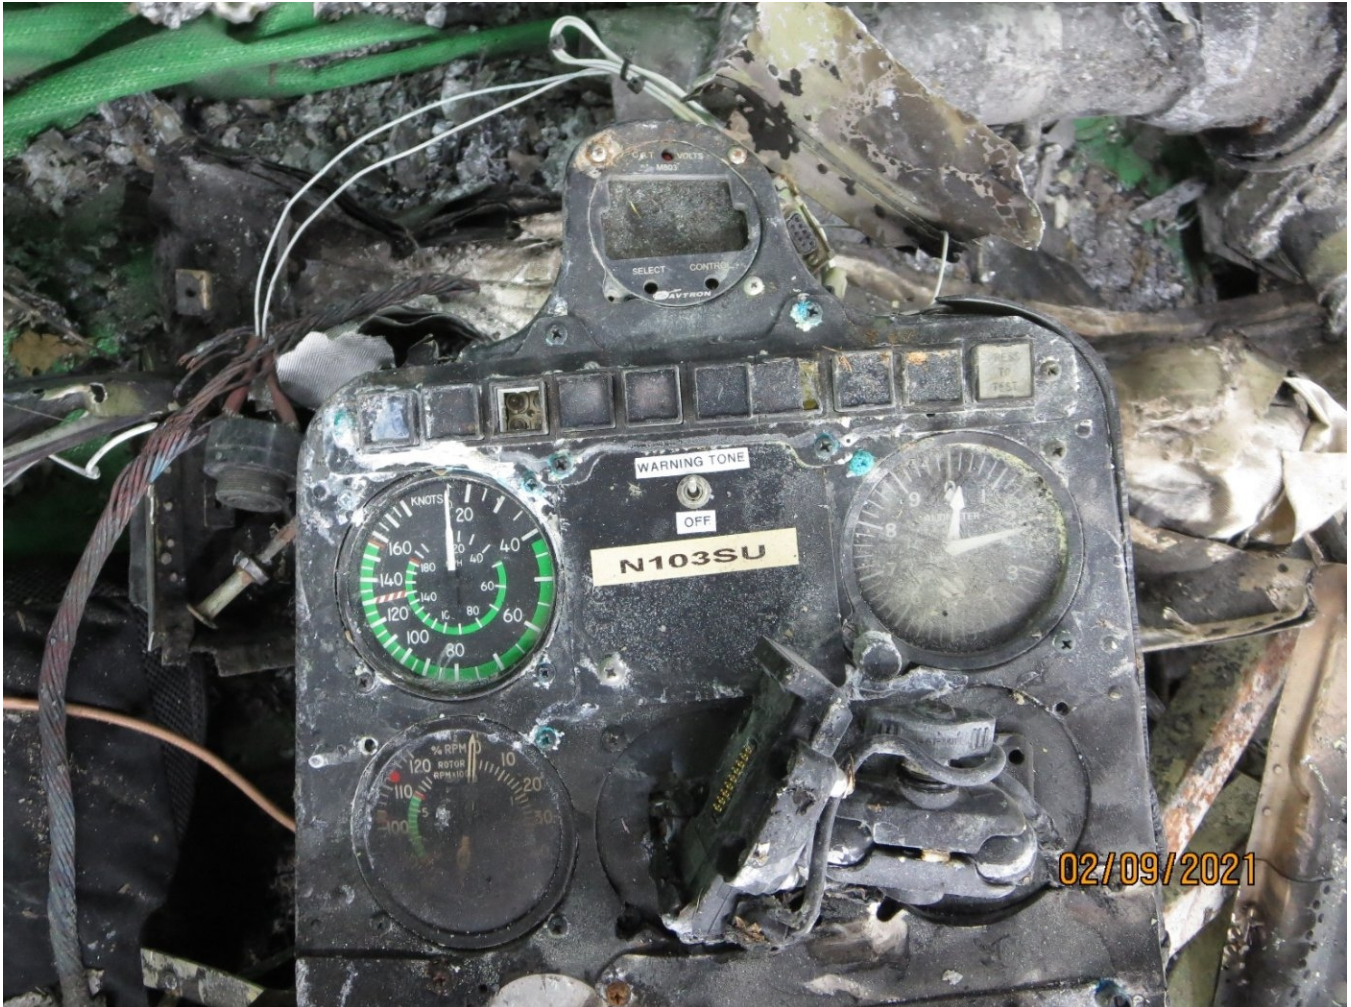
Figure 2. Instrument panel with warning tone switch (Source: MD Helicopters).

A review of the accident helicopter’s instrument panel showed a warning tone switch below the annunciator panel lights in the center of the upper instrument panel (see figure 2.). The maintenance records did not indicate an installed separate warning tone system for the helicopter.
