# Aviation Investigation Factual Report

| <b>Location:</b> | Forkston, Pennsylvania | <b>Accident Number:</b> | ERA21LA191 |
| <b>Date &amp; Time:</b> | April 22, 2021, 21:04 Local | <b>Registration:</b> | N4055N |
| <b>Aircraft:</b> | ROBINSON HELICOPTER R44 | <b>Aircraft Damage:</b> | Destroyed |

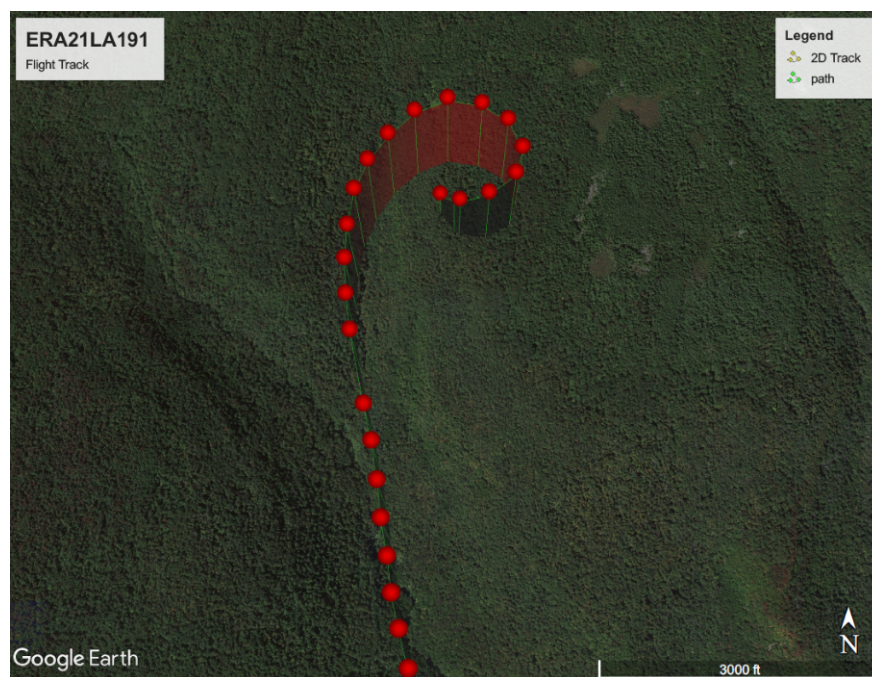
According to radar track data from the Federal Aviation Administration, the pilot took off from Allentown Queen City Municipal Airport (XLL), Allentown, Pennsylvania about 2010. He contacted Allentown approach control at 2011 and requested VFR flight-following to Bradford County Airport (N27), Towanda, Pennsylvania. After departure, the helicopter proceeded to the northwest, climbing to a cruise altitude between 3,000 and 4,000 ft above mean sea level (msl), remaining closer to 3,000 ft msl for most of the flight. At 2028, Allentown approach directed the pilot to contact Wilkes-Barre (AVP) approach. The pilot checked in with AVP approach and was issued the local altimeter setting. Shortly after passing Kasson Brook, Pennsylvania, the helicopter made a slight right turn, then entered a right, descending spiral until radar contact was lost about 2104 (see figure 1). The last recorded radar location was near the accident site location. No distress calls were received from the pilot prior to the accident.

Figure 1 - Helicopter's flight track during the final moments of the flight.
