# Aviation Investigation Factual Report

<b>Location:</b>	Cornwall, New York	<b>Accident Number:</b>	ERA22FA010
<b>Date &amp; Time:</b>	October 10, 2021, 13:57 Local	<b>Registration:</b>	N637HP
<b>Aircraft:</b>	ROBINSON HELICOPTER COMPANY R44 II	<b>Aircraft Damage:</b>	Destroyed
<b>Defining Event:</b>	Loss of control in flight	<b>Injuries:</b>	1 Fatal
<b>Flight Conducted Under:</b>	Part 91: General aviation - Personal

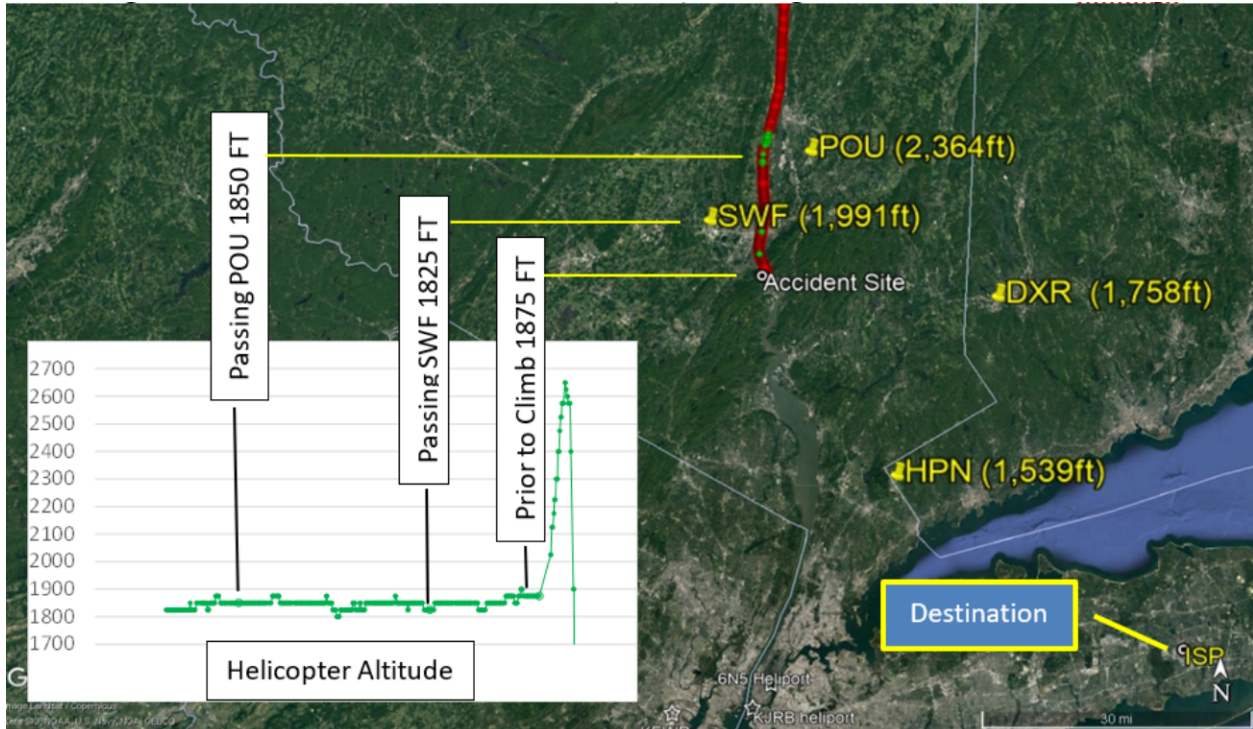
According to ADS-B tracking data and National Weather Service (NWS) records, as the helicopter flew south along the Hudson River at an altitude of 1,800 to 1,900 ft above mean sea level (msl), the overcast cloud ceiling height was decreasing. As it passed by Poughkeepsie, NY (POU) at 1349, the ceiling reported there was about 2,364 ft msl. At 1353, about 7 miles further south, the helicopter passed by the Stewart International Airport (SWF) where the ceiling was reported to be about 1,991 ft msl. At 1356, the helicopter began to climb (see figure 1).

**Figure 1 – Helicopter’s ADS-B-derived flight track (red/green dots) and cloud heights at nearby airports (yellow text)**

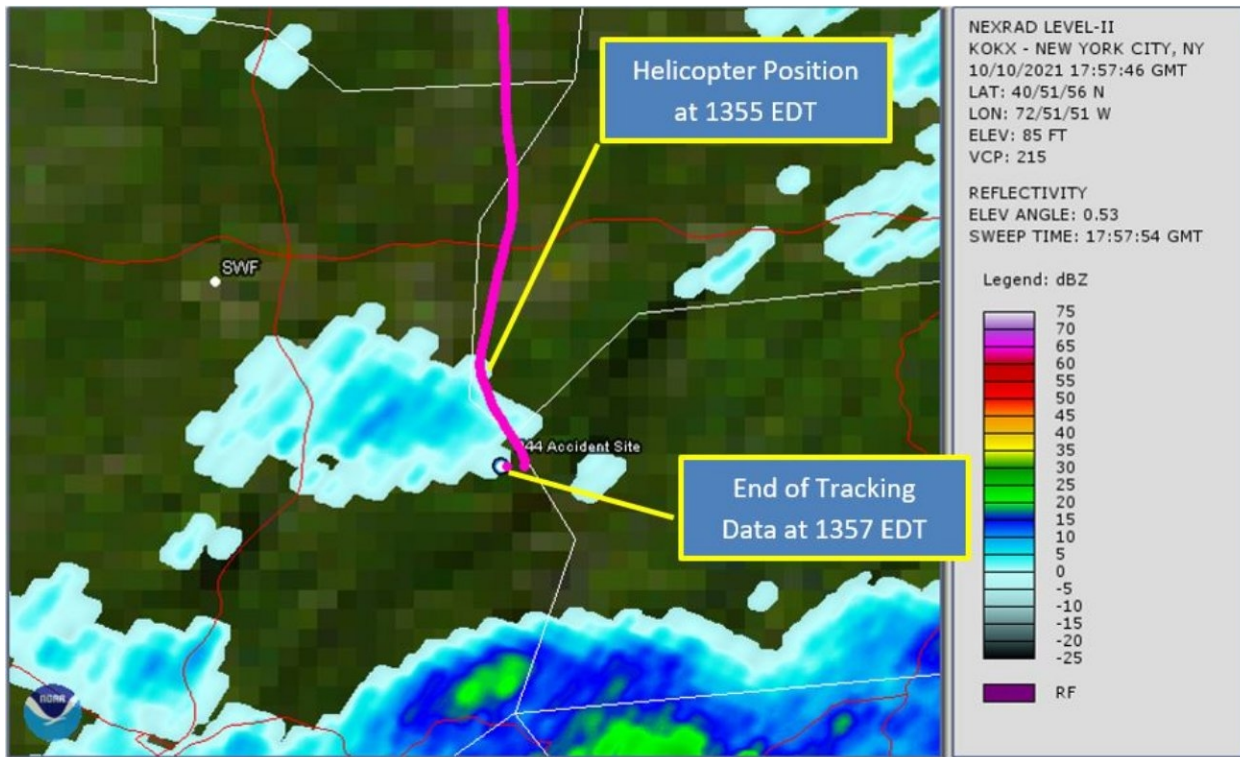
According to NWS weather surveillance radar data, near the time the climb began, the helicopter encountered an area of light intensity echoes that were moving to the north-northwest (see figure 2).

Figure 2 – Helicopter's flight track (magenta) and weather radar base reflectivity at 1357

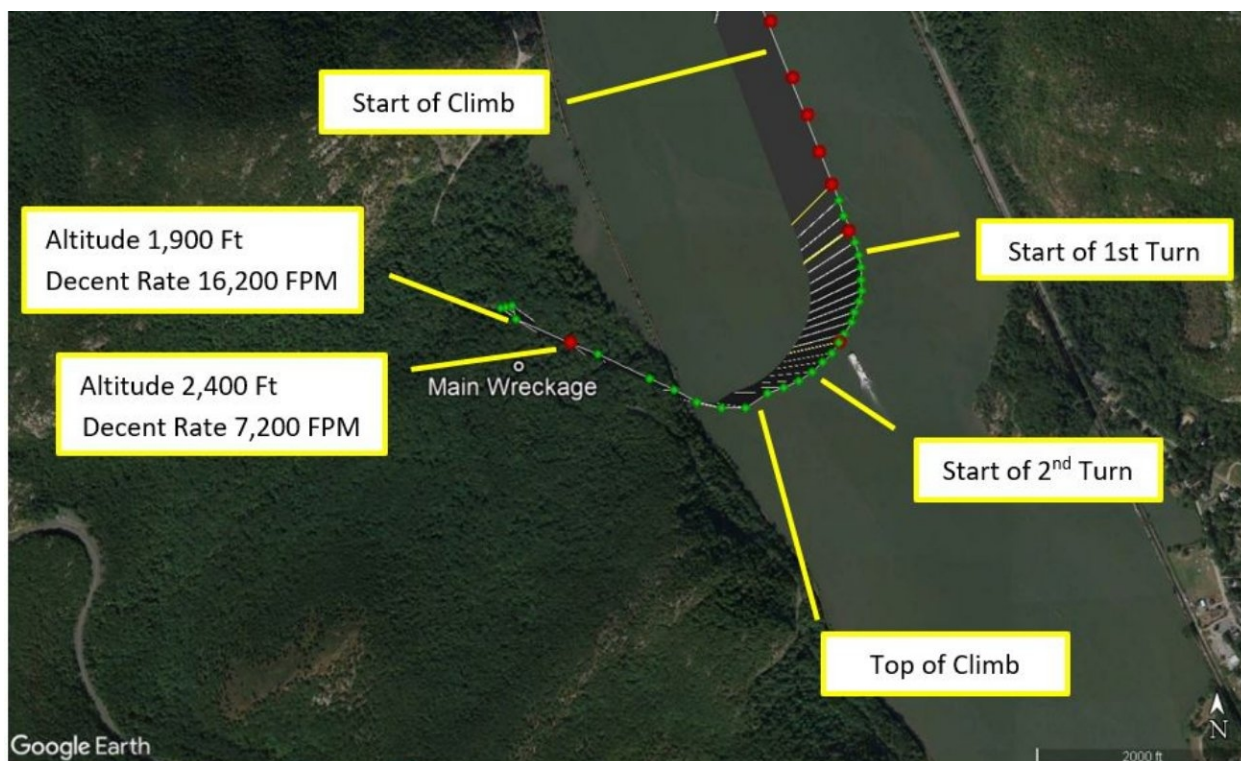
At 1356:03 while at an altitude of 1,875 ft msl, and a ground speed of 101 knots, the helicopter began to climb straight ahead. About 9 seconds later, it reached an altitude of 2,025 ft, which was above the cloud ceiling height reported at SWF (1,991 ft). About 5 seconds later it began the first of two right turns (see figure 3). The first turn lasted about 9 seconds, with an average turn rate of 7 to 11° per second.

Figure 3 – Helicopter’s flight track during climbing turn and subsequent descent (red and green dots)

From the start of the climb until about the end of the first right turn, the rate of climb continually increased, and the airspeed continually decreased. At the end of the first turn, the rate of climb plateaued at about 2,400 feet per minute, and the airspeed had decreased to about 45 knots. Just as the rate of climb plateaued, the airspeed trend reversed and began to increase. The helicopter continued to climb for about 10 seconds, as the airspeed increased to about 95 knots. During this time the second right turn began, lasted for about 9 seconds, at an average turn rate of 9-12° per second. At 1356:34, just before the end of the second turn, the helicopter began to descend rapidly from its peak altitude of 2,650 ft. About 6 seconds later, the descent rate reached 7,200 feet per minute. As it descended through 1,900 ft (just below the cloud ceiling height reported at SWF), the descent rate reached 16,200 feet per minute. The tracking data ended about 2 seconds later, about 0.6 nautical miles north of the accident site. The entire flight was about 70 minutes long and the accident site was located about 120 nautical miles south of GFL.
