Aviation Investigation Factual Report

Location:	Livingston, Texas	Accident Number:	CEN22FA086
Date & Time:	December 30, 2021, 11:41 Local	Registration:	N8AU
Aircraft:	Bell 206B	Aircraft Damage:	Substantial
Defining Event:	Loss of tail rotor effectiveness	Injuries:	2 Fatal, 2 Minor
Flight Conducted Under:	Part 91: General aviation - Personal

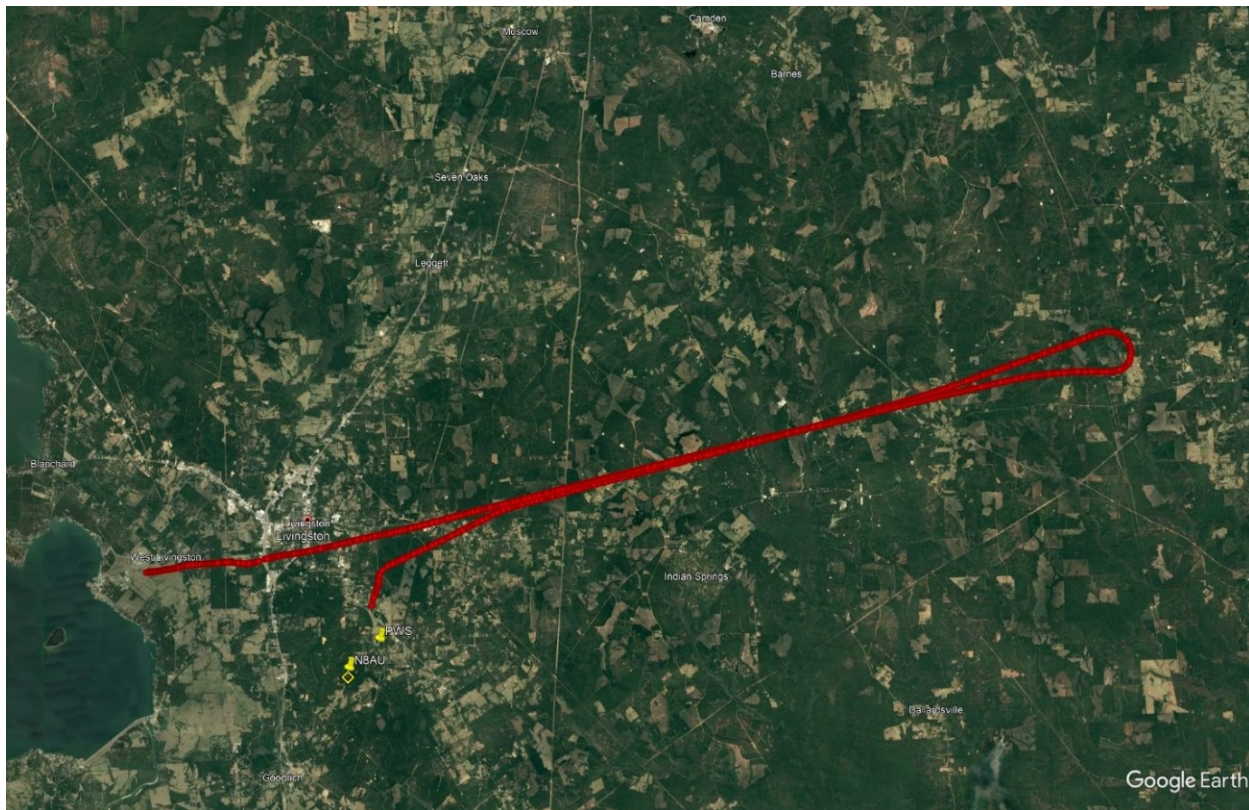
Figure 1. ADS-B Flight Path Depiction

Automatic dependent surveillance - broadcast data for the flight showed that the helicopter departed the Livingston Municipal Airport (00R) about 1107 and headed east-northeast for about 25 nautical miles (nm) before reversing course to a west-southwest direction. The helicopter then turned further south before the end of the data at 1138. The final recorded location was 1.8 nm northeast of the accident site.

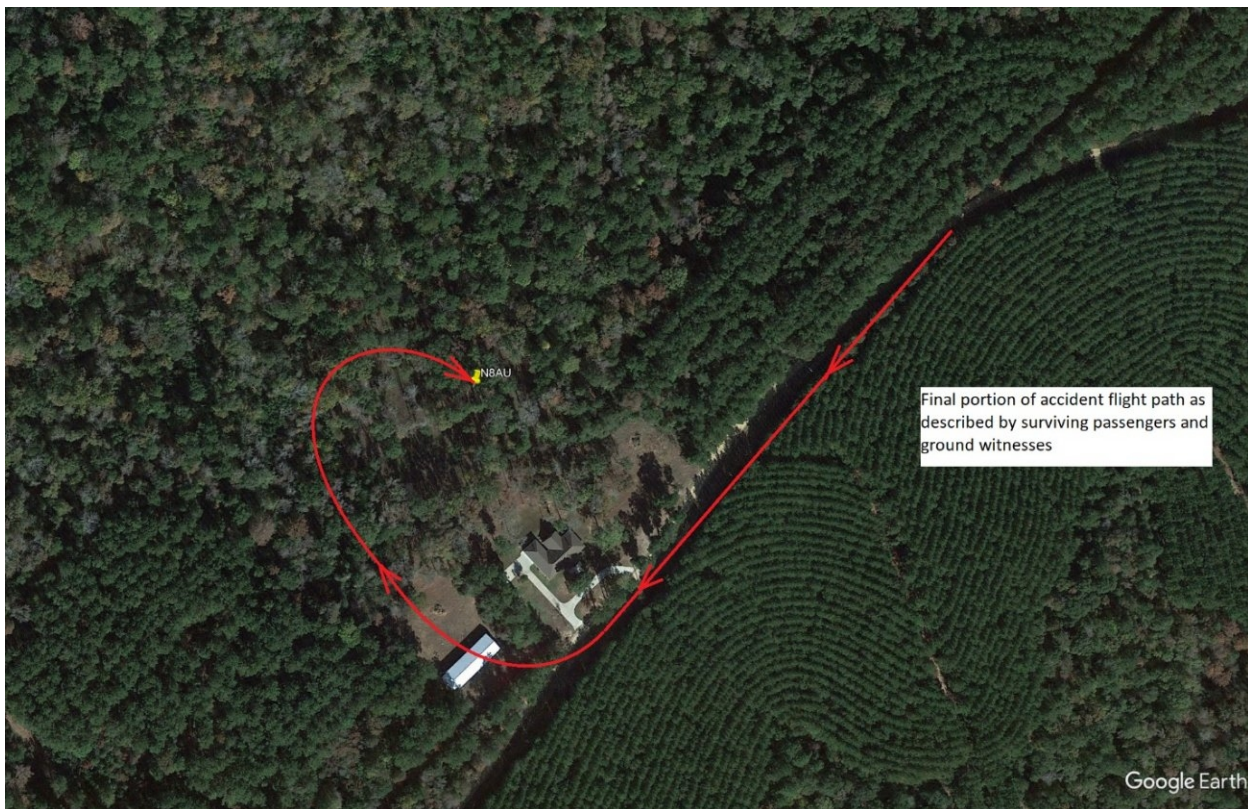
Figure 2. Depiction of the Flight Final Path to the Accident Site

According to the surviving passengers, the flight was a sightseeing flight that the deceased front-seat passenger had won at a local charity auction. On the day of the accident, the passengers met the pilot at 00R. The original intent was to fly over the deceased passenger's childhood home near Woodville, TX. While on course toward Woodville, it became evident that the flight could not be continued due to low clouds and the helicopter was then maneuvered to the passenger's current residence near Livingston, TX. The rear-seat passengers stated that the helicopter flew down the road where the residence was located and then around the house making a level right turn at low speed. The helicopter then flew over a pond on the property and toward the house. As the helicopter approached the house it was facing a south direction and came to a hover above the trees where the accident occurred. The passengers stated that the helicopter was either motionless in the hover or slightly drifting.

Once in the hover, the helicopter began to rotate to the right, which one passenger initially thought was the pilot intentionally maneuvering the helicopter. The helicopter continued to rotate, and the passenger realized the rotation was not intentional. The helicopter rotated about two full revolutions before striking a tree with the rotor blades and descending to the ground. It came to rest on its left side on top of a wood pile that had been created due to land clearing. One passenger noticed, after attending to the pilot and front-seat passenger, that the

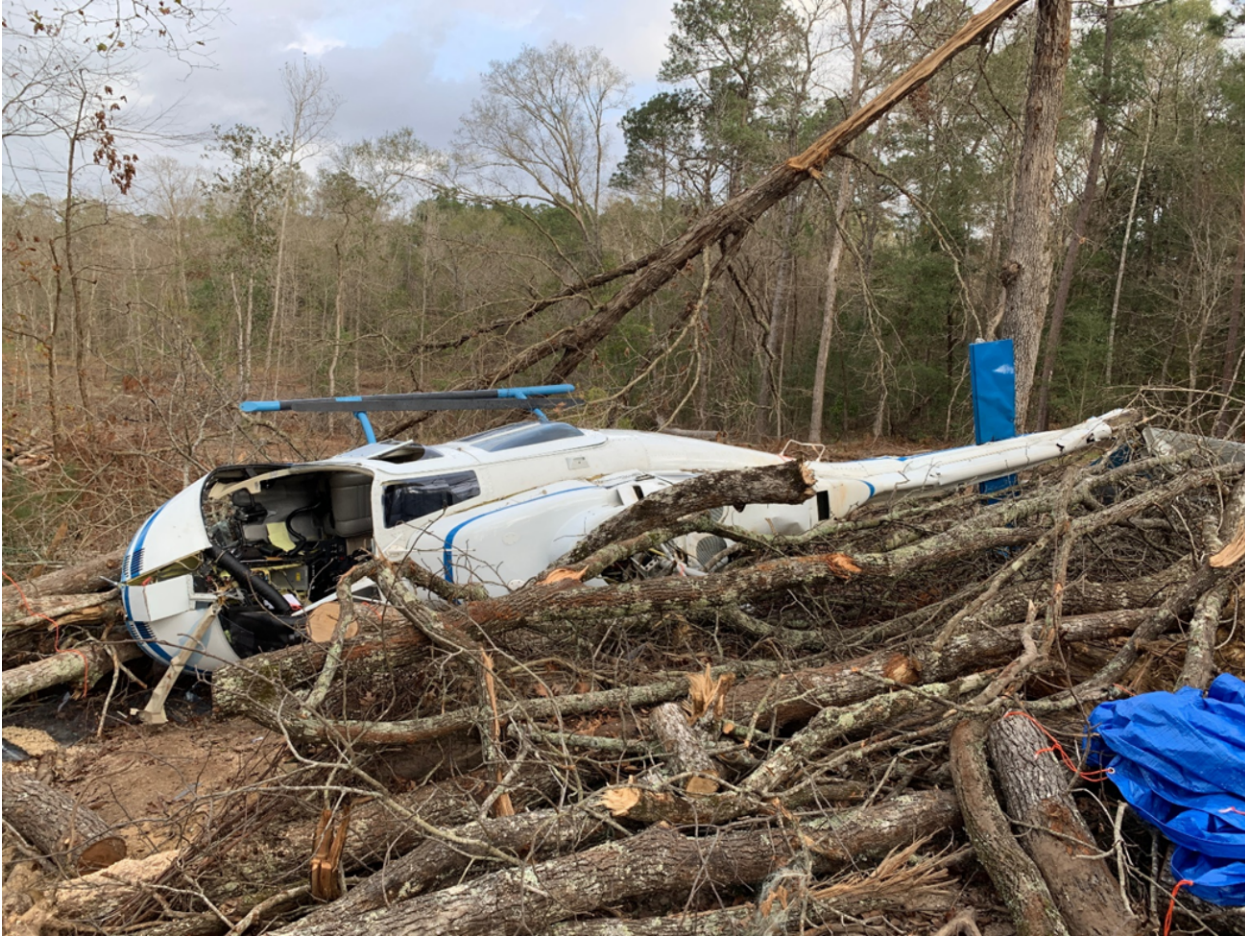
Figure 3. Helicopter as viewed during on-scene examination (NTSB Photo)

The helicopter impacted terrain and rolled over onto its left side coming to rest on a pile of logs. The forward fuselage and left side fuselage and tail boom sustained substantial damage. The main and tail rotors were separated. The elevation at the accident site was about 250 ft above mean sea level.

Postaccident examination of the helicopter did not reveal any preimpact failures or malfunctions with the airframe, rotor systems, engine, or flight controls that would have precluded normal operations.
