# Aviation Investigation Factual Report

<b>Location:</b>	Rowlett, Texas	<b>Accident Number:</b>	CEN22FA151
<b>Date &amp; Time:</b>	March 25, 2022, 11:27 Local	<b>Registration:</b>	N514CD
<b>Aircraft:</b>	ROBINSON HELICOPTER R44	<b>Aircraft Damage:</b>	Destroyed
<b>Defining Event:</b>	Loss of control in flight	<b>Injuries:</b>	2 Fatal
<b>Flight Conducted Under:</b>	Part 91: General aviation - Instructional

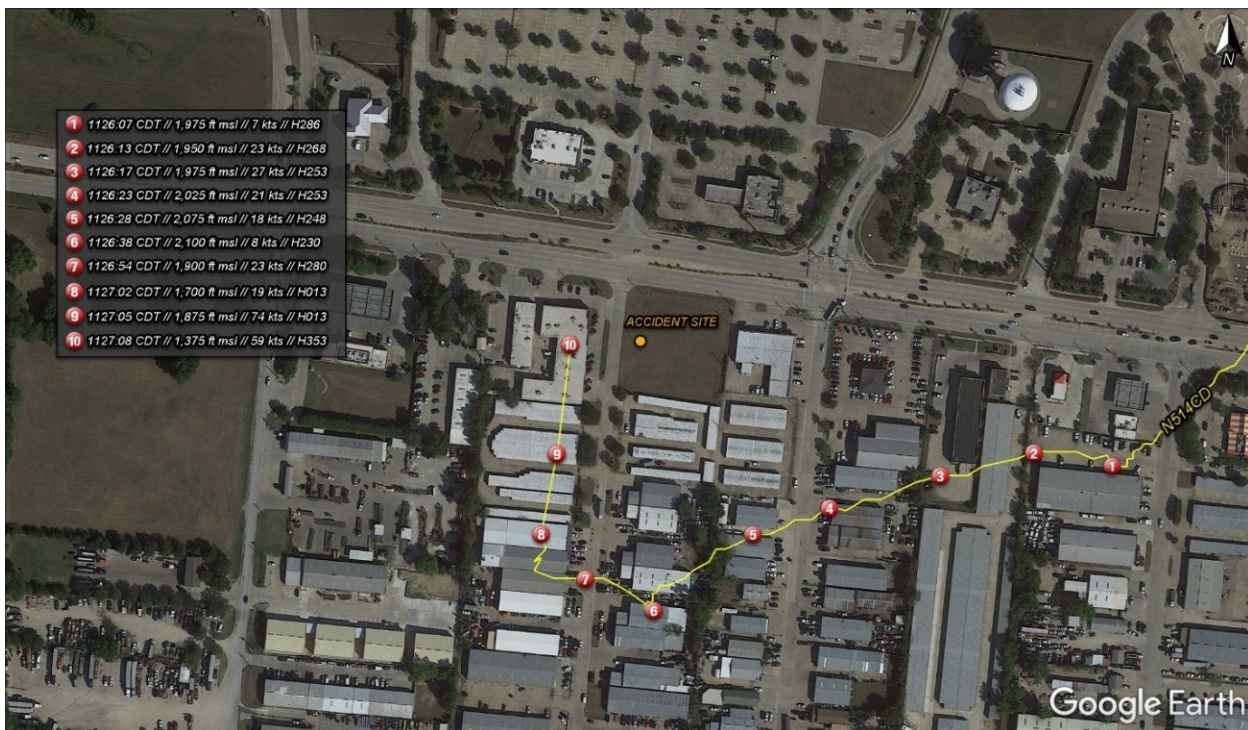
Figure 1. Final Minute of Flight Track from ADS-B Data

Video provided to the National Transportation Safety Board (NTSB) showed the helicopter and its separated tailboom and tail rotor section falling. The video did not show the actual in-flight separation of the tail section. About the last minute of the automatic dependent surveillance – broadcast (ADS-B) data for the flight showed that the helicopter was maneuvering at various slow airspeeds and altitudes. At 1126:07, the helicopter was about 1,975 ft mean sea level (msl) and flying at 7 knots ground speed. (See figure 1.)

The ADS-B data points were consistent with a witness report. The witness heard the helicopter and did not think much of it until after a minute, when he noticed that the helicopter was not moving. He then looked up and saw the helicopter hovering in one place and assumed that it was taking photos of the area. Continuing to observe the helicopter, the witness saw it move about 100 ft and hovered in one place again. After about 10 seconds, the helicopter moved about another 100 ft and hovered. The witness then observed something separate from the helicopter. He saw the helicopter start to go backwards and the tail section fell toward the west. He then saw the helicopter spiraling and falling for about 100 ft. The helicopter stopped falling and spinning for a couple of seconds. Then the helicopter started to spin again and nose-dived to the ground.
