# Aviation Investigation Factual Report

<b>Location:</b>	Livermore, California	<b>Accident Number:</b>	WPR22LA174
<b>Date &amp; Time:</b>	May 11, 2022, 09:30 Local	<b>Registration:</b>	N999GH
<b>Aircraft:</b>	BELL HELICOPTER TEXTRON CANADA 407	<b>Aircraft Damage:</b>	Substantial
<b>Defining Event:</b>	Miscellaneous/other	<b>Injuries:</b>	1 Serious, 1 Minor
<b>Flight Conducted Under:</b>	Part 133: Rotorcraft ext. load

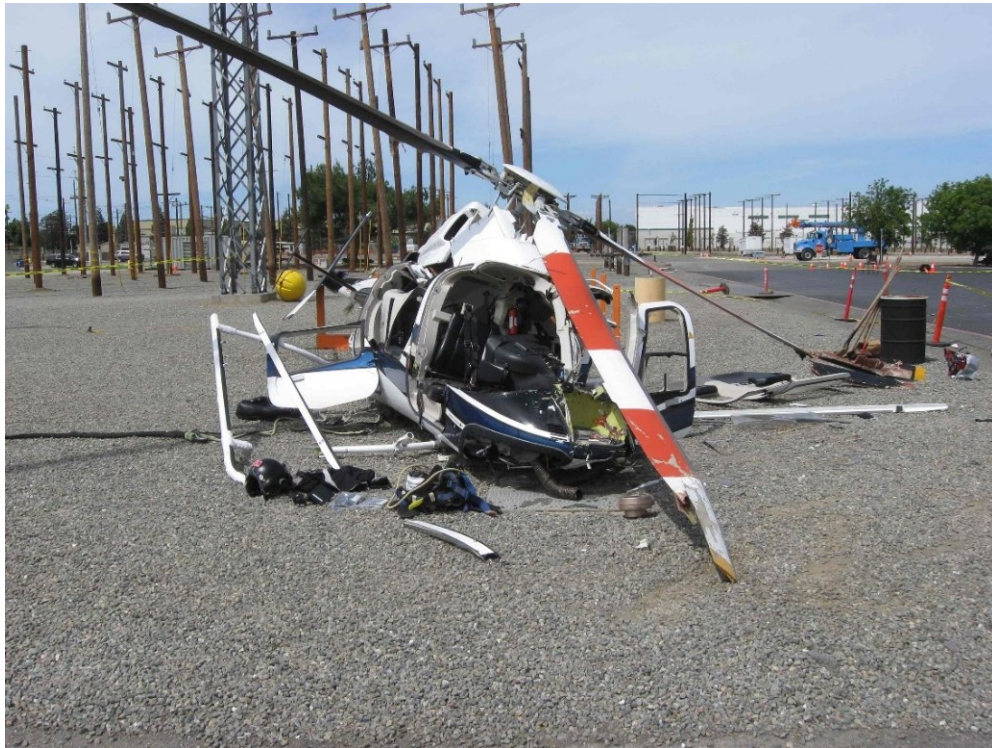
The helicopter came to rest on its belly and was tilted slightly to the left (see Figures 1 and 2). The landing skids had spread outwards on both sides. The primary airframe structure was largely intact but had buckled in the roof area below the main transmission, which had moved out of position and was tilted slightly down. All four main rotor blades remained attached to the hub assembly; one blade was essentially undamaged and the remaining three had sustained delamination, aft bending, and buckling damage from midspan outwards. The tailboom remained attached to the aft bulkhead, and both tail rotor blades had detached with their roots remaining on the hub.

Figure 1– Helicopter at the accident site (photo courtesy of the FAA).

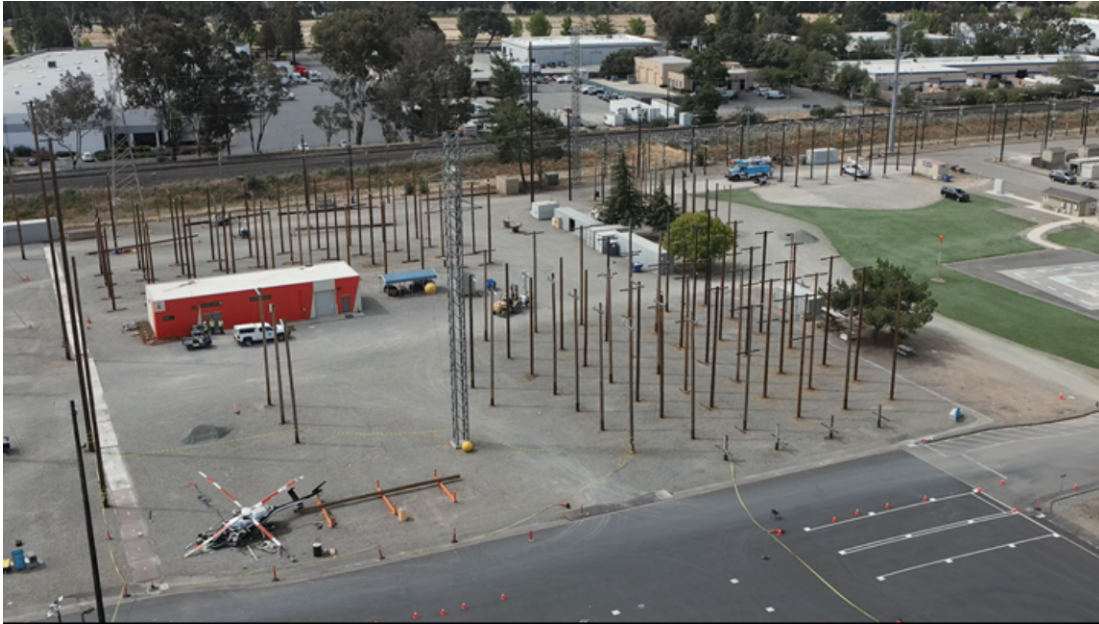
Figure 2 - Accident location within training facility (photo courtesy of PG&E).
