# Aviation Investigation Factual Report

<b>Location:</b>	Clear, Alaska	<b>Accident Number:</b>	ANC22FA047
<b>Date &amp; Time:</b>	June 26, 2022, 19:38 Local	<b>Registration:</b>	N9970F
<b>Aircraft:</b>	Bell UH1B	<b>Aircraft Damage:</b>	Destroyed
<b>Defining Event:</b>	Unknown or undetermined	<b>Injuries:</b>	1 Fatal
<b>Flight Conducted Under:</b>	Part 133: Rotorcraft ext. load

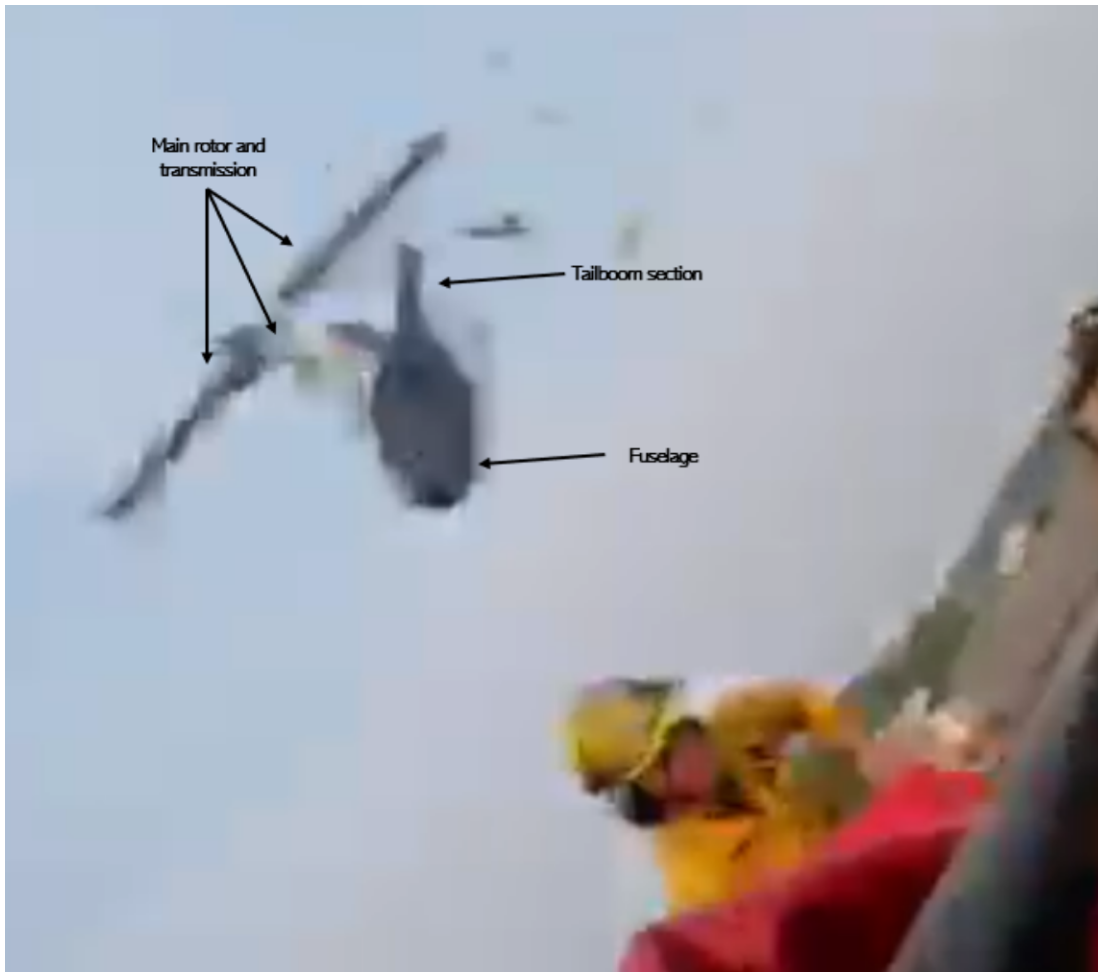
A witness video camera captured the helicopter’s final seconds before impact with the ground. A review of the recording revealed that that the helicopter was hovering with the 125-ft longline fully extended below the helicopter, and the hook at the end of the line was about 15 ft above the ground. As the pilot maneuvered the helicopter to hook up to the external load, a loud mechanical noise could be heard, after which a shudder is seen radiating through the helicopter’s airframe, followed by an extreme roll to the right past 90°, and a nose-low descent. As the descent continued, the transmission (with the rotor head and blades attached) along with the tail boom separated from the fuselage before ground impact. (See figure 1.)

Figure 1 - Screen capture of the end of the video showing the separation of the main rotor and transmission from the airframe before ground impact.

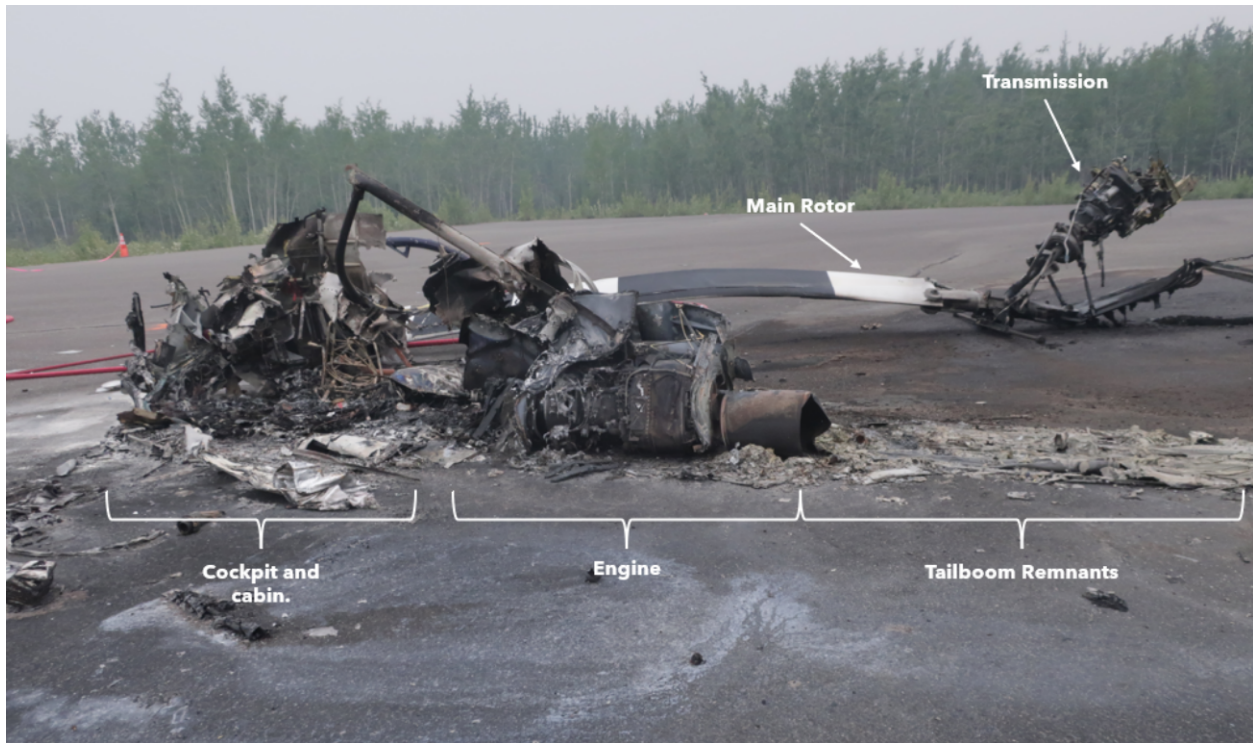
*Figure 2 - Main wreckage*

The helicopter impacted the asphalt on the north ramp area of Z84 on its left side in a nose-low attitude and was largely consumed by postcrash fire. The engine's transmission, with the rotor head and blades still attached, was found about 30 ft from the main wreckage. (See figure 2.)
