Aviation Investigation Factual Report

Location:	Chapelle, New Mexico	Accident Number:	CEN22FA317
Date & Time:	July 16, 2022, 19:20 Local	Registration:	N911SZ
Aircraft:	Bell UH-1H	Aircraft Damage:	Destroyed
Defining Event:	Powerplant sys/comp malf/fail	Injuries:	4 Fatal
Flight Conducted Under:	Public aircraft

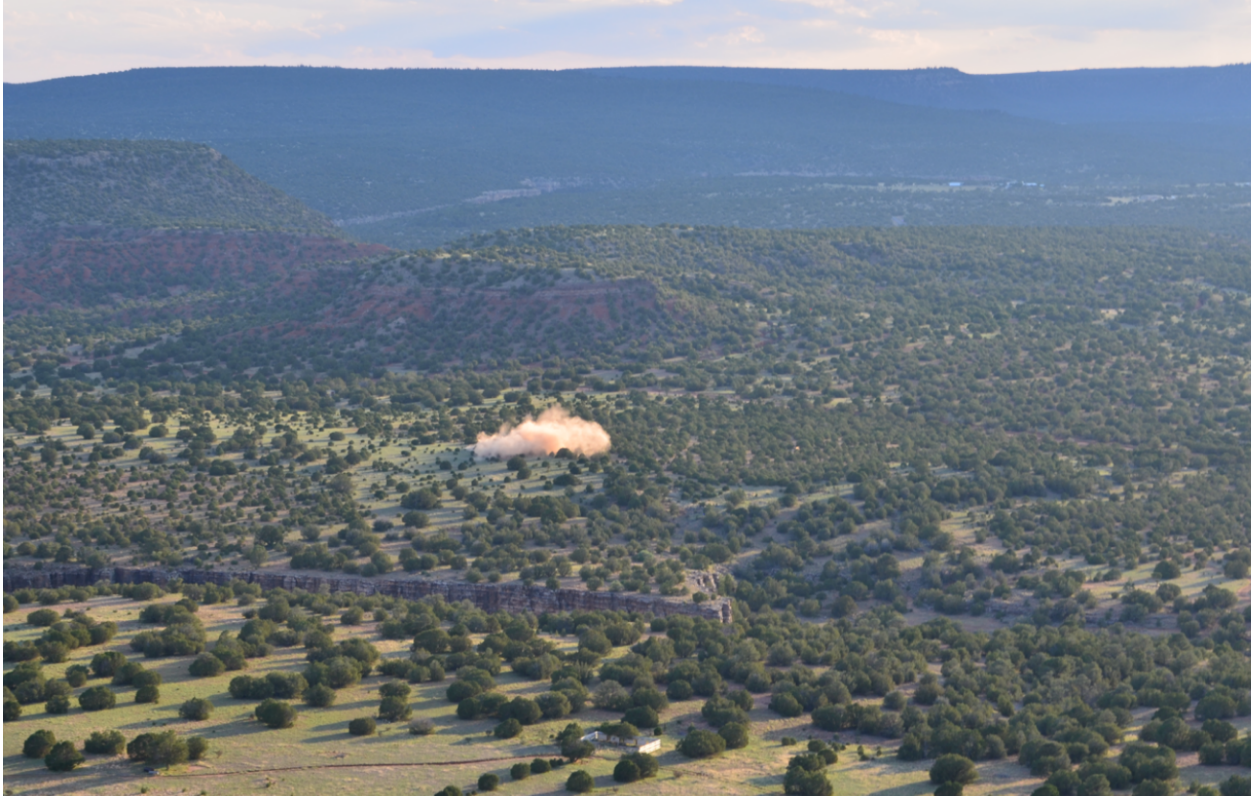
Two witnesses observing the sunset from a ridge about 0.5 mile east of the accident site reported that the helicopter flew past their location westbound, then rapidly descended without making any turns. After the helicopter impacted the ground, a large plume of dust was observed. (See photo 1.)

Photo 1. Accident Site Area with Dust from Helicopter (provided by witness)
