# Aviation Investigation Factual Report

<b>Location:</b>	Shady Cove, Oregon	<b>Accident Number:</b>	WPR22LA330
<b>Date &amp; Time:</b>	September 1, 2022, 07:35 Local	<b>Registration:</b>	N617CK
<b>Aircraft:</b>	Sikorsky S-61N	<b>Aircraft Damage:</b>	Substantial
<b>Defining Event:</b>	Loss of engine power (total)	<b>Injuries:</b>	2 Minor
<b>Flight Conducted Under:</b>	Part 133: Rotorcraft ext. load

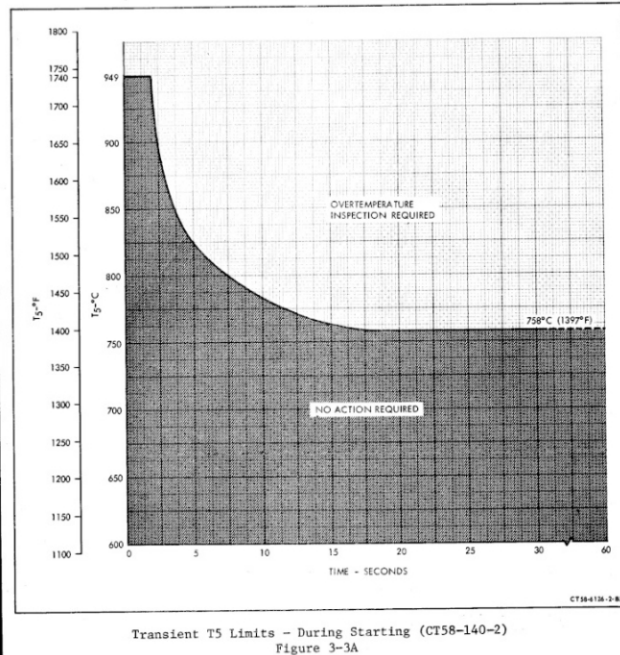
Figure 1: Engine manufacturer Hot Start guidance

The PIC stated that he did not report the hot start event to the operator’s director of maintenance because he understood a hot start to entail a T5 temperature of 950° C sustained over 2 seconds. Guidance from the engine manufacturer indicated that hot start criteria are based on a combination of temperature over time, and that hot starts may occur at temperatures of approximately 750° C within about 15 seconds (see figure 1).
