# Aviation Investigation Factual Report

<b>Location:</b>	Fresno, California	<b>Accident Number:</b>	WPR23LA004
<b>Date &amp; Time:</b>	October 1, 2022, 09:55 Local	<b>Registration:</b>	N284CA
<b>Aircraft:</b>	Bell 206B	<b>Aircraft Damage:</b>	Substantial
<b>Defining Event:</b>	Sys/Comp malf/fail (non-power)	<b>Injuries:</b>	2 Serious
<b>Flight Conducted Under:</b>	Part 91: General aviation - Other work use

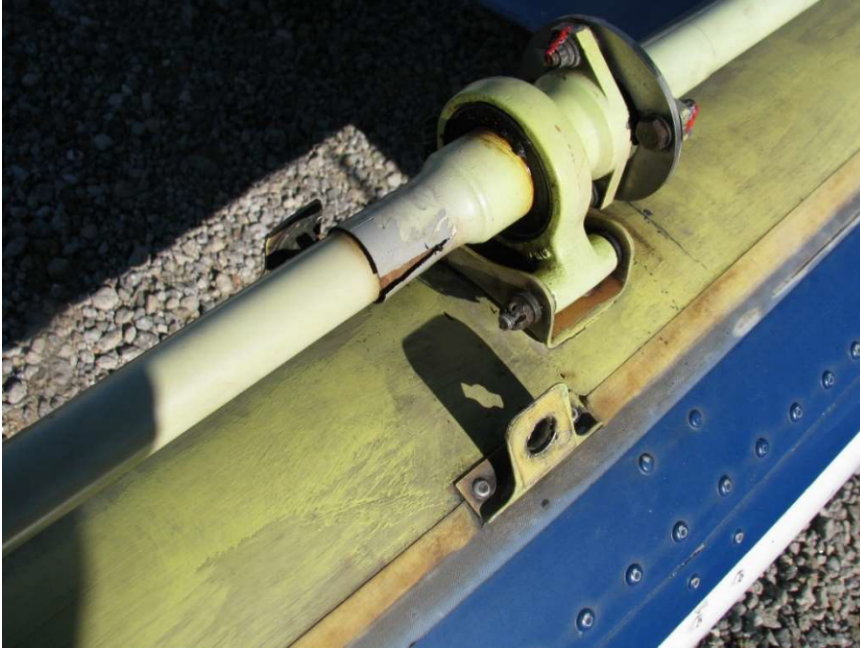
Postaccident examination of the helicopter found that the No. 4 segmented tail rotor drive shaft and the splined adapter on the forward end of the drive shaft had separated from the drive shaft tube. The area of separation was consistent with a disbond between the splined adapter and the drive shaft tube. The No. 4 segmented tail rotor drive shaft was retained for further examination.

The No. 4 segmented tail rotor drive shaft was shipped to the National Transportation Safety Board Materials Lab for further examination. The lab examination of the No. 4 segmented tail rotor drive shaft found no evidence of anomalous damage within the splined connection. The serial number marking “VN12657” was observed on the outer surface of the splined adapter.

The outer diameter of the splined adapter at the aft end was tapered (the thickness of the outer diameter continuously decreases towards the aft end), while the inner diameter remained constant. The thickness measurements for the tapered wall were below the specified limits. The adhesive material between the drive shaft tube and the splined adapter showed evidence of heating and resolidification. The main wall thickness of the drive shaft tube measured approximately 0.051 inch, which is within the specified thickness. The outer diameter measured approximately 1.004 inch, which was within specified limits. The inner diameter measured approximately 0.9 inch, which was within specified limits.

*Figure 1: The separated splined adapter at the forward end of the No. 4 segmented tail rotor drive shaft. Photo courtesy of Bell Helicopters.*
