# **Aviation Investigation Factual Report**

Location: Las Vegas, Nevada Accident Number: WPR23LA041

**Date & Time:** November 18, 2022, 10:27 Local **Registration:** N88E (A1); N4050P

Midair collision

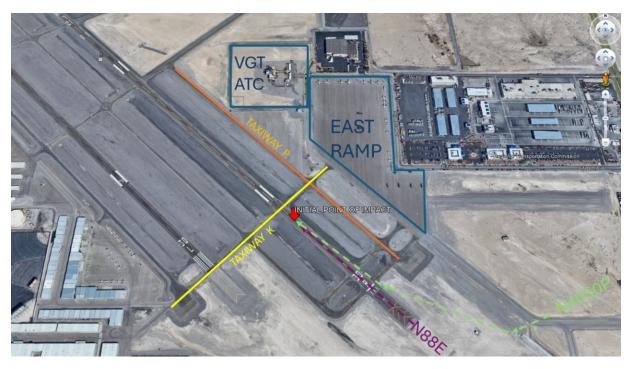
At 10:27, the controller instructed the accident helicopter to, when able, make a right turn on taxiway Kilo, and that landing on the east ramp was at the pilot's own risk. (See Figure 2.) The pilot responded by stating "Las Vegas tower, five zero papa." The controller again instructed the helicopter pilot to make a right turn onto taxiway Kilo. The pilot did not acknowledge the instruction.

Figure 2. View of initial point of impact in relation to Taxiway Papa, Taxiway Kilo, the East Ramp, and ATC.

The student pilot in the accident helicopter, who was conducting a solo instructional flight, reported that he had departed from taxiway Papa, flew the right-hand traffic pattern, and was instructed by the controller to fly his approach to taxiway Papa. However, he reported that he mistakenly flew his approach to runway 30R and terminated the approach in a hover over the runway. Video surveillance footage shows that the nose of the helicopter was oriented in the landing direction; the student pilot reported being unaware that an airplane was on approach to land on the runway. The airplane collided with the aft section of the skids and the helicopter pitched up, rotated left about 90° and landed upright on the runway.
