Aviation Investigation Factual Report

Location: Las Vegas, Nevada Accident Number: WPR23LA041

Date & Time: November 18, 2022, 10:27 Local **Registration:** N88E (A1); N4050P

Aircraft: Cessna 172M (A1); ROBINSON HELICOPTER R44 (A2) Aircraft Damage: Substantial (A1); Minor (A2)

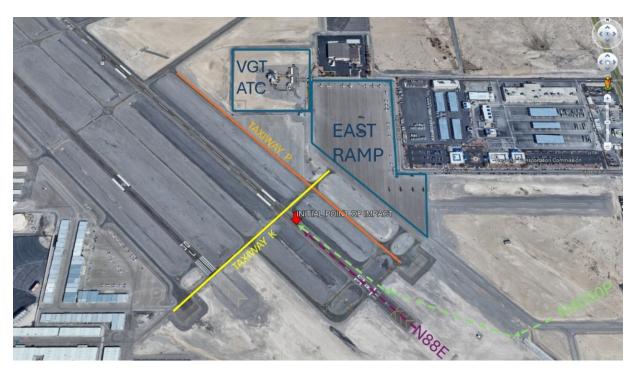
At 10:27, the controller instructed the accident helicopter to, when able, make a right turn on taxiway Kilo, and that landing on the east ramp was at the pilot's own risk. (See Figure 2.) The pilot responded by stating "Las Vegas tower, five zero papa." The controller again instructed the helicopter pilot to make a right turn onto taxiway Kilo. The pilot did not acknowledge the instruction.

Figure 2. View of initial point of impact in relation to Taxiway Papa, Taxiway Kilo, the East Ramp, and ATC.
