# Aviation Investigation Factual Report

<b>Location:</b>	San Diego, California	<b>Accident Number:</b>	WPR23LA045
<b>Date &amp; Time:</b>	November 22, 2022, 17:57 Local	<b>Registration:</b>	N160AQ (A1); 166583 (A2)
<b>Aircraft:</b>	Sikorsky UH-60A (A1); Sikorsky MH-60R (A2)	<b>Aircraft Damage:</b>	Substantial (A1); Substantial (A2)
<b>Defining Event:</b>	Collision during takeoff/land	<b>Injuries:</b>	2 None (A1); 3 None (A2)
<b>Flight Conducted Under:</b>	Part 91: General aviation - Instructional (A1); Armed Forces (A2)

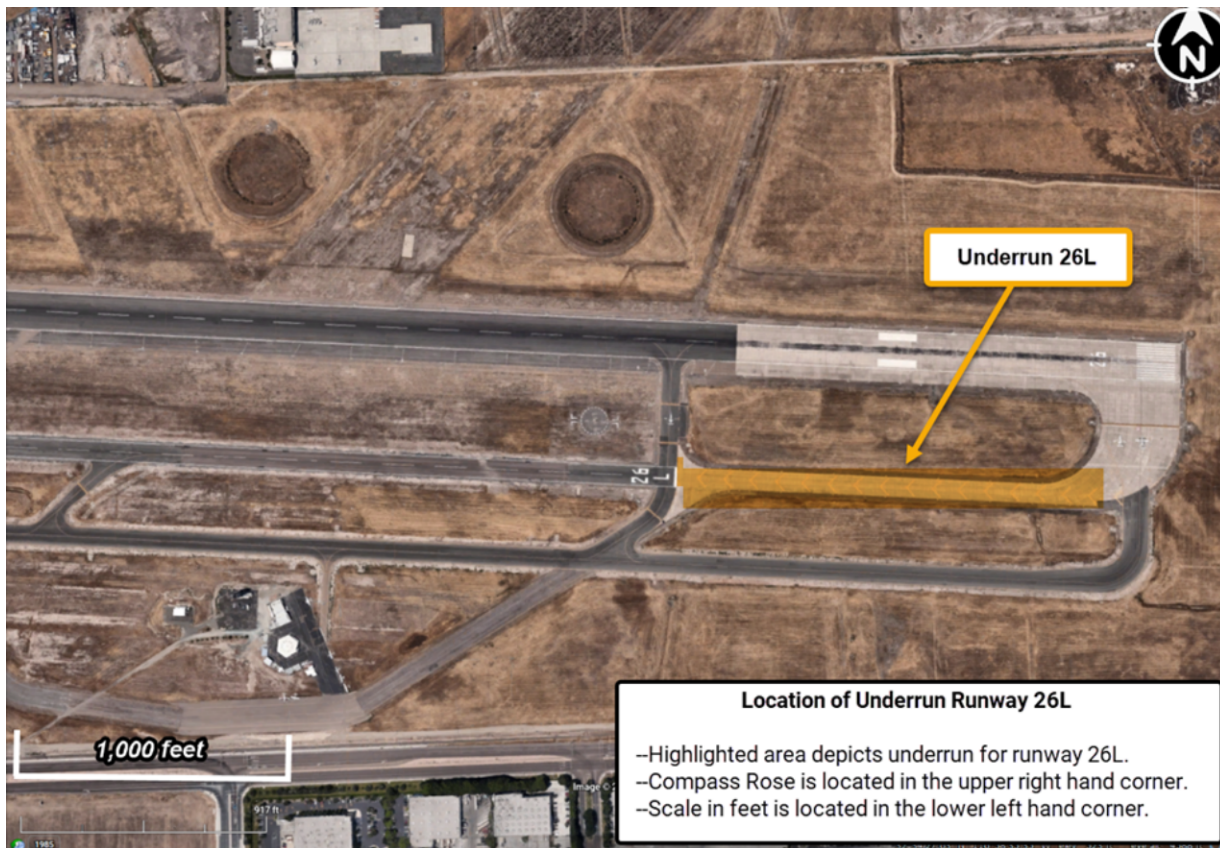
Figure 1. Google Earth image of SDM, showing the underrun runway 26L.

During postaccident interviews, ATCT personnel explained that the underrun was a non-movement portion of runway 26L, about 1,800 to 2,000 ft long, that was neither maintained by the airport nor lighted. The underrun was used for helicopter operations by civilian and military helicopters without written procedures. According to the air traffic manager, runway 26L was not approved for UH-60 helicopters to touch down on the runway because of the weight restriction. A review of airport data revealed the weight bearing capacity for runway 26L was 12,500 pounds.
