Aviation Investigation Factual Report

Location:	Yuma, Arizona	Accident Number:	WPR23LA107
Date & Time:	February 6, 2023, 21:35 Local	Registration:	N36FA
Aircraft:	Bell OH-58A	Aircraft Damage:	Substantial
Defining Event:	Unknown or undetermined	Injuries:	1 Minor
Flight Conducted Under:	Part 137: Agricultural

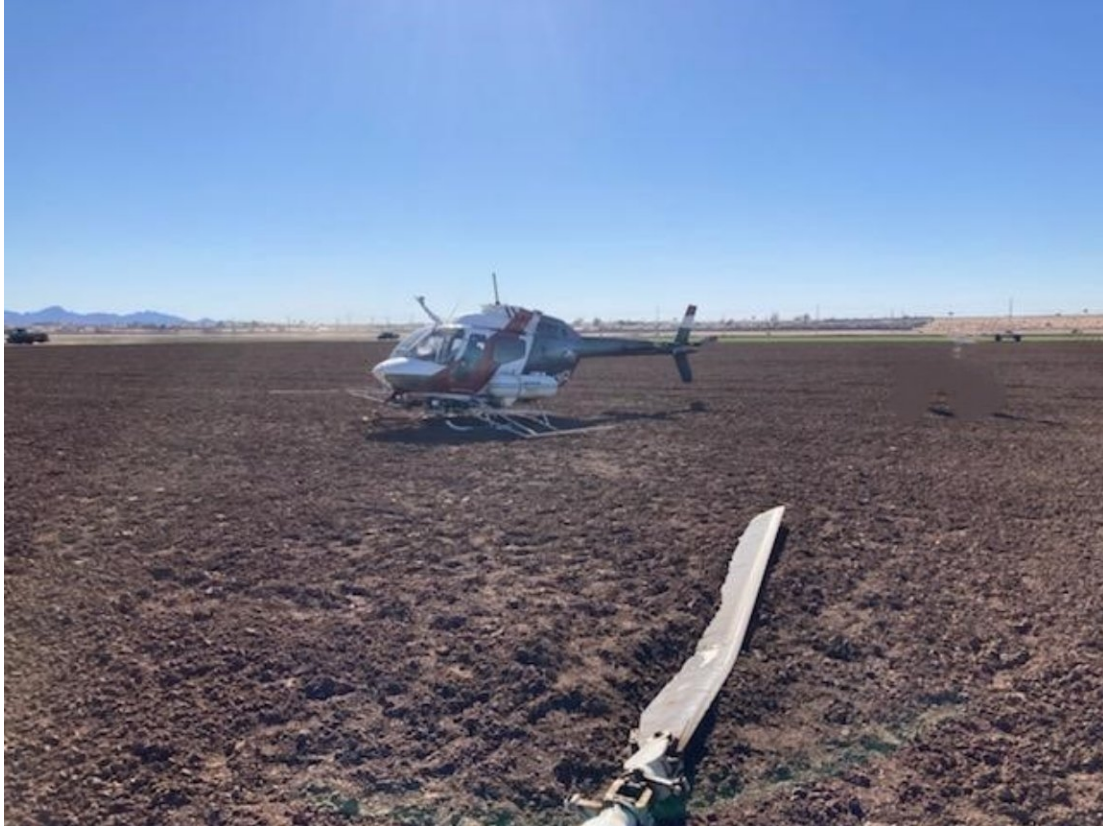
The pilot stated that he landed in night conditions on the load truck and the chemical hopper was filled with 50 gallons of water to rinse out the applicator system. The pilot departed from the load truck toward an open field about 200 yards away. While maneuvering about 40 ft above ground level, with a speed near effective translational lift, and about 80% transmission torque, the helicopter suddenly started to bounce and yaw. The pilot stated that, when the spray tank was almost empty, the helicopter began to “bounce and tilt in all directions,” then “fish-tailed” before the engine lost total power. The pilot arrested the helicopter’s forward movement by pulling back on the control stick and leveled the helicopter while lowering the collective. Unable to judge his height above the ground, the pilot alternately raised and lowered the collective to control the descent, and the helicopter landed hard in the dirt field, and a main rotor blade struck and severed the tail rotor driveshaft. The main rotor and blades assembly separated from the mast and landed about 100 ft from the upright helicopter, as shown in Figure 1.

Figure 1 - Main rotor yoke and blades (Photo courtesy of operator)
