# Aviation Investigation Factual Report

<b>Location:</b>	Nuevo, California	<b>Accident Number:</b>	ANC23FA031
<b>Date &amp; Time:</b>	March 24, 2023, 12:17 Local	<b>Registration:</b>	N14Z
<b>Aircraft:</b>	BELL HELICOPTER TEXTRON 407	<b>Aircraft Damage:</b>	Destroyed
<b>Defining Event:</b>	Low altitude operation/event	<b>Injuries:</b>	2 Fatal
<b>Flight Conducted Under:</b>	Part 91: General aviation - Personal

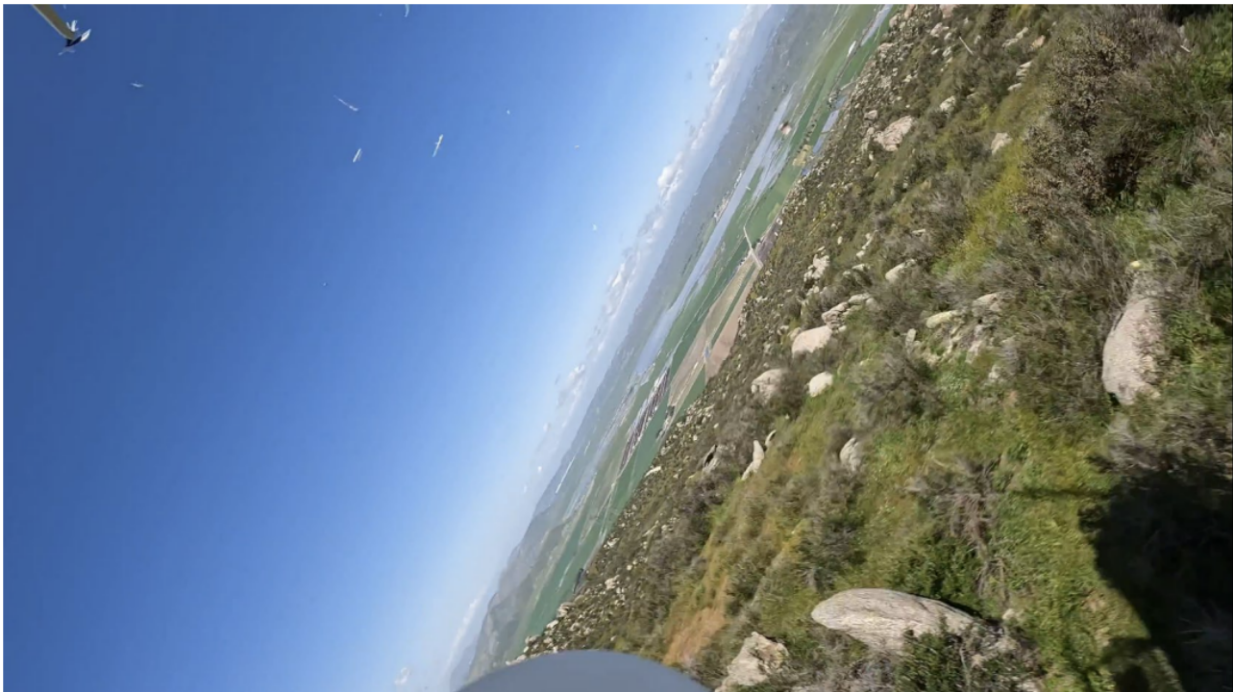
Moments later, as the helicopter passed over a rocky outcropping at the top of the hill, the main rotor blade contacted terrain and shards of main rotor blades can be seen on the video. See figure 2.

Figure 2. Video frame from on board Go-Pro camera at point of impact, with portions of fragmented main rotor blade seen in upper left of photo.
