Aviation Investigation Factual Report

| Location: | Nuevo, California | Accident Number: | ANC23FA031 |
| Date & Time: | March 24, 2023, 12:17 Local | Registration: | N14Z |
| Aircraft: | BELL HELICOPTER TEXTRON 407 | Aircraft Damage: | Destroyed |

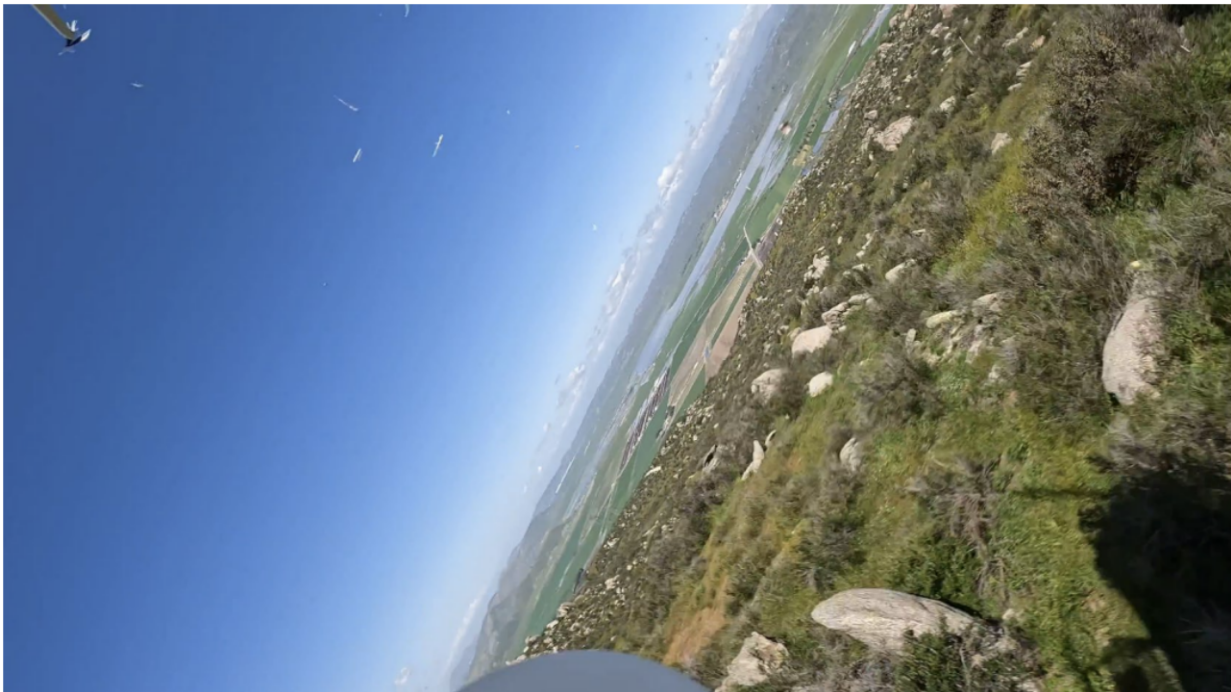
Moments later, as the helicopter passed over a rocky outcropping at the top of the hill, the main rotor blade contacted terrain and shards of main rotor blades can be seen on the video. See figure 2.

Figure 2. Video frame from on board Go-Pro camera at point of impact, with portions of fragmented main rotor blade seen in upper left of photo.
