Aviation Investigation Factual Report

Location:	Port Allen, Louisiana	Accident Number:	CEN23FA142
Date & Time:	March 26, 2023, 02:38 Local	Registration:	N441PD
Aircraft:	ROBINSON HELICOPTER COMPANY R44 II	Aircraft Damage:	Destroyed
Defining Event:	VFR encounter with IMC	Injuries:	2 Fatal
Flight Conducted Under:	Part 91: General aviation - Aerial observation

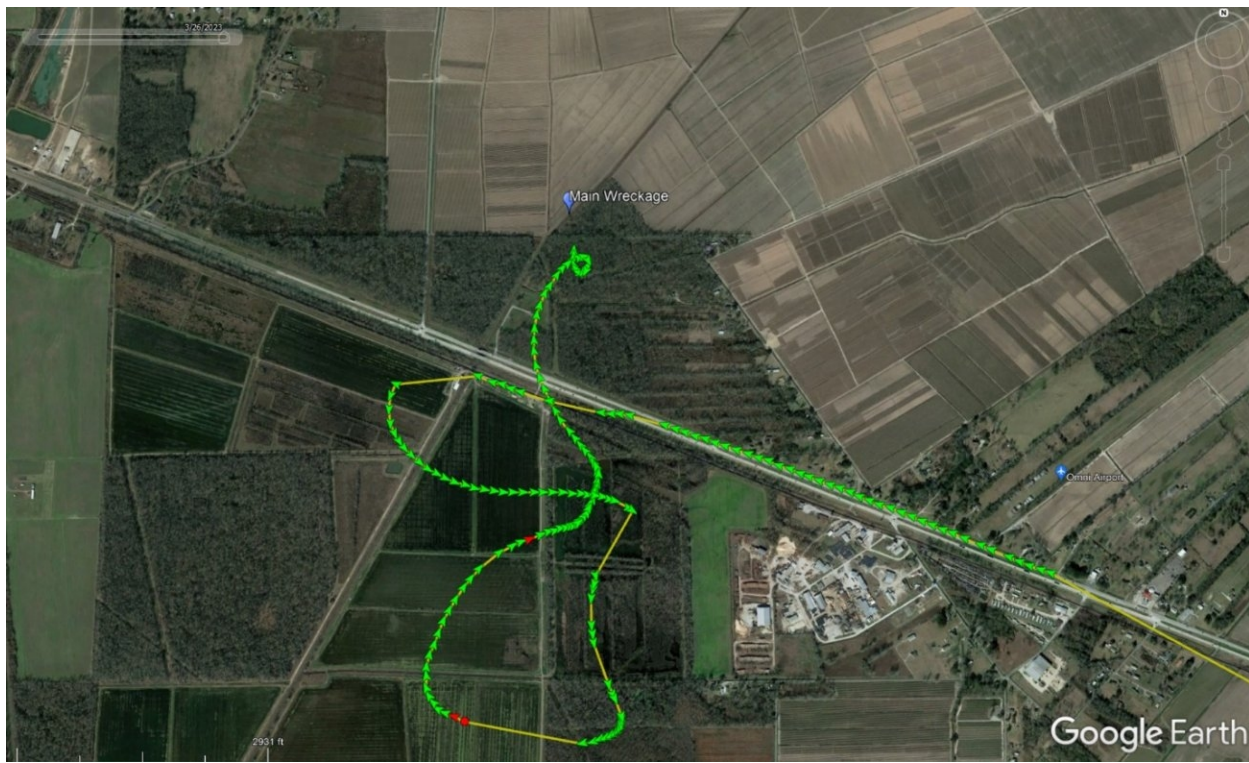
Figure

According to Baton Rouge Police Department (BRPD) personnel and ADS-B data, the BRPD helicopter, call sign Air 1, departed the Baton Rouge Metropolitan Airport (BTR), Baton Rouge, Louisiana, about 0226, to provide aerial support to BRPD ground units that were conducting a high-speed pursuit of a fleeing vehicle. Air 1 advised dispatch and ground units via radio that they were assisting and requested updates to the vehicle movement and location. ADS-B data showed the helicopter depart BTR to the south, turned west, then overfly Highway 190, west of Baton Rouge. Unable to maintain a safe pursuit of the vehicle, BRPD dispatch terminated the pursuit to all BRPD units, including the helicopter, via radio at 0235. There were no further communications received from the helicopter. About that time, the data showed the helicopter executed a shallow left deviation to the south of Highway 190. Following the deviation, a left turn was initiated and the turn rate increased. The initial turn was followed by a series of turns and altitude changes (see Figures 1 and 2). The ADS-B data ended at 0238 at an altitude of about 1,450 agl. There were no witnesses to the accident.

1. ADS-B data overlayed on Google Earth.

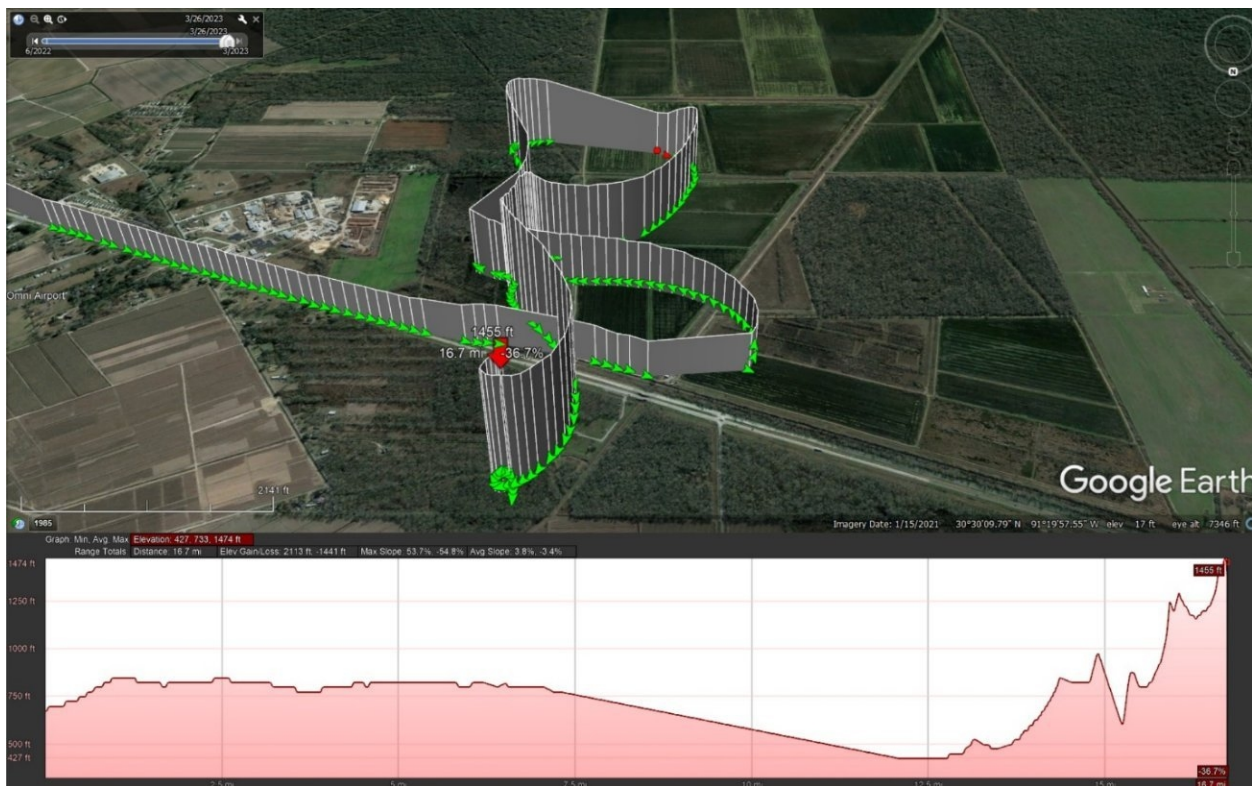
Figure 2. ADS-B data overlayed on Google Earth with an altitude profile.
