Aviation Investigation Factual Report

Location:	Port Allen, Louisiana	Accident Number:	CEN23FA142
Date & Time:	March 26, 2023, 02:38 Local	Registration:	N441PD
Aircraft:	ROBINSON HELICOPTER COMPANY R44 II	Aircraft Damage:	Destroyed
Defining Event:	VFR encounter with IMC	Injuries:	2 Fatal
Flight Conducted Under:	Part 91: General aviation - Aerial observation

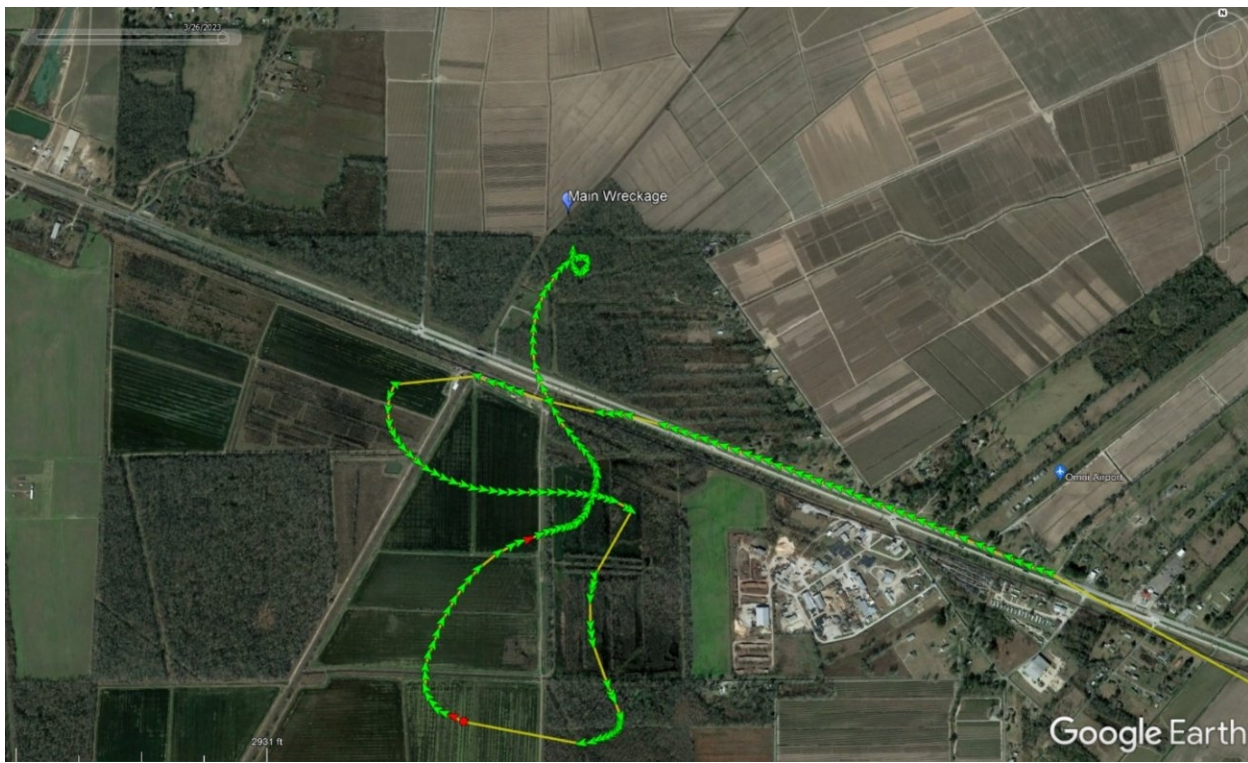
Figure

1. ADS-B data overlaid on Google Earth.

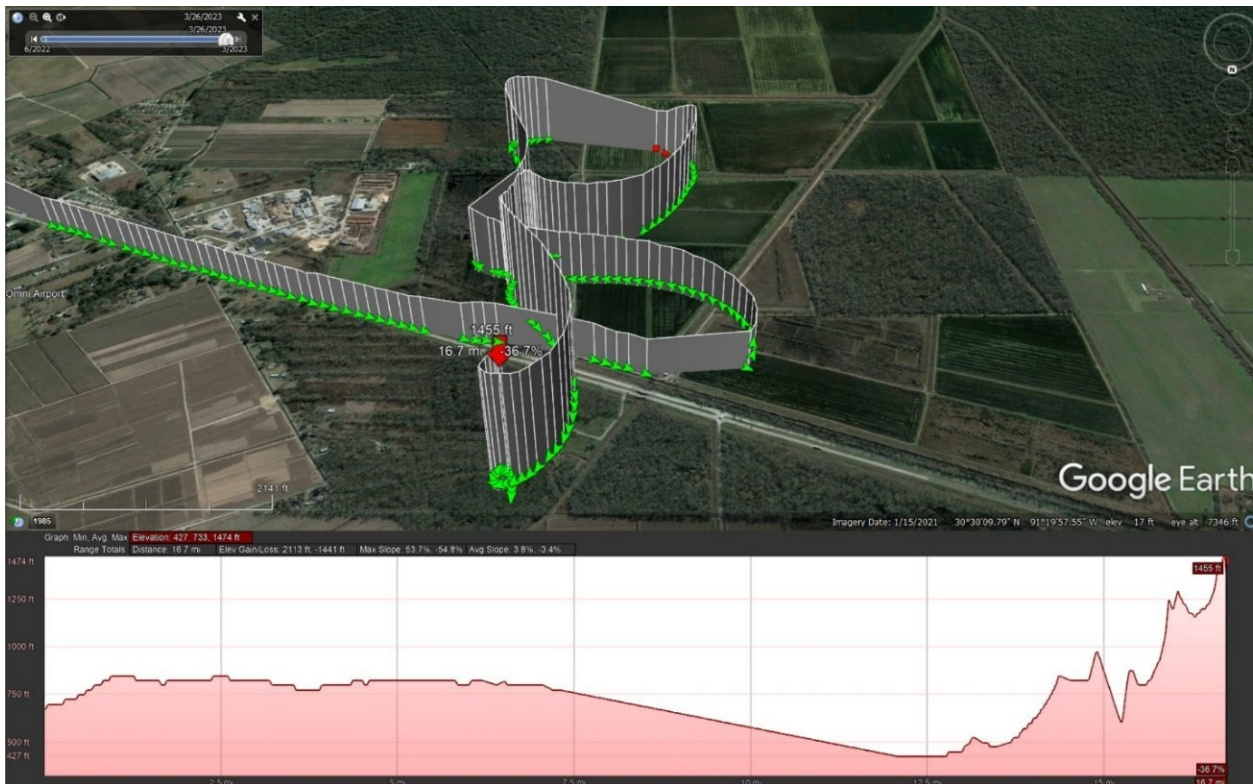
Figure 2. ADS-B data overlaid on Google Earth with an altitude profile.
