# Aviation Investigation Factual Report

<b>Location:</b>	Oshkosh, Wisconsin	<b>Accident Number:</b>	CEN23FA333
<b>Date &amp; Time:</b>	July 29, 2023, 12:27 Local	<b>Registration:</b>	N193AZ (A1); N221EL (A2)
<b>Aircraft:</b>	Rotorway 162F (A1); ELA ECLIPSE 10 (A2)	<b>Aircraft Damage:</b>	Destroyed (A1); Destroyed (A2)
<b>Defining Event:</b>	Midair collision	<b>Injuries:</b>	2 Fatal (A1); 2 Serious (A2)
<b>Flight Conducted Under:</b>	Part 91: General aviation - Personal (A1); Part 91: General aviation - Personal (A2)

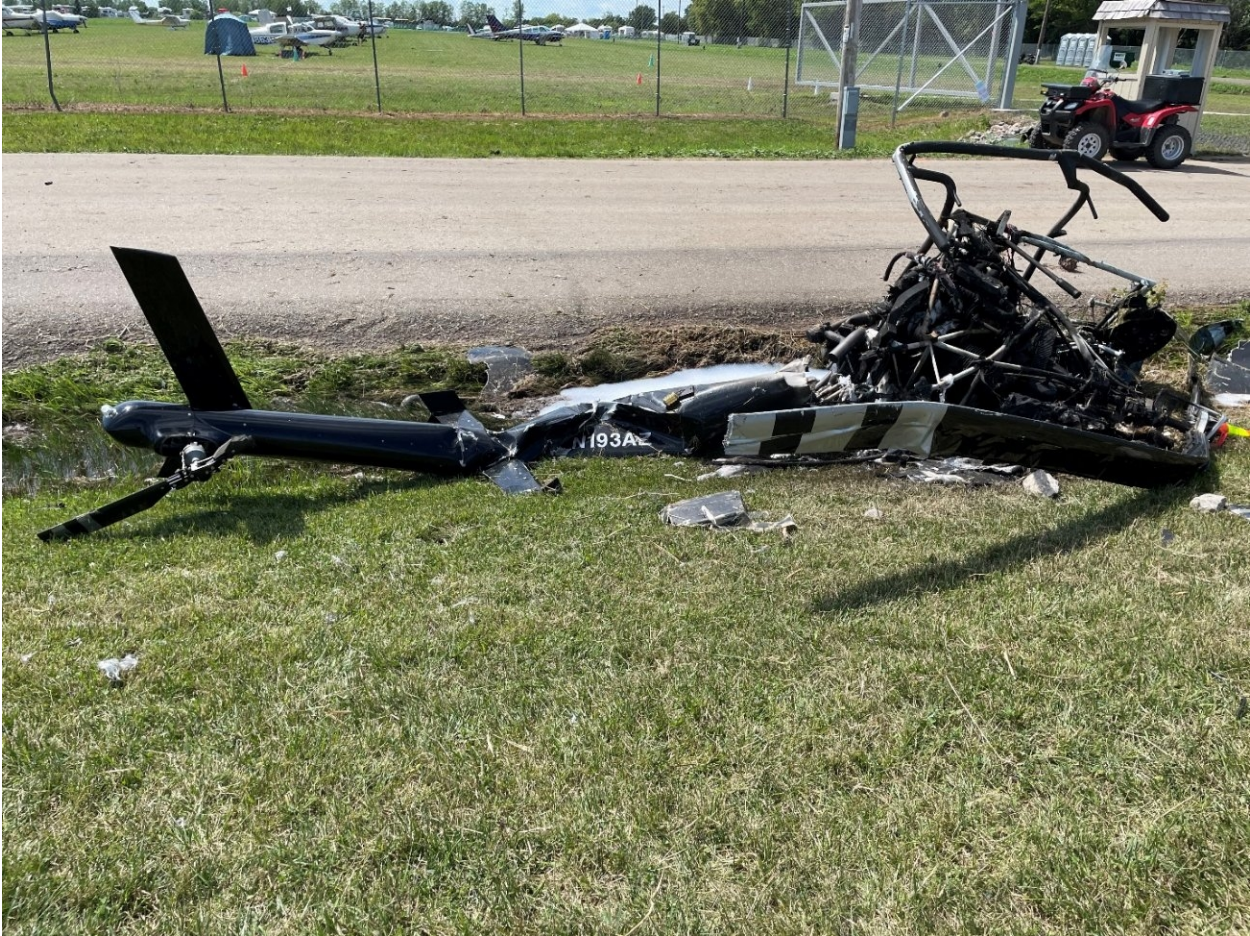
Both aircraft descended in a near-vertical attitude with debris separating from both aircraft. The helicopter impacted terrain, came to rest inverted, and a postaccident fire ensued (see figure 2). The gyroplane impacted an unoccupied airplane that was parked between the north/south paved road and runway 36L (see figure 3). No ground injuries were reported.

Figure 2. Helicopter as it came to rest

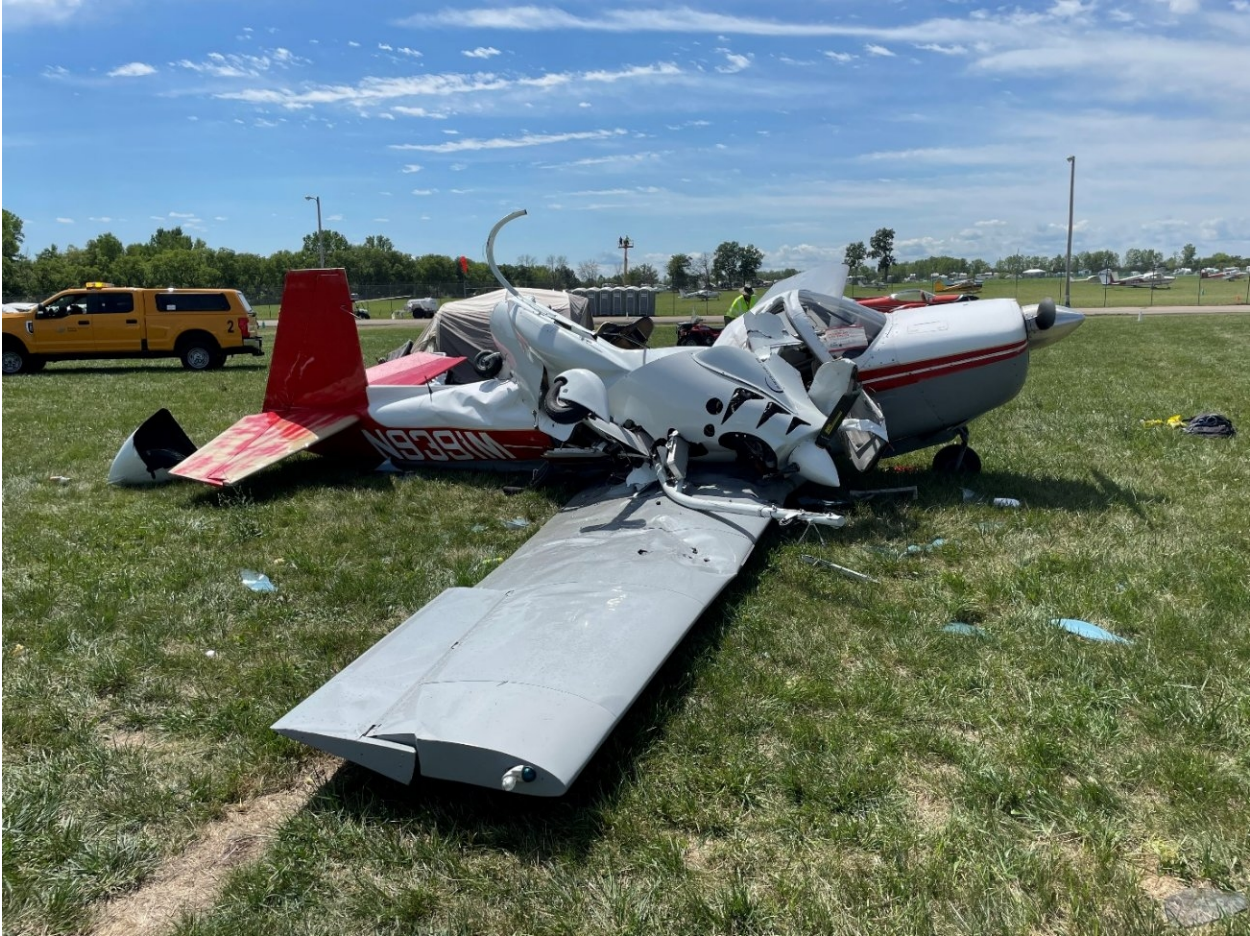
Figure 3. Gyroplane and unoccupied parked airplane
