Aviation Investigation Factual Report

Location:	Oshkosh, Wisconsin	Accident Number:	CEN23FA333
Date & Time:	July 29, 2023, 12:27 Local	Registration:	N193AZ (A1); N221EL (A2)
Aircraft:	Rotorway 162F (A1); ELA ECLIPSE 10 (A2)	Aircraft Damage:	Destroyed (A1); Destroyed (A2)
Defining Event:	Midair collision	Injuries:	2 Fatal (A1); 2 Serious (A2)
Flight Conducted Under:	Part 91: General aviation - Personal (A1); Part 91: General aviation - Personal (A2)

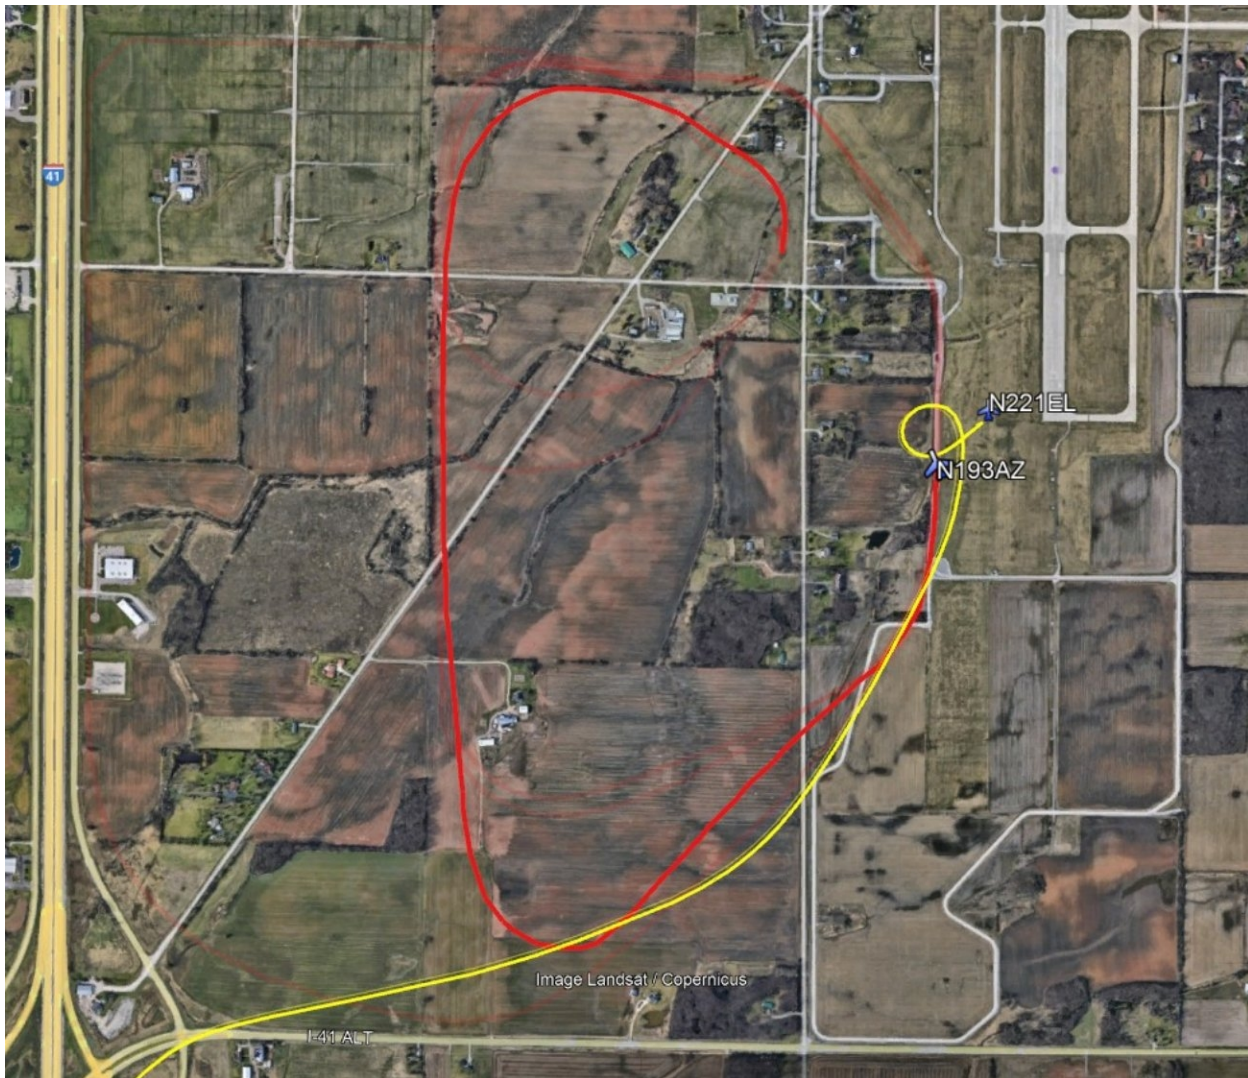
Figure 1. Flight tracks of the helicopter (red) and gyroplane (yellow).

About 35 seconds before the collision, the rear seat passenger in the gyroplane began taking a video with his cellular phone camera. At this time, the gyroplane was on the base leg from the south and began a 360° left turn. The helicopter, which was positioned behind the gyroplane in the traffic pattern, was also approaching the runway on the base leg from the south, following the north/south paved road (see figure 1).

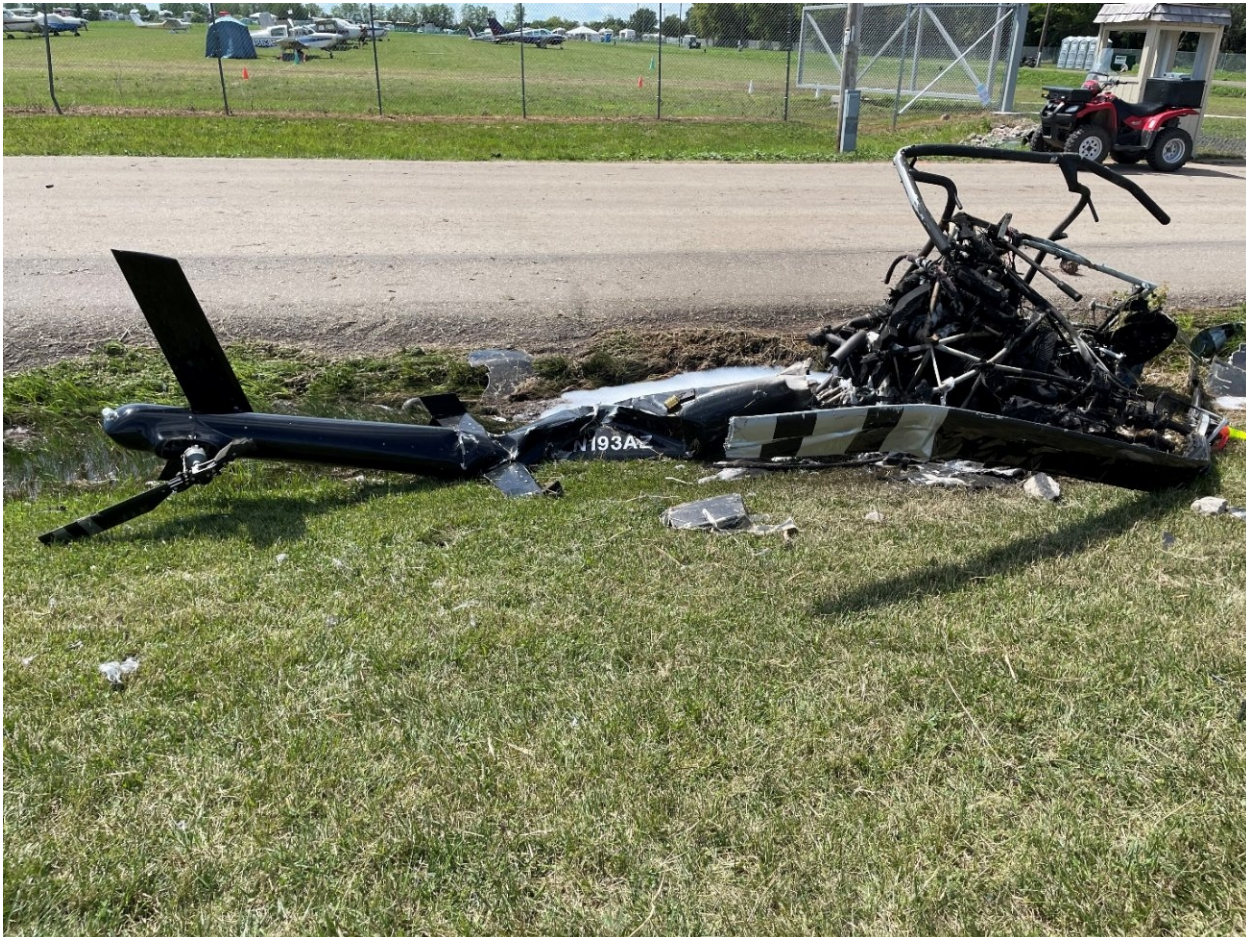
Figure 2. Helicopter as it came to rest

Both aircraft descended in a near-vertical attitude with debris separating from both aircraft. The helicopter impacted terrain, came to rest inverted, and a postaccident fire ensued (see figure 2). The gyroplane impacted an unoccupied airplane that was parked between the north/south paved road and runway 36L (see figure 3). No ground injuries were reported.

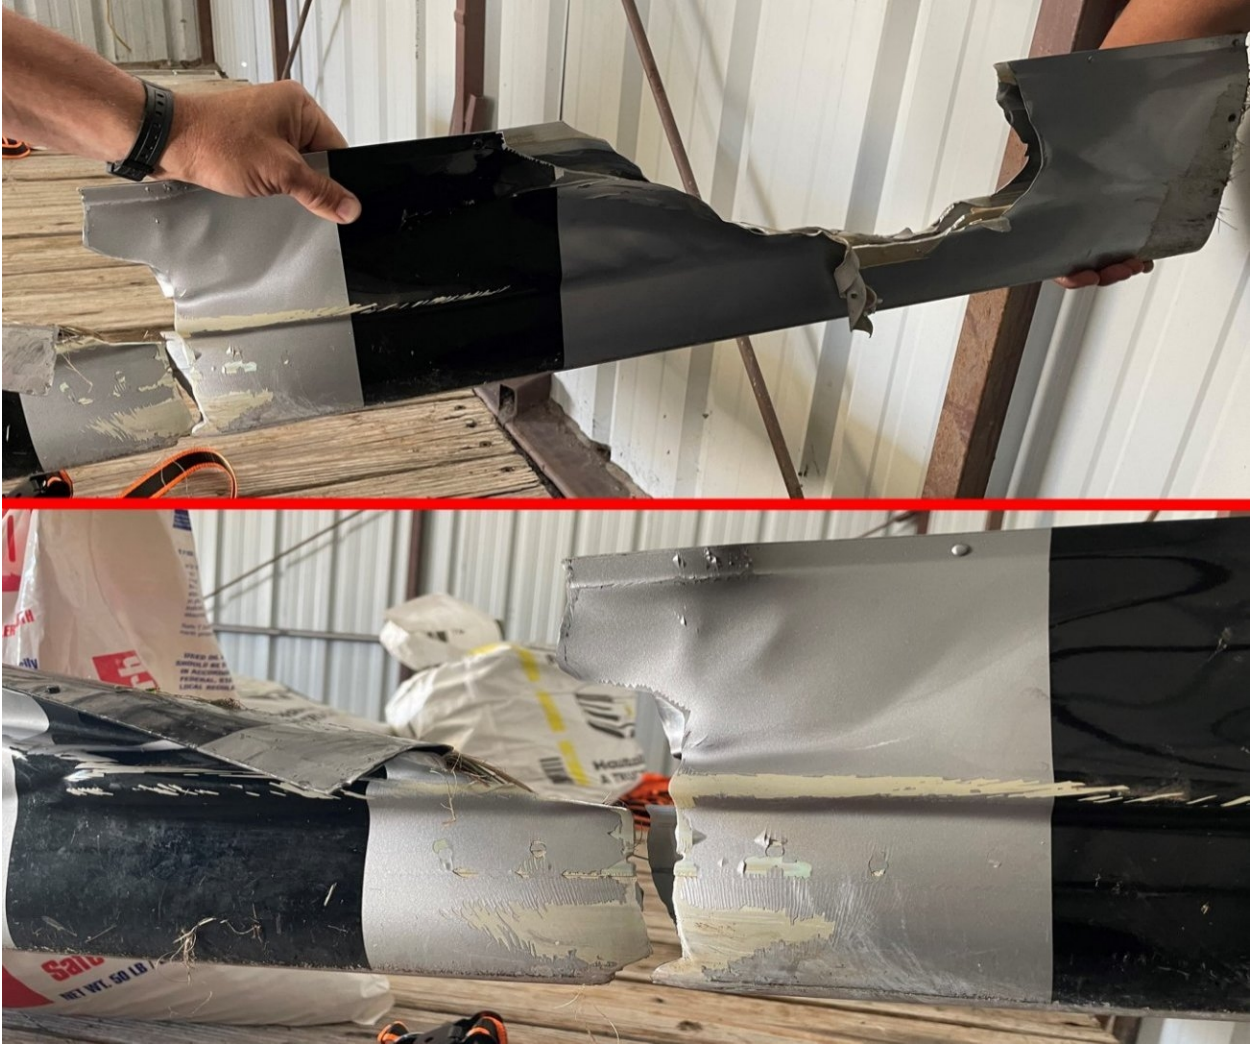
Postaccident examination of the helicopter revealed that both outboard sections of the main rotor blades were separated and came to rest in the debris field (see figure 4). The main rotor blade's structure displayed impact marks and white paint transfers, consistent with the gyroplane's structure and paint color.

Figure 4. Separated outboard sections of the helicopter's main rotor blades.

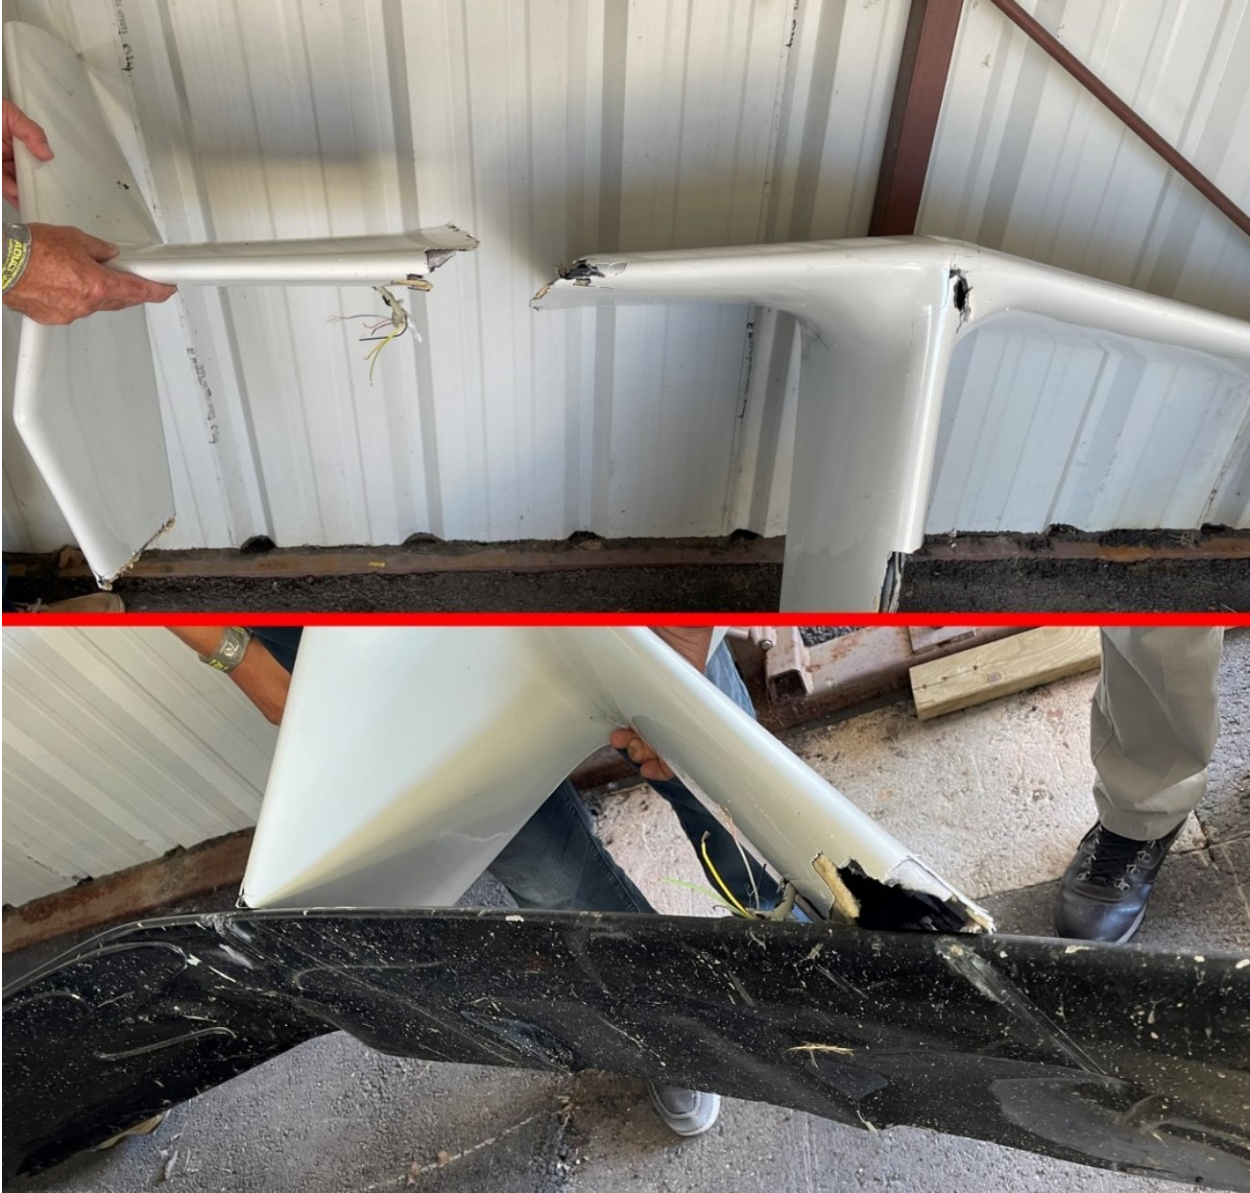
The gyroplane's right horizontal and vertical stabilizers displayed shear cuts and separated structure consistent with helicopter main rotor blade contact (see figure 5). The gyroplane's main rotor mast was separated about mid-length with an impact signature consistent with the helicopter's main rotor blade (see figure 6).

Figure 5. The upper photograph depicts the gyroplane's separated right horizontal stabilizer and lower vertical stabilizer. The lower photograph depicts the separated stabilizer section in comparison with the helicopter main rotor blade contact witness marks and white paint transfer.
