Aviation Investigation Factual Report

Location:	North Charleston, South Carolina	Accident Number:	ERA23LA319
Date & Time:	August 1, 2023, 15:30 Local	Registration:	N31PB
Aircraft:	BELL HELICOPTER TEXTRON CANADA 407	Aircraft Damage:	Substantial
Defining Event:	Flight control sys malf/fail	Injuries:	1 Minor
Flight Conducted Under:	Public aircraft

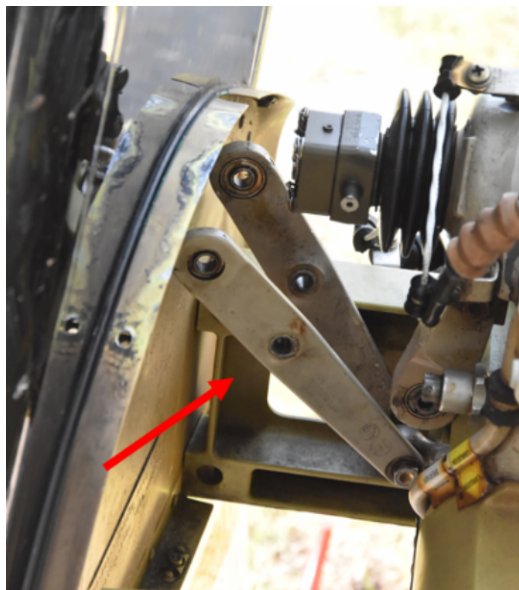
Inspectors with the Federal Aviation Administration (FAA) responded to the accident site and examined the wreckage. They confirmed substantial damage to the fuselage, main rotor system, and tail rotor system. They found 1 of the 2 bolts that secured the tail rotor pitch change lever assembly was missing (Photo 1). The lever assembly was disconnected from the trunnion. The other bolt that connected the levers to the rod assembly was in place, but loose; the cotter pin for its attachment nut was missing (Photo 2).

Photo 1: Tail rotor Pitch Change Lever Assembly. Red arrow points to area of missing bolt.

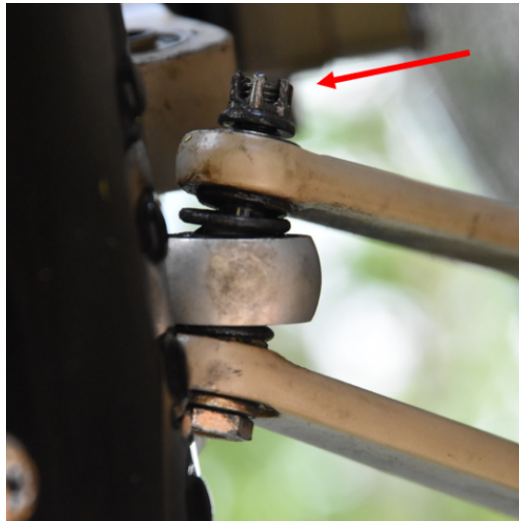
Photo 2: Pitch Change Lever Assembly. Red arrow points to loose nut on bolt; cotter pin was missing.

A review of the maintenance records by FAA inspectors revealed that a 300 hour/3 month inspection was performed on the helicopter on June 28, 2023. The helicopter had been flown about 15.4 hours since this inspection. According to Bell Helicopter technical support personnel, the inspection/lubrication procedure that was accomplished on June 28 would not require removal of the lever assembly bolts; however, the nuts and bolts should have been clearly visible during the inspection of the area. The mechanic who performed the inspection stated that he must have overlooked them.
