# Aviation Investigation Factual Report

<b>Location:</b>	Hydro, Oklahoma	<b>Accident Number:</b>	CEN24FA094
<b>Date &amp; Time:</b>	January 20, 2024, 23:23 Local	<b>Registration:</b>	N295AE
<b>Aircraft:</b>	Bell 206	<b>Aircraft Damage:</b>	Destroyed
<b>Defining Event:</b>	Birdstrike	<b>Injuries:</b>	3 Fatal
<b>Flight Conducted Under:</b>	Part 135: Air taxi & commuter - Non-scheduled - Air Medical (Discretionary)

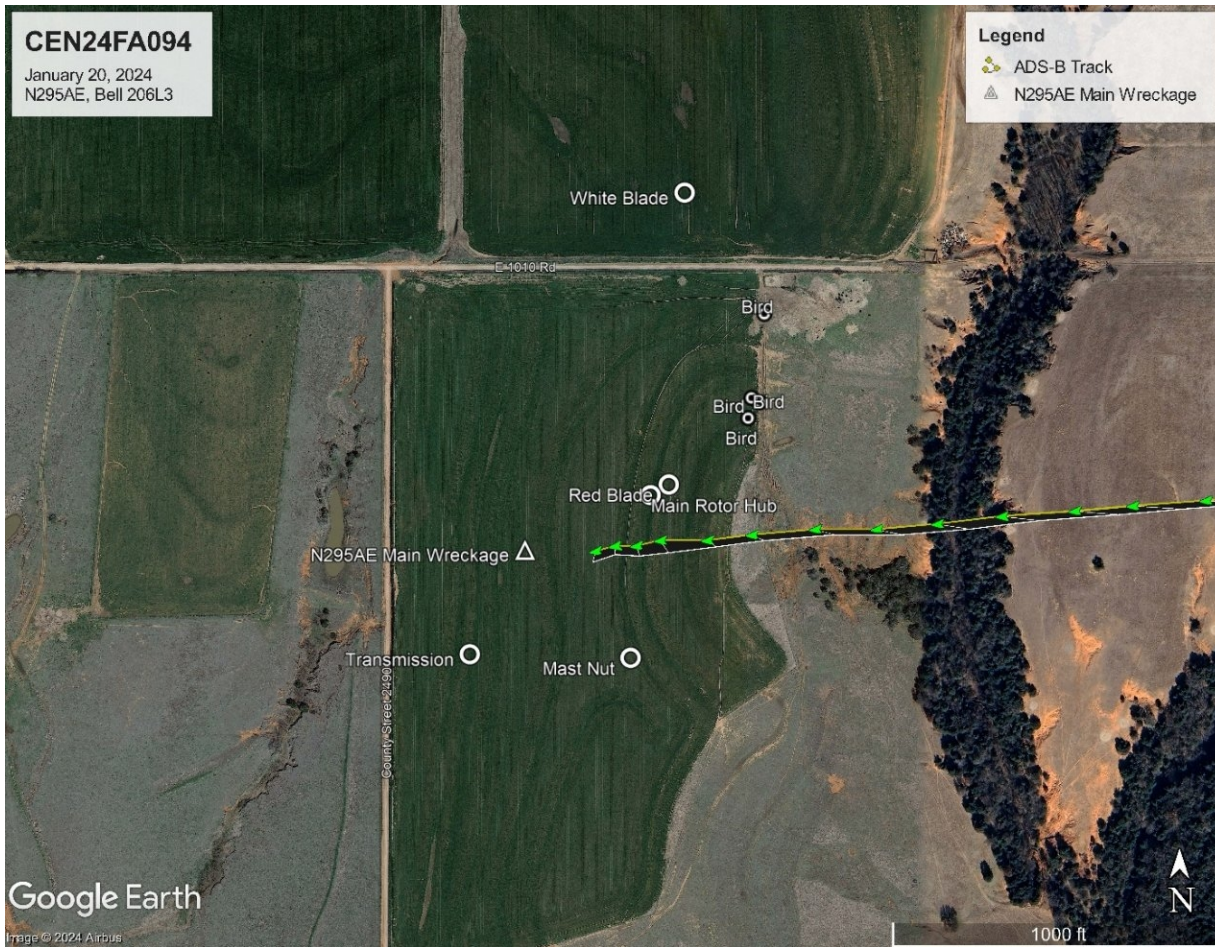
**Figure 1.** ADS-B Flight Track with Wreckage and Bird Locations

ADS-B data captured the accident flight as it departed OL16 and flew west towards OL16 between 500 ft and 600 ft above ground level and about 110 knots groundspeed. The last ADS-B point was at 2323:39 about 210 ft east of the main wreckage location (see Figure 1).
