Aviation Investigation Factual Report

Location:	Sevierville, Tennessee	Accident Number:	ERA16FA188
Date & Time:	May 19, 2016, 11:39 Local	Registration:	N2967B
Aircraft:	Beech D35	Aircraft Damage:	Substantial
Defining Event:	Landing gear not configured	Injuries:	1 Fatal
Flight Conducted Under:	Part 91: General aviation - Personal

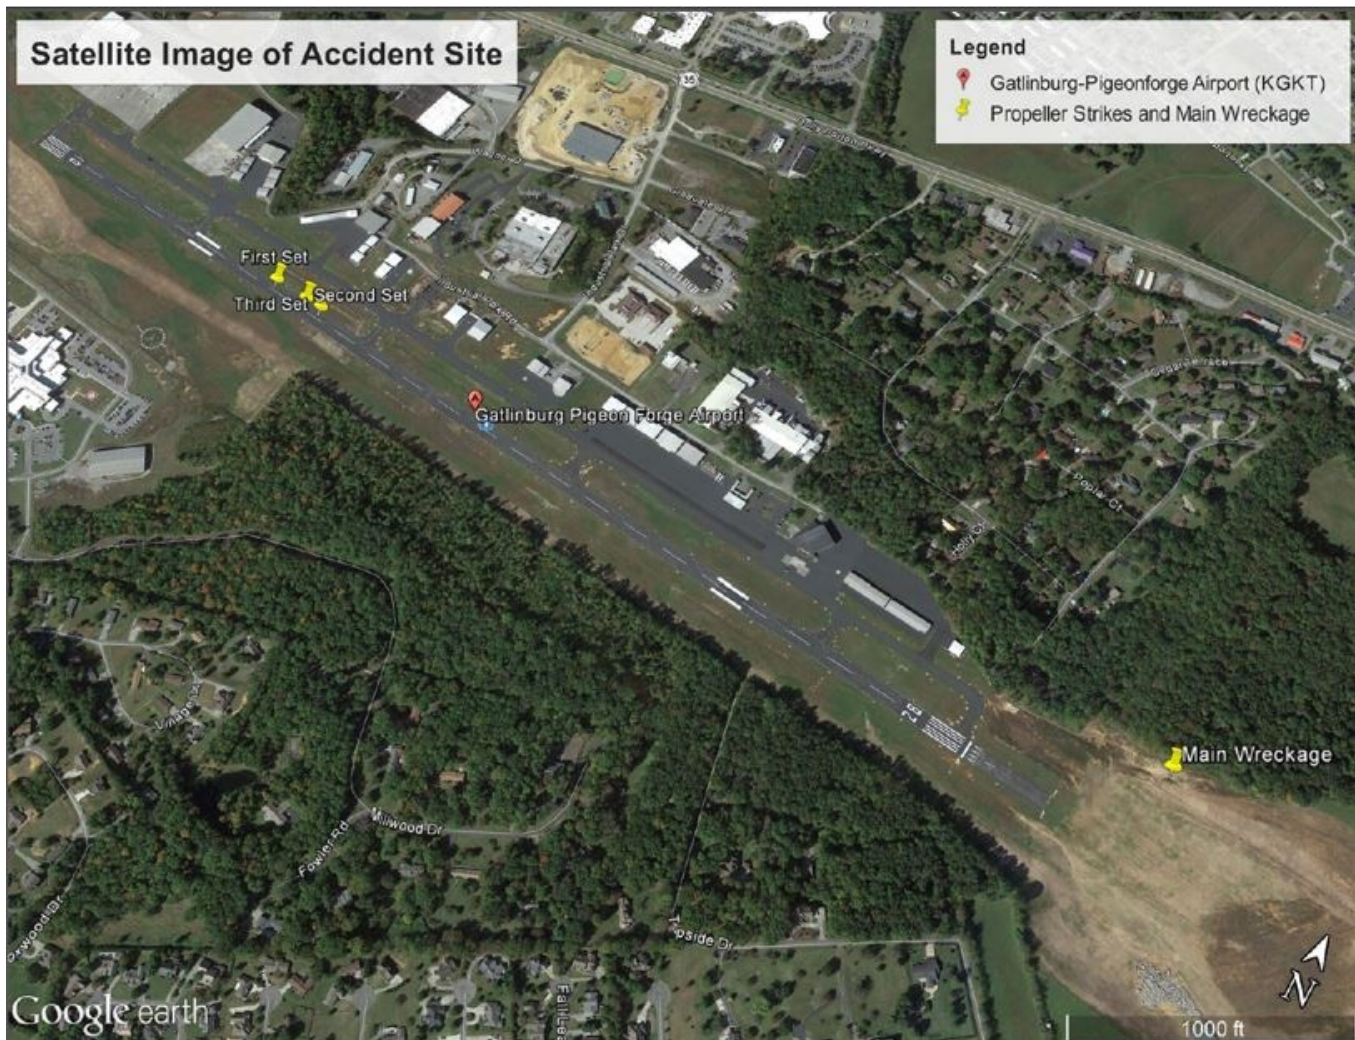
Examination of runway 10 revealed propeller strike marks on the runway pavement in three different areas on the runway. The first set of propeller strikes began about 1,535 ft from the runway threshold and continued for about 51 ft. The second set of propeller strikes began about 1,714 ft from the runway threshold and continued for about 41 ft. The third set of propeller strikes began about 1,798 ft from the runway threshold and continued for about 45 ft. Examination of the propeller strike marks indicated that they were oriented mostly perpendicular to the runway's centerline markings and appeared to coincide with the airplane's flight path along the runway (see figure 1).

Figure 1 – Aerial image of runway 10 with the propeller strike marks and final wreckage positions annotated.
