Aviation Investigation Final Report

Location:	Los Angeles, California	Incident Number:	DCA201A034
Date & Time:	December 4, 2019, 19:15 Local	Registration:	N71HD
Aircraft:	Airbus AS 350 B2	Aircraft Damage:	Minor
Defining Event:	Midair collision	Injuries:	3 None
Flight Conducted Under:	Part 91: General aviation - Aerial observation

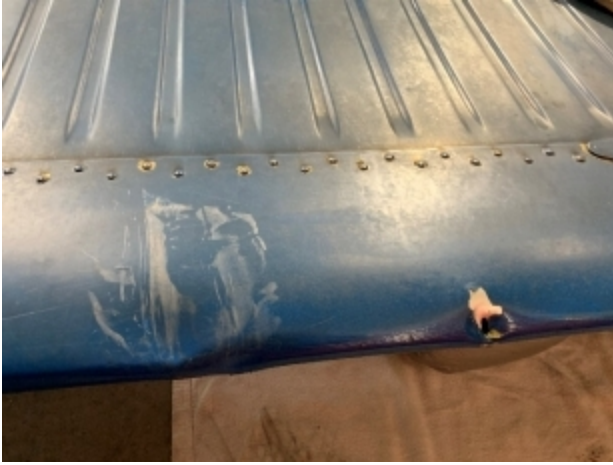
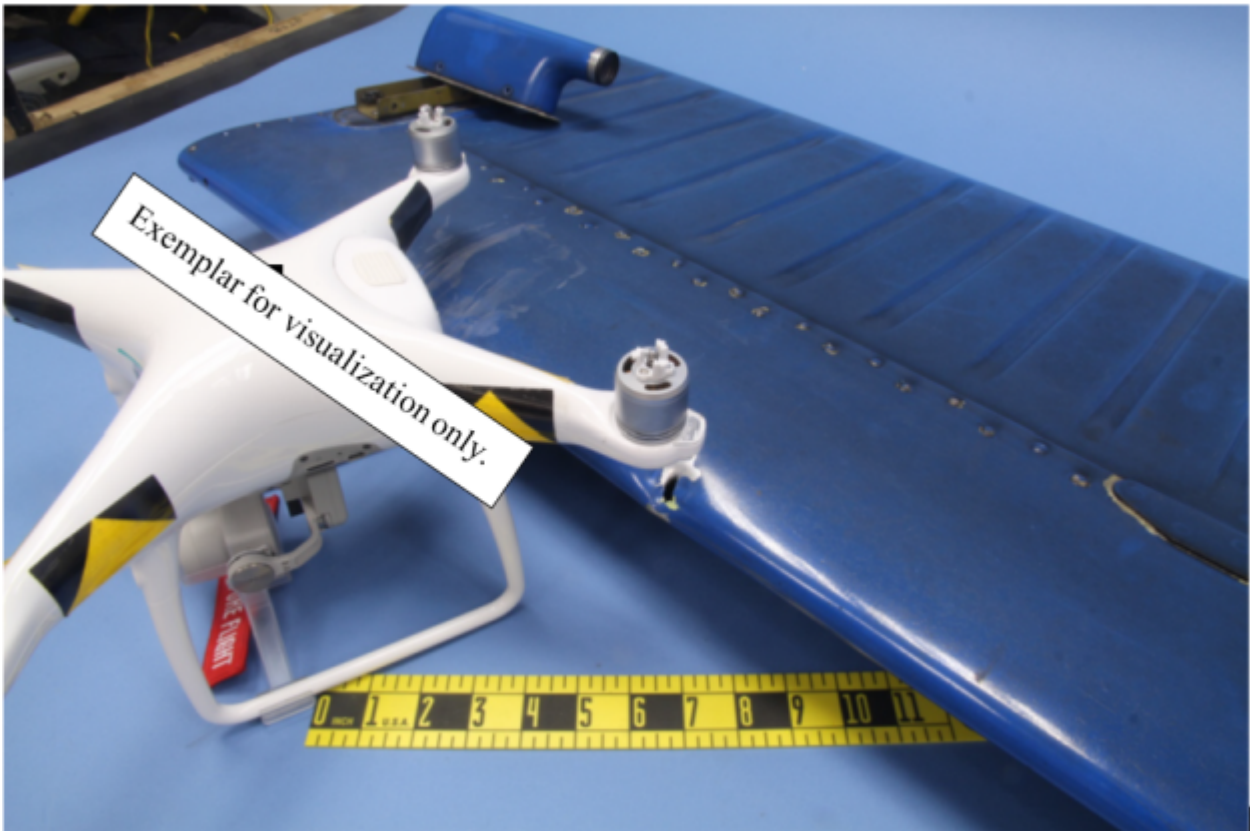
Figure 2 – Damage to helicopter

Laboratory examinations indicated that the shape and dimensions of the damage to the horizontal stabilizer were consistent with the configuration and dimensions of many popular small drones. A small mark inside the larger round dent was consistent with the propeller shaft diameter of common small drones.

Infrared examination revealed material transfer of polycarbonate polymer, which is a commonly used construction material of small drones. Although many items which could come in contact with the helicopter as ground FOD, are manufactured of polycarbonate (e.g. safety glasses, light lenses), the shape and configuration of the indentations and scuffs were very consistent with a small drone.

There was a small round dent which partially punctured the leading edge of the horizontal stabilizer. Further dents and scuff marks were approximately 6 to 8 inches outboard of the round dent on the leading edge and along the upper surface. One of the tail rotor blades exhibited a small gouge in the composite surface approximately mid-chord.

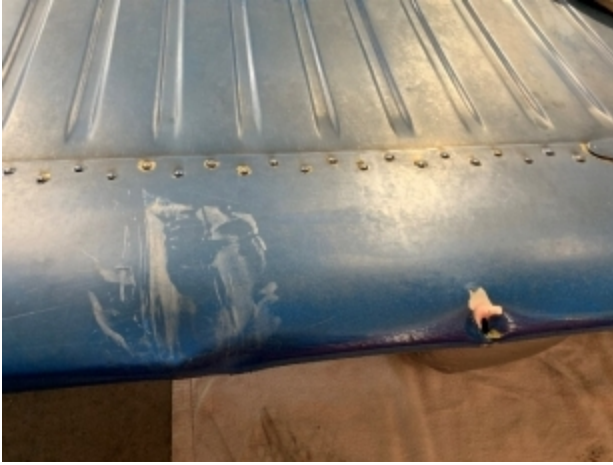
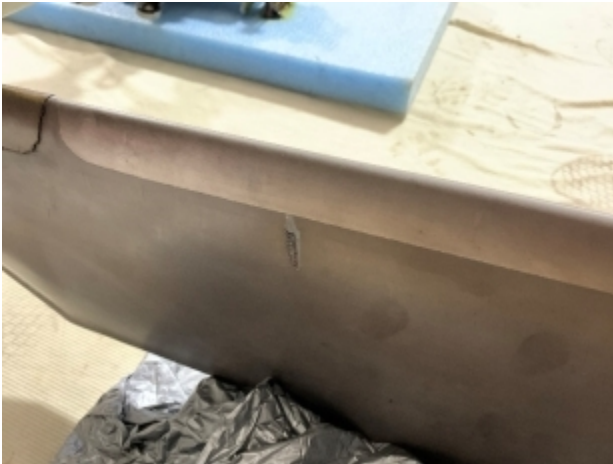
Figure 2 – Damage to helicopter

There was a small round dent which partially punctured the leading edge of the horizontal stabilizer. Further dents and scuff marks were approximately 6 to 8 inches outboard of the round dent on the leading edge and along the upper surface. One of the tail rotor blades exhibited a small gouge in the composite surface approximately mid-chord.

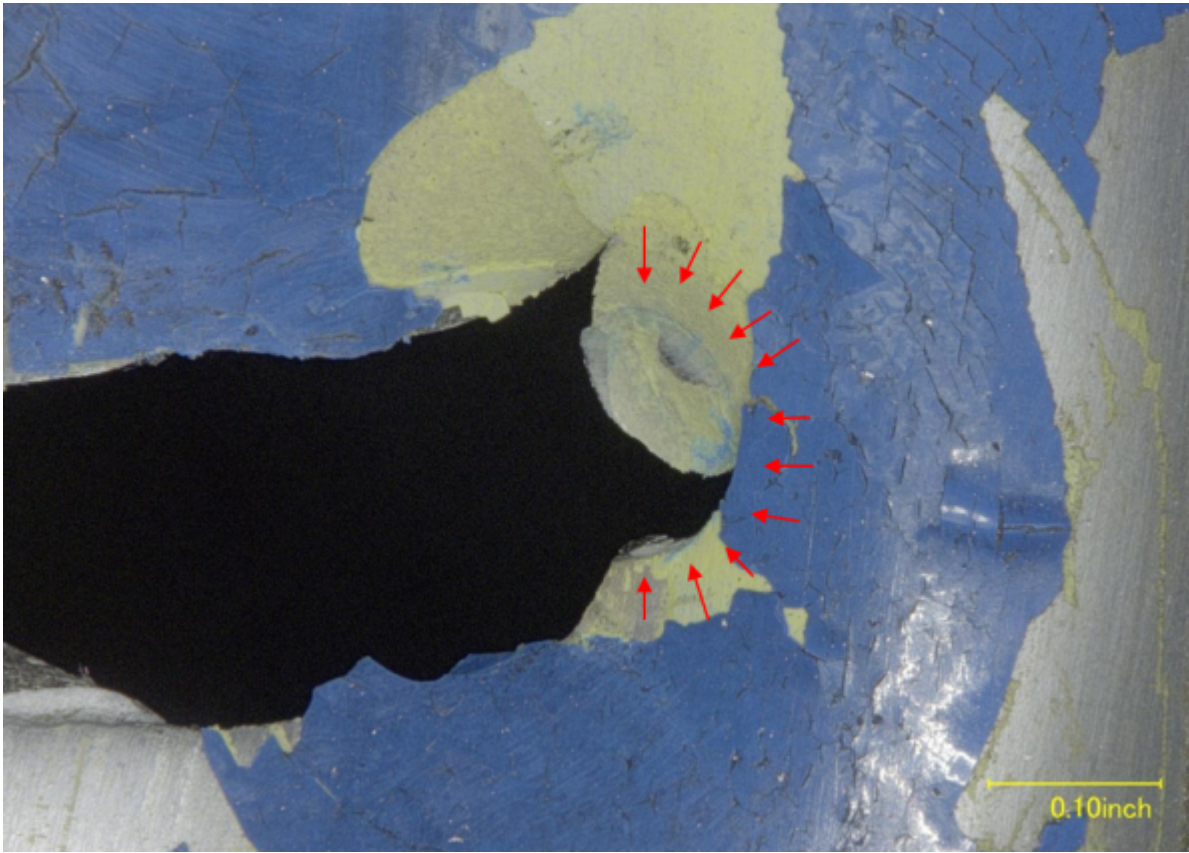
Figure 4 – Small indentation inside larger dent

Ultraviolet light inspection revealed no evidence of biological material. The dented region exhibiting material transfer was examined using Fourier-transform infrared spectroscopy (FTIR). The white and gray areas were probed, and the data were contrasted with an area of the painted stabilizer skin surface away from the impact zone. In subtracting out the spectrum peaks from the control area away from the impact zone, several peaks consistent with a different or foreign material were noted. These peaks were consistent with a polycarbonate polymer. Examination of an exemplar popular drone indicated the primary construction material is polycarbonate. (Polycarbonate plastics are used in many other common items, such as safety glasses or light lenses.)

Under magnification, inside the round dent, a small circular indentation was noted of approximately 0.125 inches (~3 mm) in diameter, exhibiting tears and cracking around its circumference (Figure 4). These features were consistent with fore-to-aft impact with a hard, cylindrical object. The propeller shafts on many common small drones are approximately 3 mm in diameter.
