Aviation Investigation Final Report

Location:	Soldotna, Alaska	Accident Number:	ANC20LA074
Date & Time:	July 31, 2020, 08:27 Local	Registration:	N4982U (A1); N2587M (A2)
Aircraft:	De Havilland DHC-2 (A1); Piper PA 12 (A2)	Aircraft Damage:	Substantial (A1); Substantial (A2)
Defining Event:	Midair collision	Injuries:	6 Fatal (A1); 1 Fatal (A2)
Flight Conducted Under:	Part 135: Air taxi & commuter - Non-scheduled (A1); Part 91: General aviation - Personal (A2)

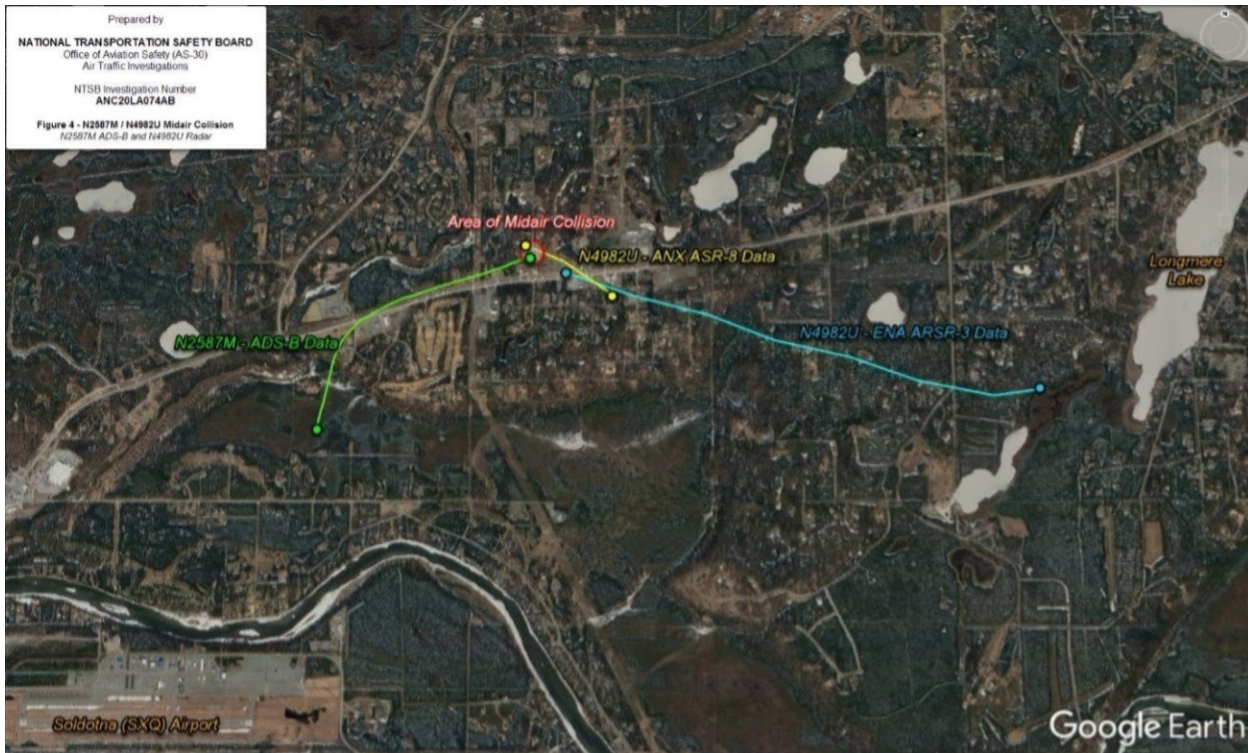
Flight track data revealed that the DHC-2 was traveling northwest about 78 knots (kts) groundspeed and gradually climbing through about 1,175 ft mean sea level (msl) when it crossed the Sterling Highway. The PA-12 was traveling northeast about 1,175 ft msl and about 71 kts north of, and parallel to, the Sterling Highway. The airplanes collided about 2.5 miles northeast of the Soldotna airport at an altitude of about 1,175 ft msl. See figure 1 for the airplanes' flight tracks.

Figure 1 - Flight track. ADS-B data (N2587M) and ENA/ANX radar data (4982U).

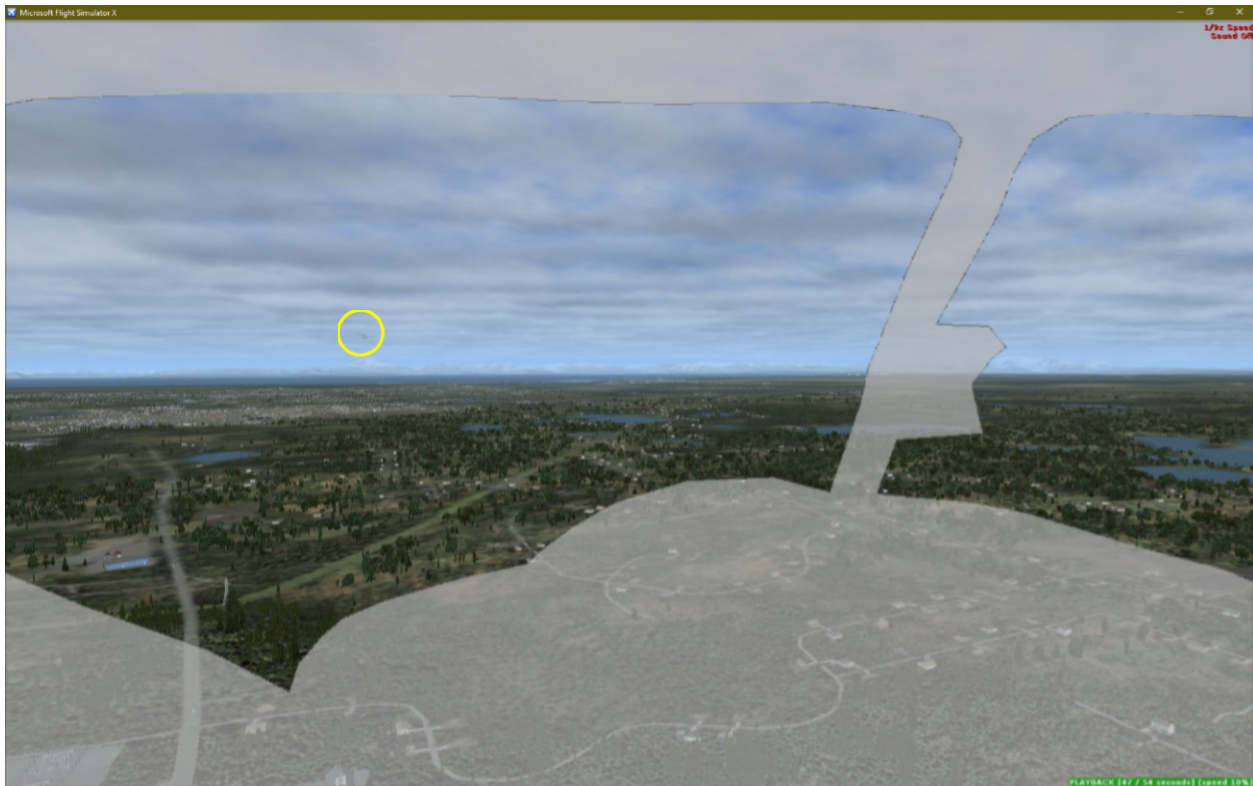
The cockpit visibility study revealed that for the 53-second period before the collision, the Piper would have been unobscured and visible from the DHC-2 pilot through the DHC-2 left windshield.

Figure 2 - Recreation of the view from the DHC-2 cockpit at 0826:27 (5.3 seconds before the collision). The location of the PA-12 is indicated by the yellow circle.

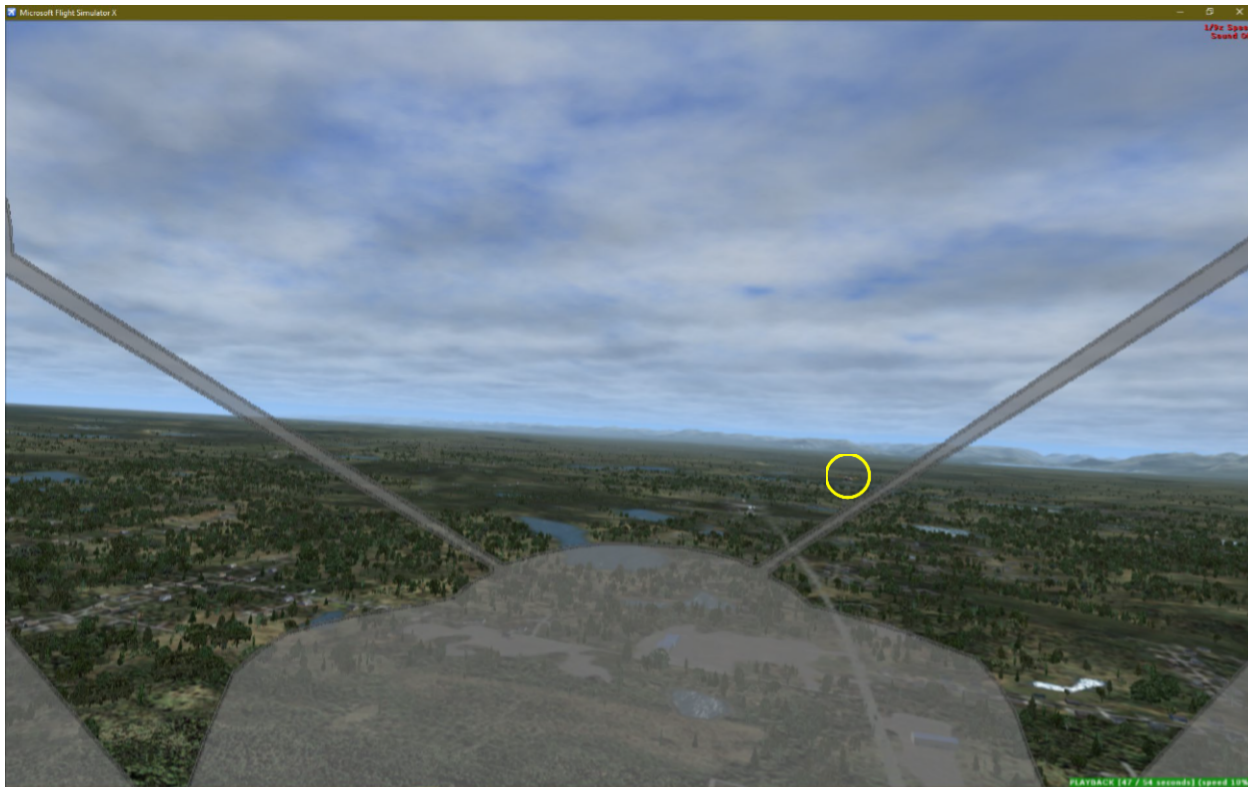
Regarding whether the PA-12 pilot could have seen the DHC-2, between 0825:39 to just before 0825:51 (12 seconds) the DHC-2 would have been unobscured and visible through the PA-12

right window. The DHC-2 would have then been obscured behind the PA-12 right wing root until about 0825:58. The DHC-2 would then have appeared on the right edge of, or been obscured by, a structural support tube inside the cockpit from about 0825:58 to about 0826:04 (6 seconds). From 08:26:04 to the collision at 08:26:32.3 (28.3 seconds), the DHC-2 would have been unobscured and visible in the PA-12 windshield, just to the left of the support tube.

Figure 3 - Recreation of the view from the Piper cockpit at 0826:27 (5.3 seconds before the collision). The location of the DHC-2 is indicated by the yellow circle.
