Aviation Investigation Final Report

| Location: | Medford, Oregon | Incident Number: | OPS18IA003 |
| Date & Time: | December 24, 2017, 18:08 Local | Registration: | N162PQ |
| Aircraft: | BOMBARDIER INC CL600 2D24 | Aircraft Damage: | None |

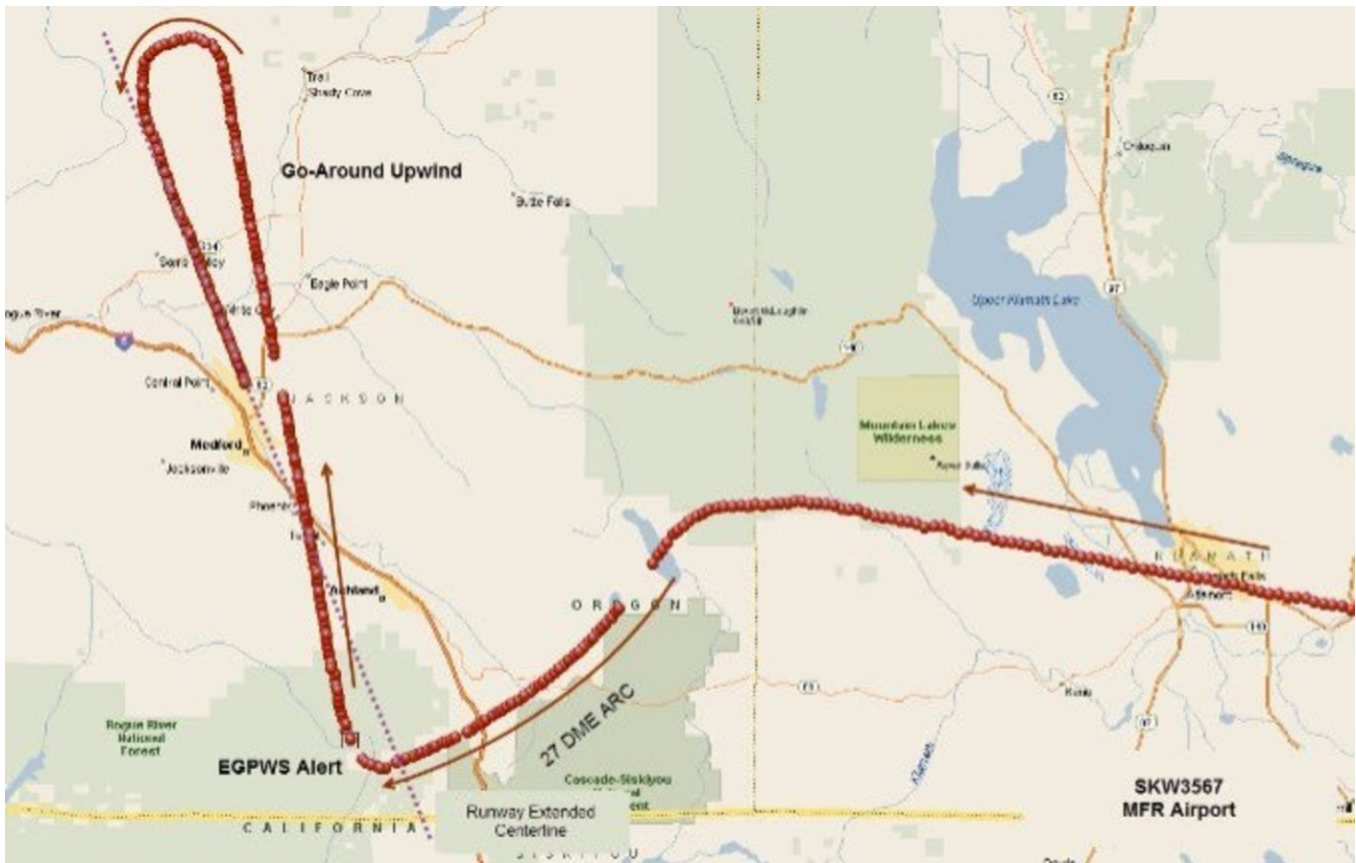
Radar data for this report was obtained from the Federal Aviation Administration (FAA) EUG ASR. The EUG plot playback (PPB) data was useable, of good quality, and was part of the STARS. Figure 1 illustrates the flight track of SKW3567 as the aircraft flew the VOR/DME-C instrument procedure into MFR. Figure 2 illustrates the location of SKW3567 as it descended below the 10,000-foot procedure altitude. Figure 3 illustrates the position of SKW3567 when the crew began their climb in response to the GPWS warning.

Figure 1 - Flight track of SKW3567 as the aircraft flew the VOR/DME-C instrument procedure into MFR.

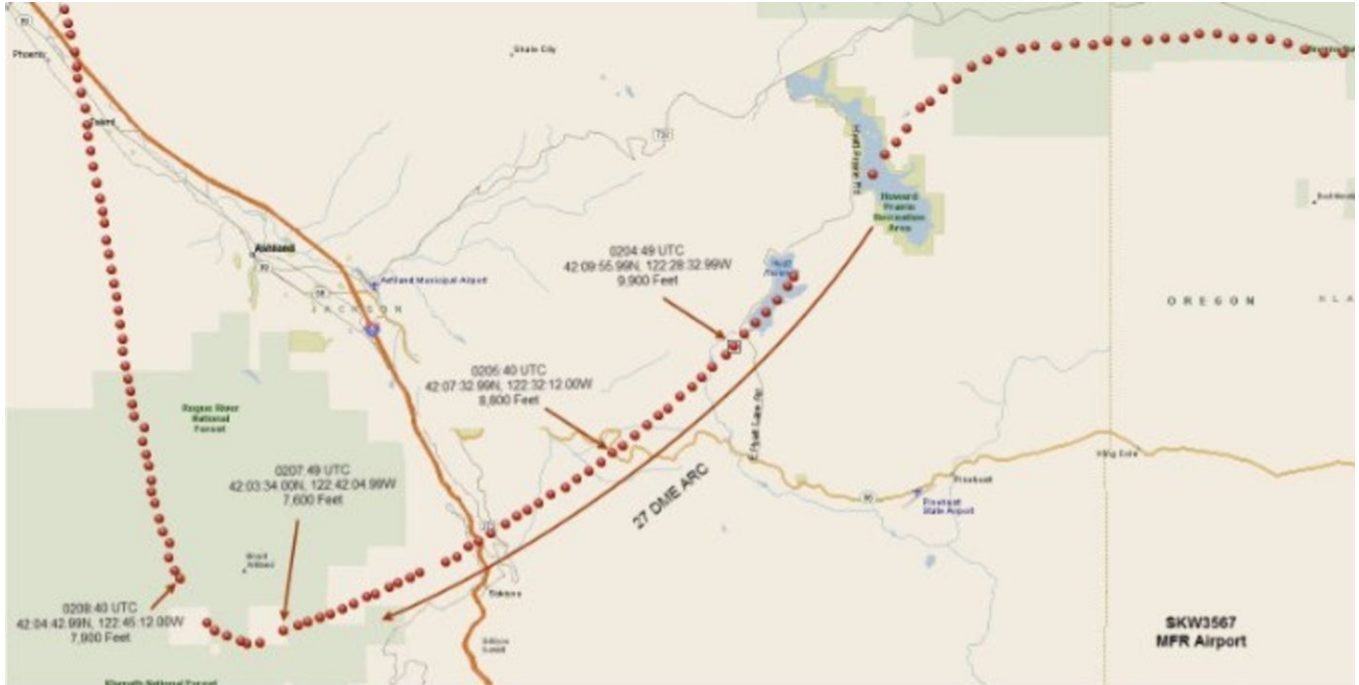
At 1804:59, the mode C altitude information indicated the flight descended below 10,000 feet while still established on the 27 DME arc.

Figure 2 - The location of SKW3567 as it descended below the 10,000-foot procedure altitude.

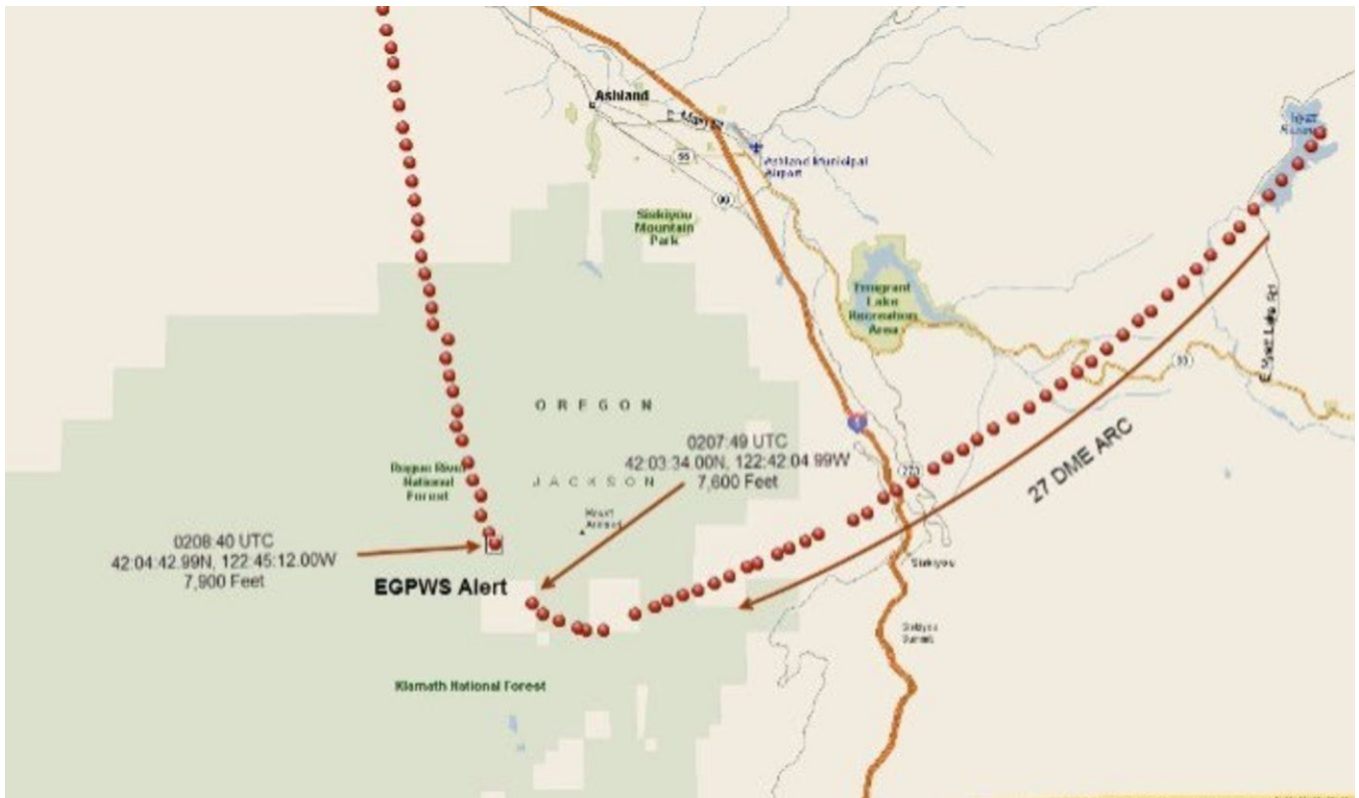
At 1810:04, the pilot of SKW3567 transmitted "approach SkyWest thirty five sixty seven we received a ah G-P-S or a excuse me a G-P-W-S which is one of our terrain warnings ah that ah comes up when ah we are too low and we just wanted to let you when we called you we wanted to let you know that we thought were ah too low for this sector and we wanted to confirm with you the altitude on the approach". The Medford sector controller responded, "stand by".

Figure 3 - The position of SKW3567 when the crew began climbing the aircraft.

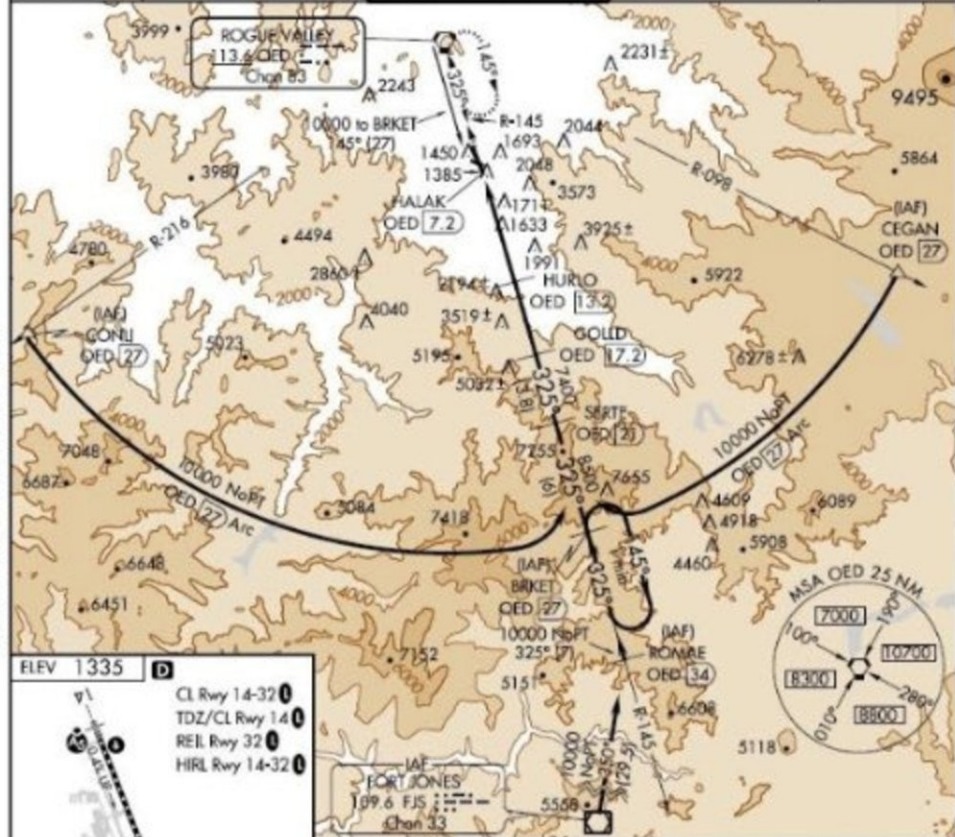
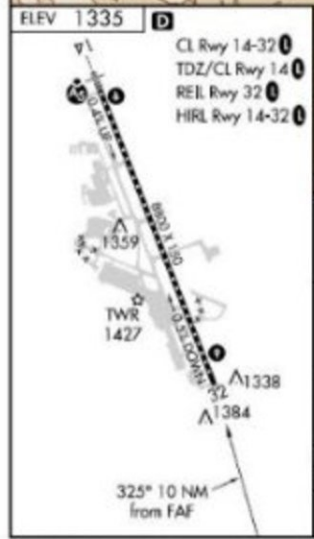
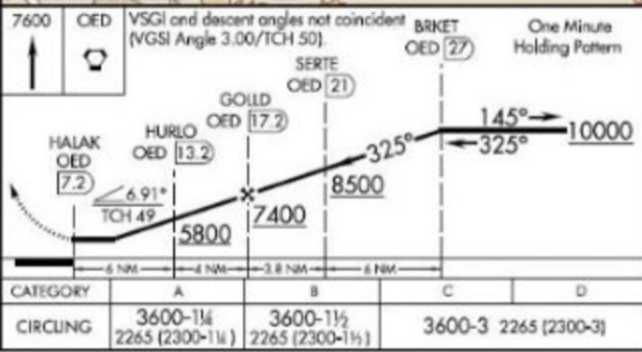
Figure 4 - The approach chart for the MFR VOR/DMA-C approach plate.

During the incident investigation, it was determined that an antenna adjacent to the IAF BRKET was not depicted on the Jeppesen produced approach chart for the VOR DME C current on the day the incident. Jeppesen changed the approach chart to reflect the antennae and a new obstacle height of 7,614 feet. Additionally, Jeppesen conducted a review of the terrain surrounding the MFR airport to support produced navigation products.

The VOR DME-C standard instrument approach procedure (SIAP) published an altitude of 10,000 feet for the segment of the approach from the IAF CEGAN while the aircraft was on a 27-mile DME arc to the IAF BRKET. The published altitude from BRKET to the fix SERTE was 8,500 feet. The published altitude from SERTE to the fix GOLLD was 7,400 feet. The published altitude to the fix HURLO was 5,800 feet. Figure 4 illustrates the published approach chart for the MFR VOR/DMA-C approach. The instrument procedure listed the airport elevation as 1,335 feet and a descent angle of 6.91 degrees.

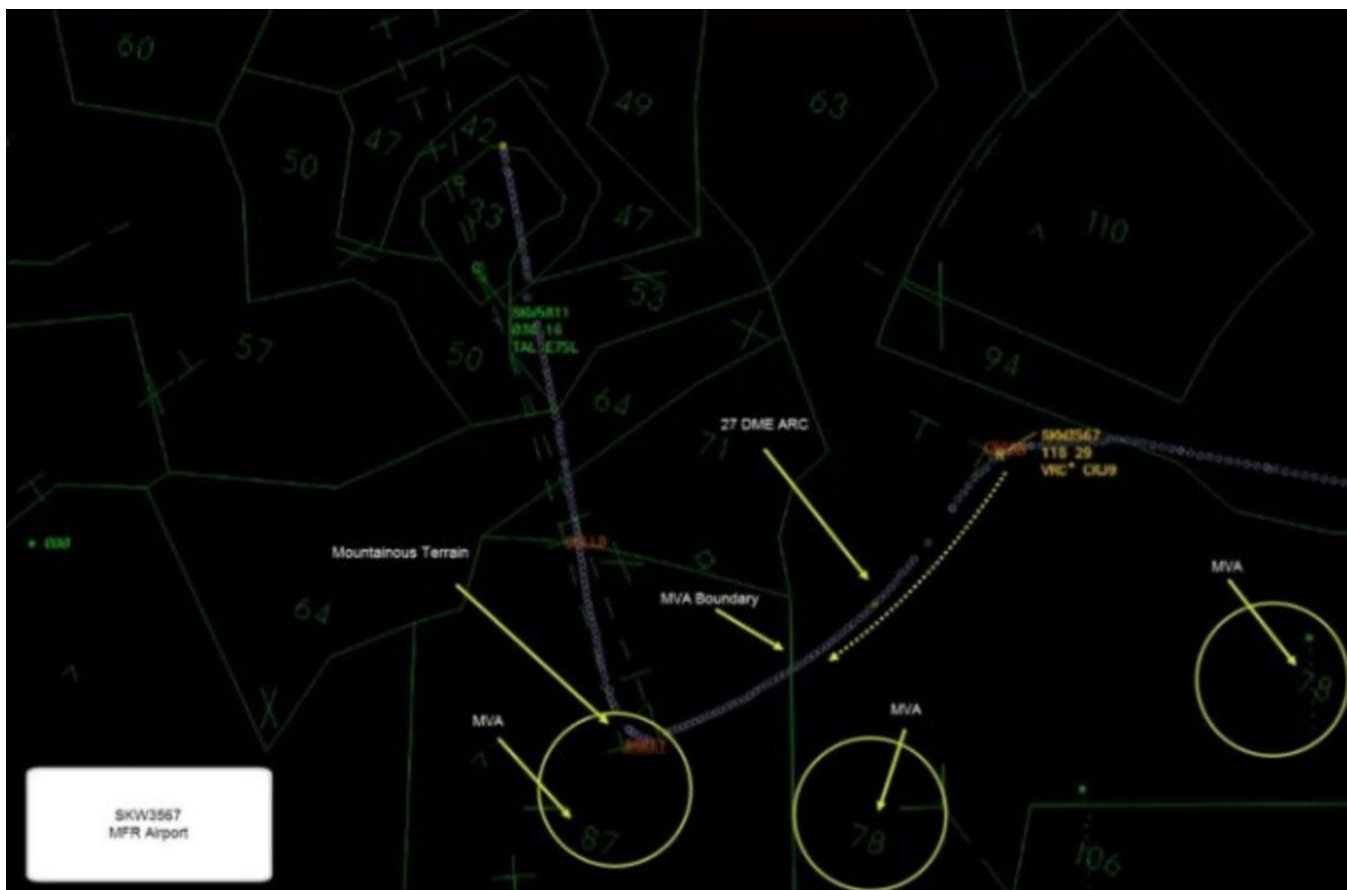
At 1806:12, SKW3567 entered an 8,700-foot MVA area at a mode C reported altitude of 8,300 feet.

The FAA defines the MVA as "The lowest msl altitude at which an Instrument Flight Rules (IFR) aircraft may be vectored by a radar controller, except as otherwise authorized for radar approaches, departures, and missed approaches. The altitude meets IFR obstacle clearance criteria. It may be lower than the published minimum enroute altitude (MEA) along an airway or jet route (J-route) segment. It may be utilized for radar vectoring only upon the controller's determination that an adequate radar return is being received from the aircraft being controlled. Charts depicting minimum vectoring altitudes are normally available only to the controllers and not to pilots". The MVA in the airspace that contained the IAF CEGAN was 7,800 feet and the IAF BRKET was 8,700 feet (see figure 5).

Figure 5 – Map showing MVA's and SKW3567 flight track.

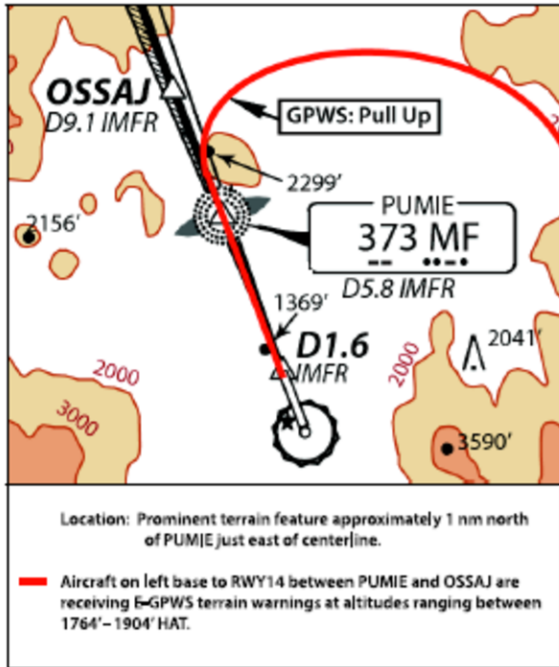
Figure 6: EGPWS WARNING from 10-7 Page
