# Aviation Investigation Final Report

<b>Location:</b>	Gustavus, Alaska	<b>Accident Number:</b>	CEN18FA391
<b>Date &amp; Time:</b>	September 28, 2018, 10:57 Local	<b>Registration:</b>	N907PL
<b>Aircraft:</b>	AIRBUS HELICOPTERS INC AS350	<b>Aircraft Damage:</b>	Destroyed
<b>Defining Event:</b>	Loss of control in flight	<b>Injuries:</b>	3 Fatal, 1 Serious
<b>Flight Conducted Under:</b>	Part 91: General aviation - Personal

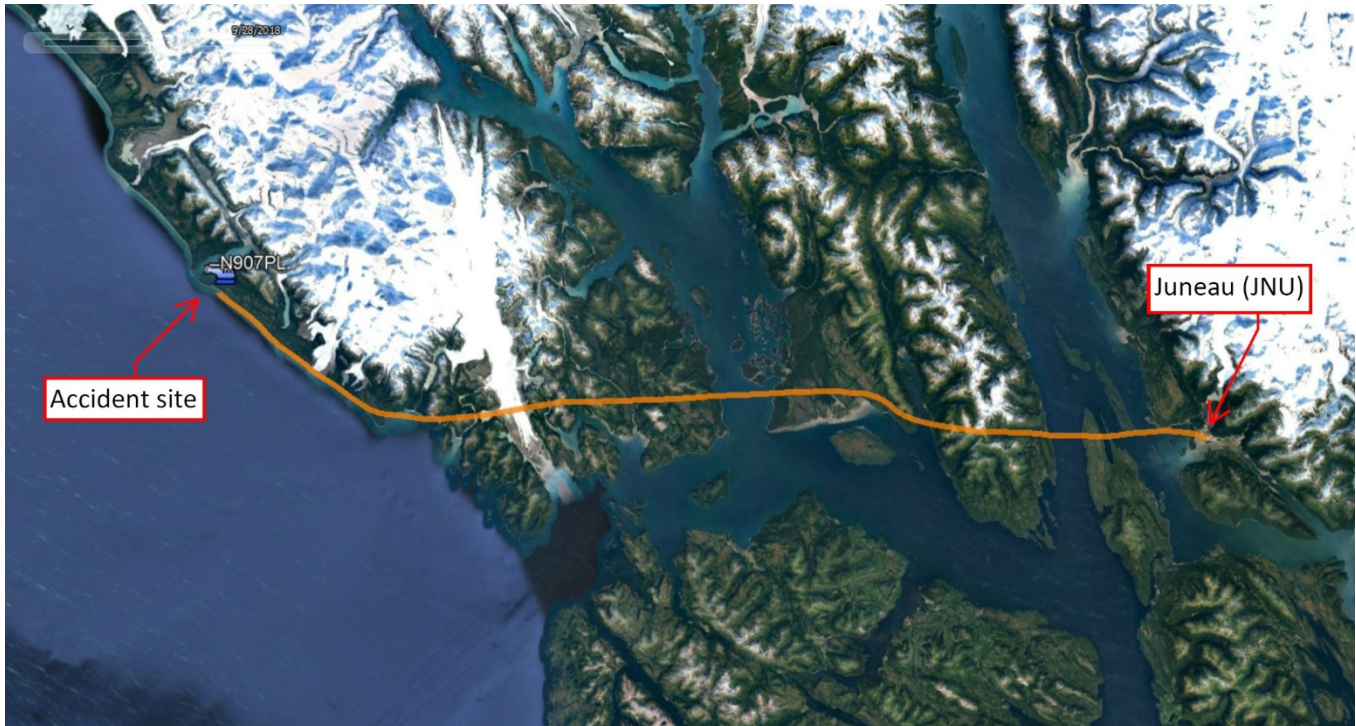
Figure 1 – The helicopter flight track in orange from JNU to the accident site.

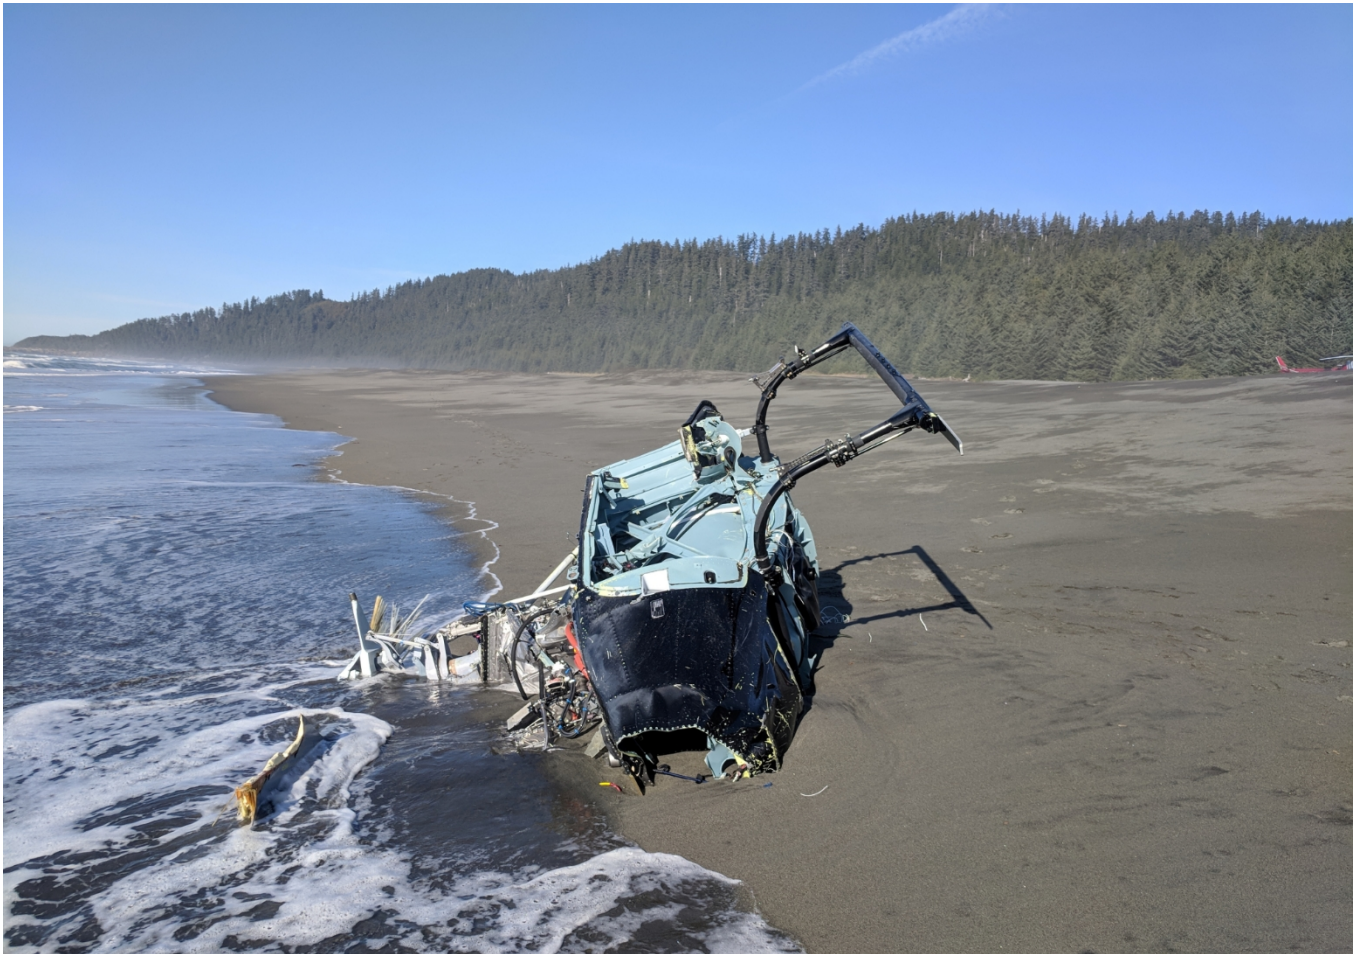
The main fuselage was found on a beach on its left side and partially embedded in the sand as shown in Figure 3. The structure forward of the aft cabin bulkhead had separated from the main fuselage. The left and right aft bench seats remained attached to the aft cabin bulkhead. The two longitudinal floor beams

for the cabin floor structure were fractured several inches forward of the aft cabin bulkhead. The rear structure of the main fuselage was crushed inward throughout its circumference. The engine firewall remained attached to the main fuselage; its base was deformed in the aft direction and its upper portion was partially fractured. The engine deck was deformed downward. The engine air inlet barrier filter remained installed within its frame, but the cowling surrounding the frame had separated. Sand was found within the barrier filter.

Figure 3 – Helicopter main wreckage partially embedded in the sand at low tide.

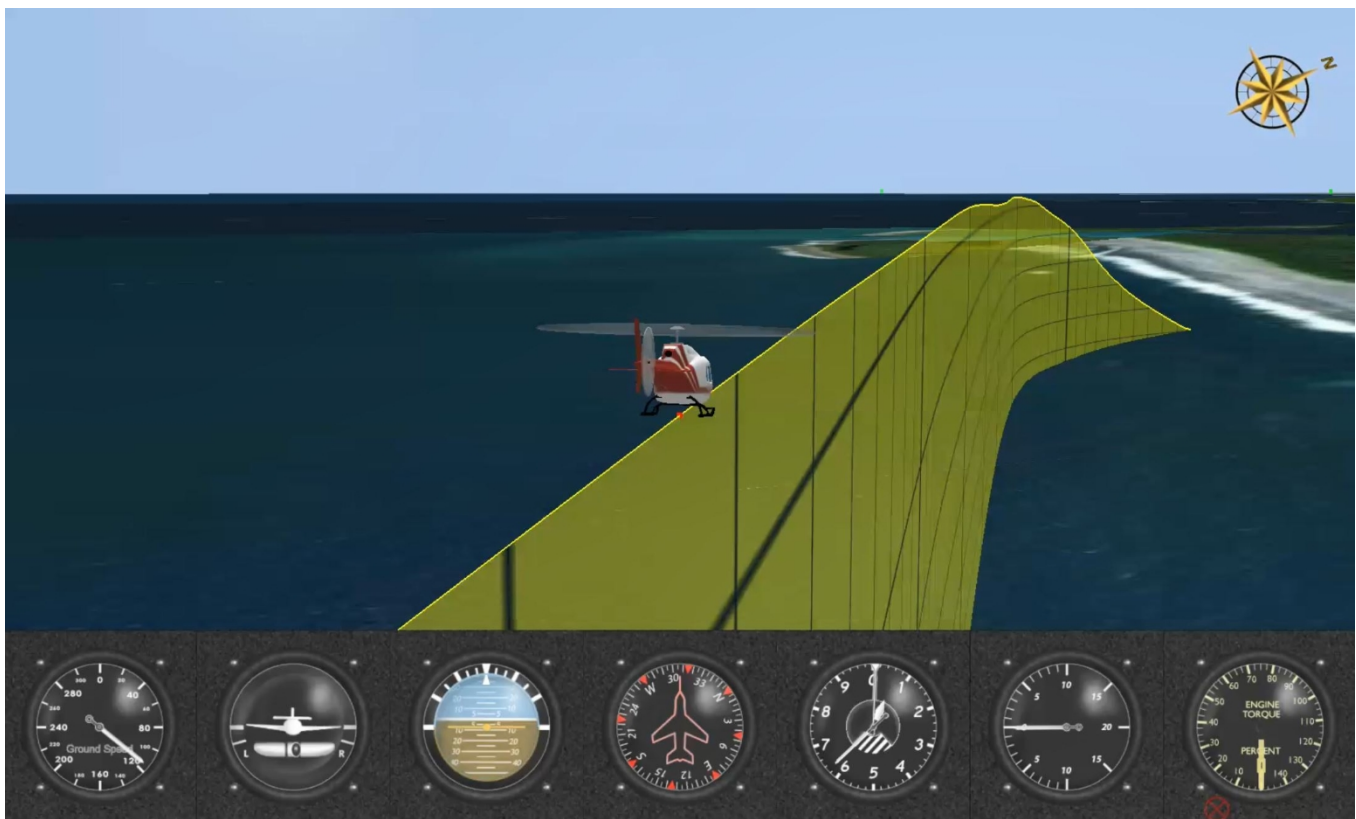
Figure 2 depicts a snapshot of a simulation created from the Vision 1000 data. The figure shows a representative helicopter and the flight track in yellow. The flight track descends toward the water where the recorded data ended.

Figure 2 – Snapshot from Vision 1000 data simulation.
