# Aviation Investigation Final Report

<b>Location:</b>	Gustavus, Alaska	<b>Accident Number:</b>	CEN18FA391
<b>Date &amp; Time:</b>	September 28, 2018, 10:57 Local	<b>Registration:</b>	N907PL
<b>Aircraft:</b>	AIRBUS HELICOPTERS INC AS350	<b>Aircraft Damage:</b>	Destroyed
<b>Defining Event:</b>	Loss of control in flight	<b>Injuries:</b>	3 Fatal, 1 Serious
<b>Flight Conducted Under:</b>	Part 91: General aviation - Personal

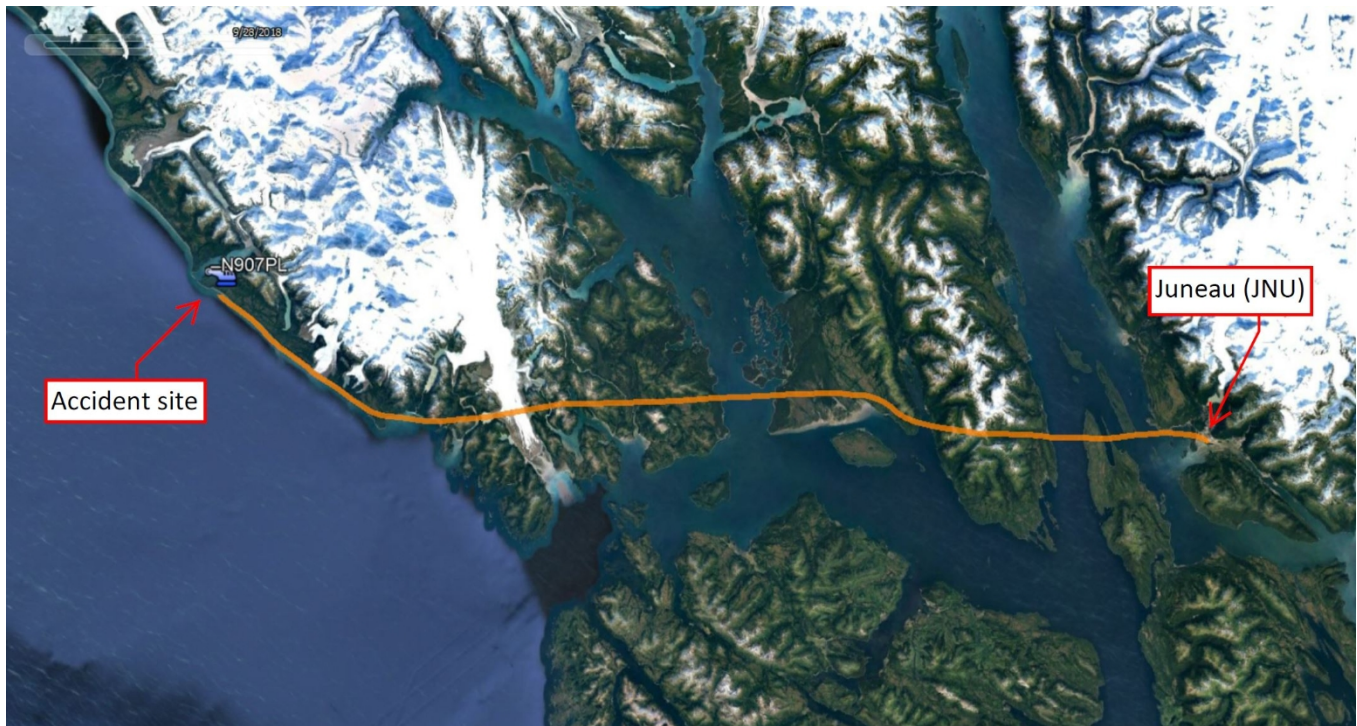
Figure 1 – The helicopter flight track in orange from JNU to the accident site.

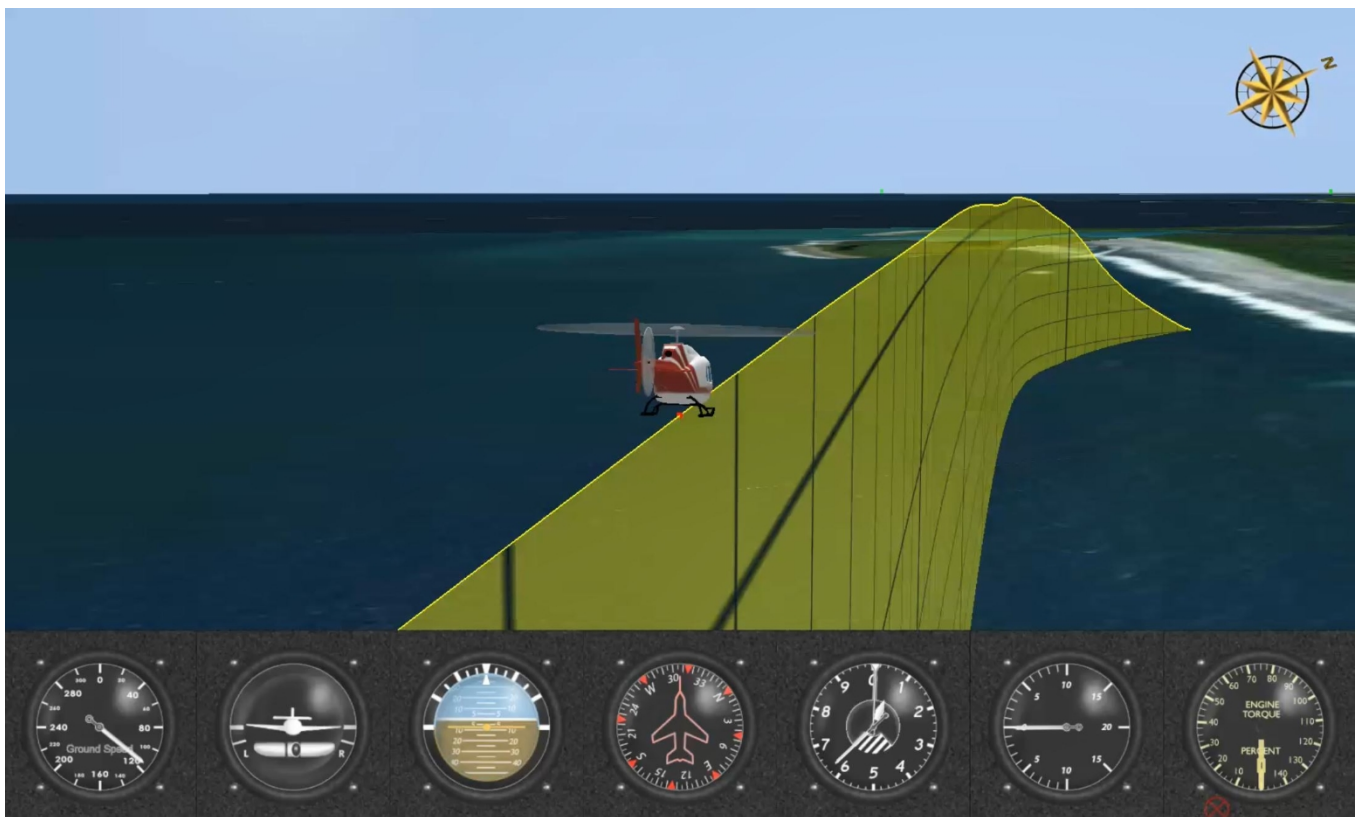
Figure 2 depicts a snapshot of a simulation created from the Vision 1000 data. The figure shows a representative helicopter and the flight track in yellow. The flight track descends toward the water where the recorded data ended.

Figure 2 – Snapshot from Vision 1000 data simulation.
