Aviation Investigation Final Report

Location:	Uvalde, Texas	Accident Number:	CEN19FA024
Date & Time:	November 3, 2018, 23:47 Local	Registration:	N417WT
Aircraft:	Bell 206	Aircraft Damage:	Destroyed
Defining Event:	Controlled flight into terr/obj (CFIT)	Injuries:	3 Fatal
Flight Conducted Under:	Part 91: General aviation - Personal

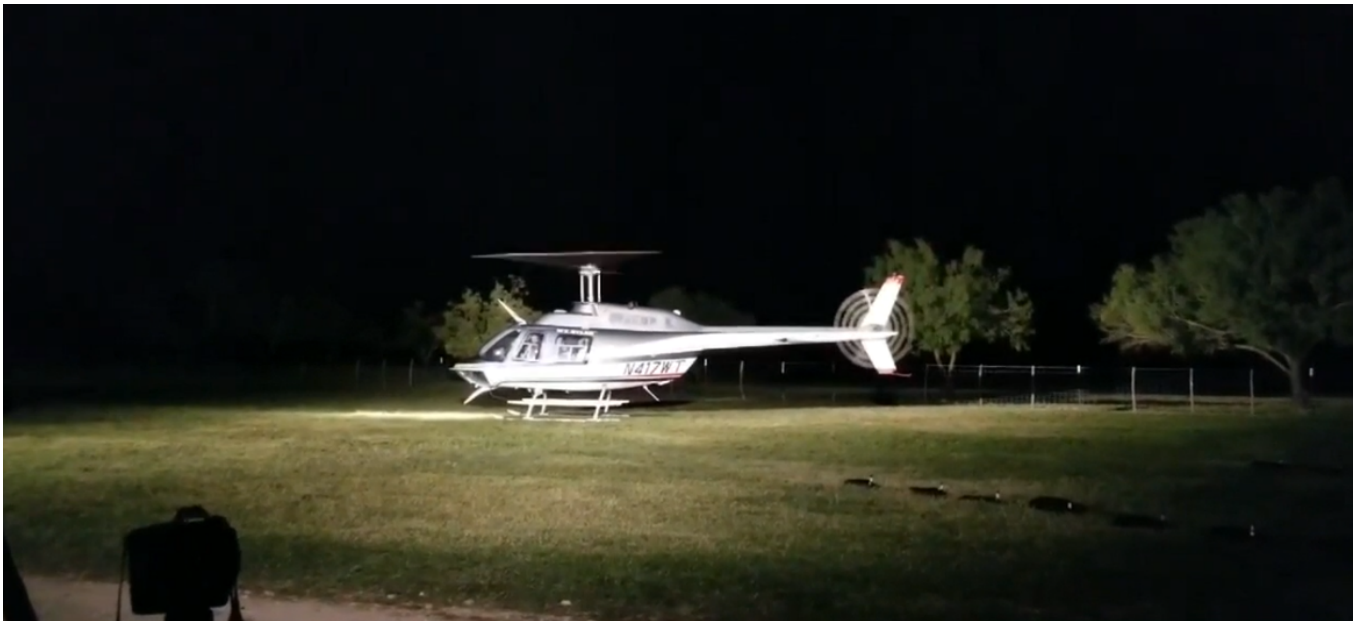
The pilot and two passengers onboard the turboshaft-powered helicopter departed from a private ranch on a night cross-country flight in visual meteorological conditions. Video evidence from witnesses who observed the departure showed that bright flood lights were shown directly at the helicopter during the departure. The helicopter impacted terrain shortly after takeoff about 100 ft below the top of a 1,500-ft hill and about 5 miles east of the departure point.

reported cataracts to the FAA in 2005, and it is possible that they could have increased in severity enough to have compromised his night vision and contributed to his difficulty avoiding the hill. Additionally, the pilot's eyesight may not have adjusted to the night conditions after being exposed to bright lights during departure. However, the severity of his cataracts at the time of the accident is unknown, and whether visual limitations from cataracts or bright lights contributed to the accident, could not be determined.

Figure 1. Helicopter departure with flood lights shining on helicopter (Video screenshot from KSAT and Jason Martinez).

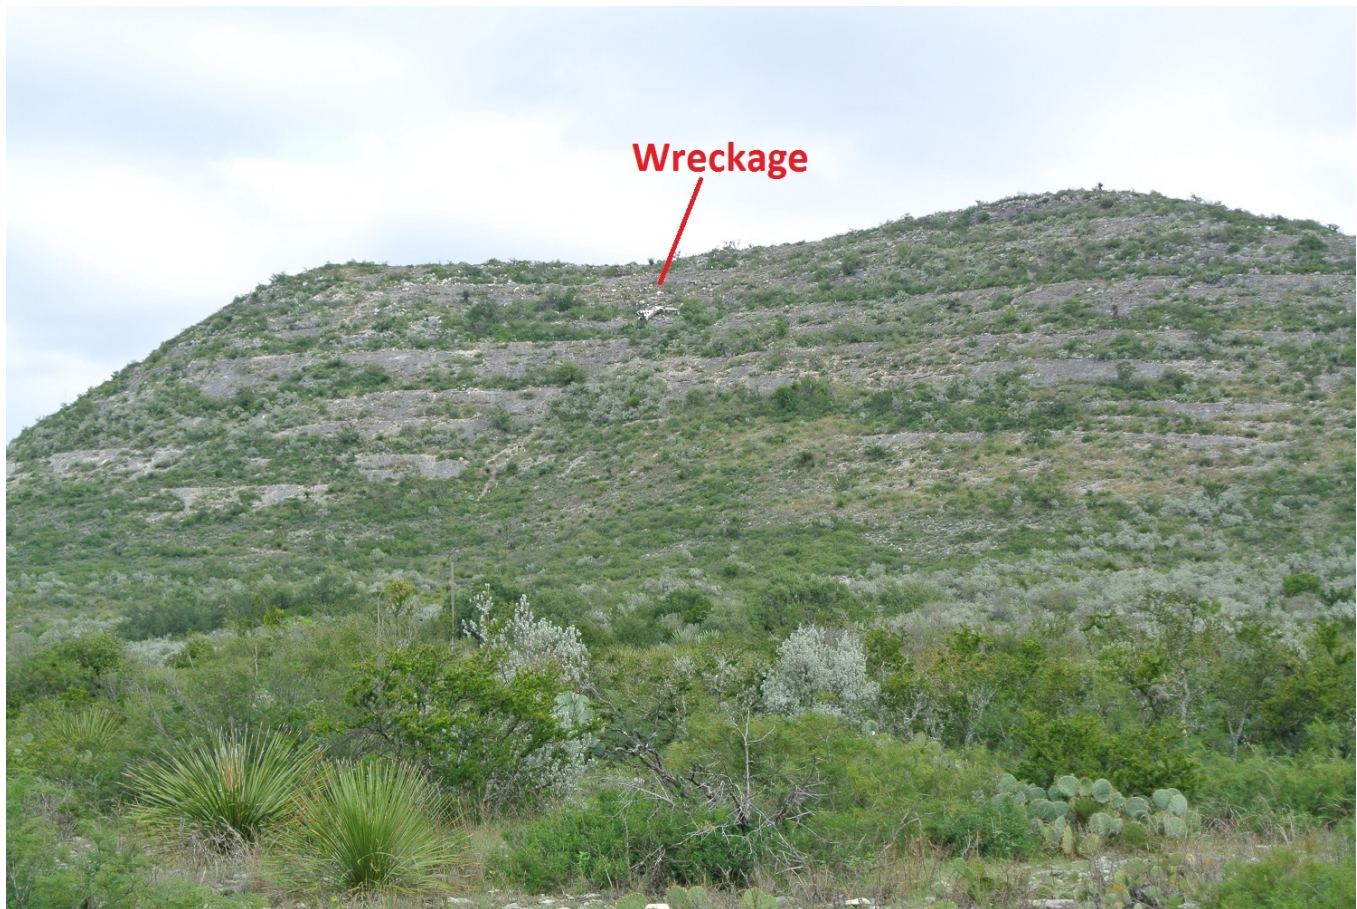
The helicopter impacted about 100 ft below the apex of a hill that measured about 1,500 ft mean sea level (see figure 2). A wreckage path about 75 to 100 yards long was distributed along the hillside leading to the main wreckage. There was no post-crash fire.

Figure 2. Wreckage at the accident site (Courtesy of FAA)

All major components of the helicopter were located at the accident site. The forward portion of the cabin/cockpit area was largely destroyed by impact. The tail boom remained attached to the fuselage but was twisted and damaged due to the impact. The fuel bladder remained in the fuselage and contained an undetermined quantity of fuel. The tail rotor gearbox was found several feet away from the tail boom. Both tail rotor blades were bent near the doubler but remained attached. The tail rotor was rotated by hand with no binding or anomalies noted with the tail rotor gearbox. Oil was present in the tail rotor gearbox. The tail rotor gearbox's magnetic chip detector was removed and no particles were observed.

The main rotor hub and blade assembly had separated from the main rotor mast below the main rotor hub. The main rotor mast exhibited a fracture consistent with mechanical overload. The two main rotor blades were fractured outboard of the doublers and located near the wreckage path. Main rotor drivetrain continuity was established by rotating the input drive by hand and observing the rotation of the mast. No abnormalities were noted when the transmission was rotated by hand. The transmission chip detectors were removed and no particles were observed.
