Aviation Investigation Final Report

Location:	Galliano, Louisiana	Accident Number:	CEN19FA095
Date & Time:	March 10, 2019, 12:03 Local	Registration:	N577AL
Aircraft:	Bell 407	Aircraft Damage:	Destroyed
Defining Event:	Loss of control in flight	Injuries:	2 Fatal
Flight Conducted Under:	Part 135: Air taxi & commuter - Non-scheduled

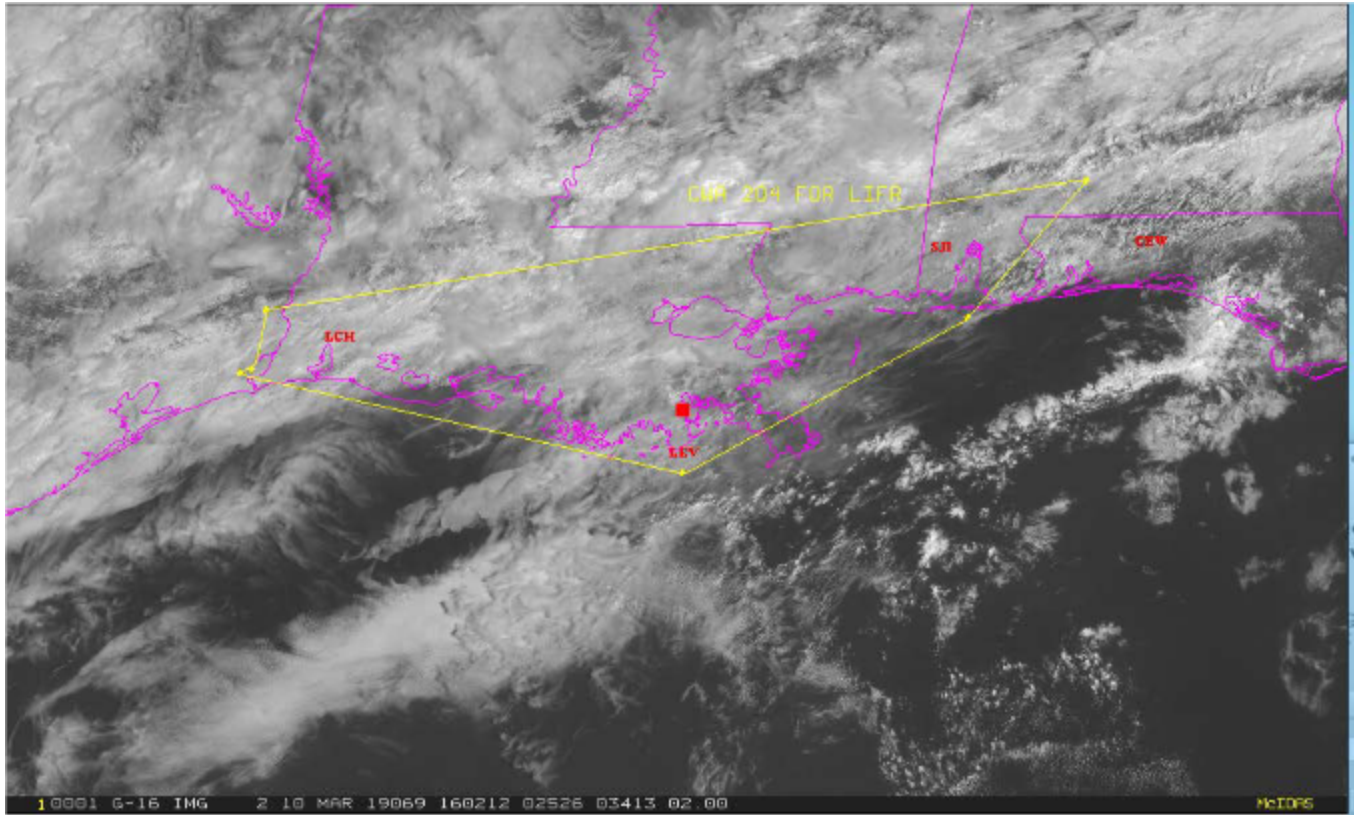
The Houston, Texas, Center Weather Service Unit issued several center weather advisories (CWA) during the period between 0904 through 1300 warning of low instrument flight rules (IFR) conditions over the region. The GOES-16 visible satellite image with the CWA advisory for low IFR conditions were plotted with reference to the accident site, depicted in Figure 1.

Figure 1: GOES-16 visible satellite image at about 1100 with CWA 204 for LIFR conditions.

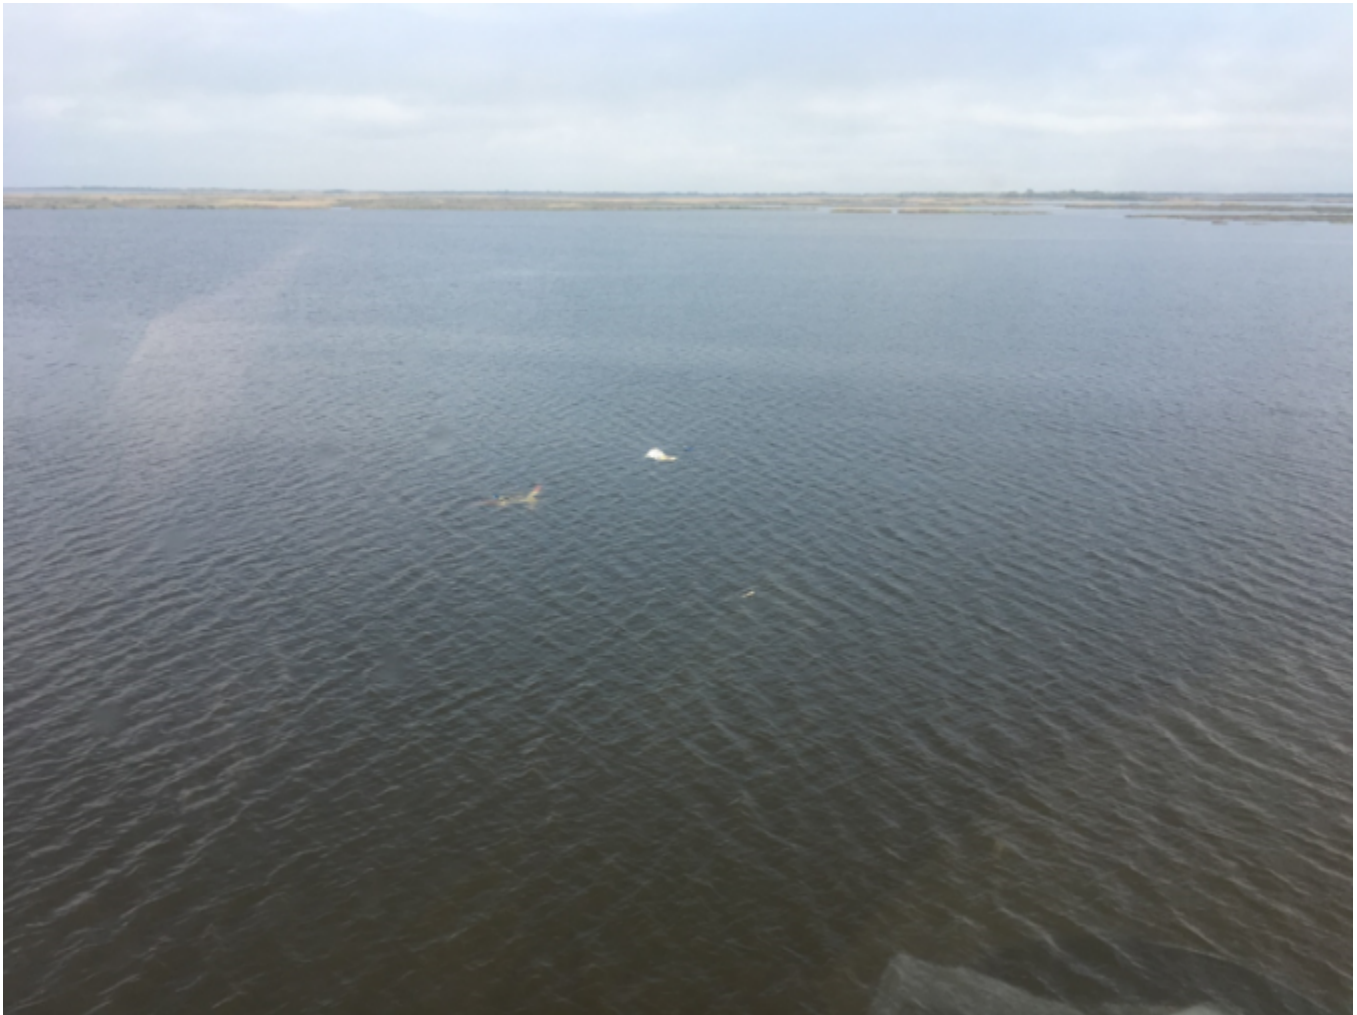
The wreckage was located in a brackish marsh. Terrain features in day visual meteorological conditions are depicted in Figure 2.

Figure 2: Wreckage Site Viewed Toward Northeast

The fuselage was fragmented, and the transmission, main rotor hub and engine remained partially attached to the fuselage structure. Both skids were separated from the fuselage through separations consistent with overload. The wreckage exhibited signatures of a left-turning, nose-low impact attitude.
