Aviation Investigation Final Report

Location:	Brainerd, Minnesota	Accident Number:	CEN19FA185
Date & Time:	June 28, 2019, 00:40 Local	Registration:	N11NM
Aircraft:	Agusta A109	Aircraft Damage:	Substantial
Defining Event:	Loss of control in flight	Injuries:	2 Fatal, 1 Serious
Flight Conducted Under:	Part 135: Air taxi & commuter - Non-scheduled - Air Medical (Discretionary)

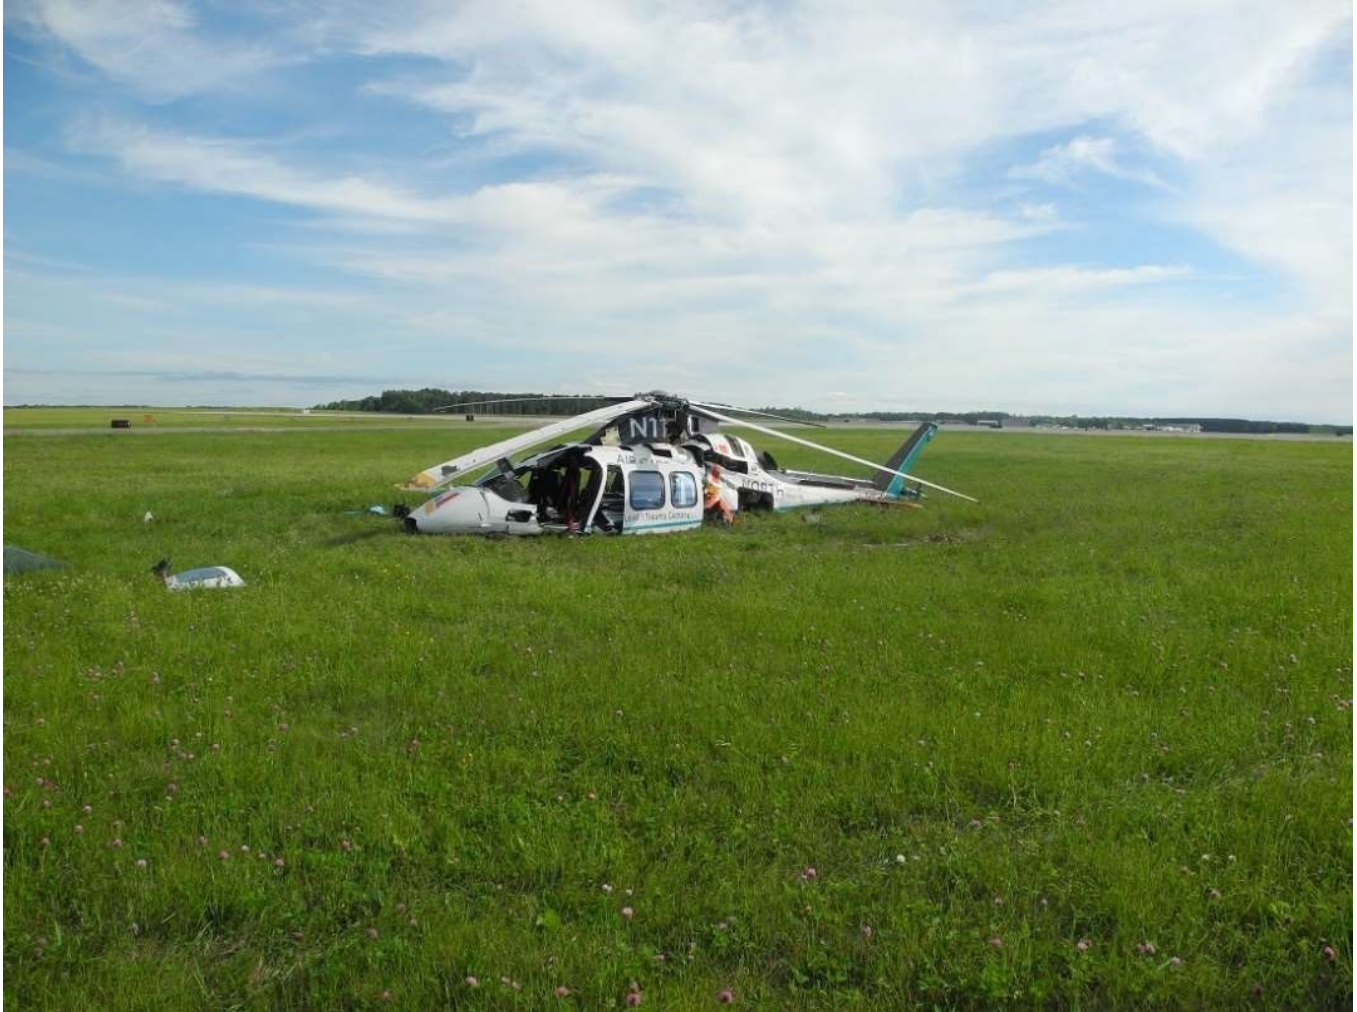
Figure 1. View of Helicopter at Accident Site

The helicopter impacted a grassy area south of runway 23 and came to rest upright and nearly intact on a heading of 074°. The main fuselage and tail boom exhibited crushing consistent with a high-velocity vertical descent and impact. (See Figure 1.) The helicopter was upright and nearly intact, with no movement from the initial impact point. There was no evidence of a postcrash fire. The ground adjacent to the wreckage was soaked with fuel and the smell of fuel was present at the accident site.

Examination of the helicopter and review of recorded flight information revealed no evidence of mechanical malfunctions or failures that would have precluded normal operation.
