Is Automated Driving Part of a Safe System Approach?

Member Michael Graham

April 3, 2023

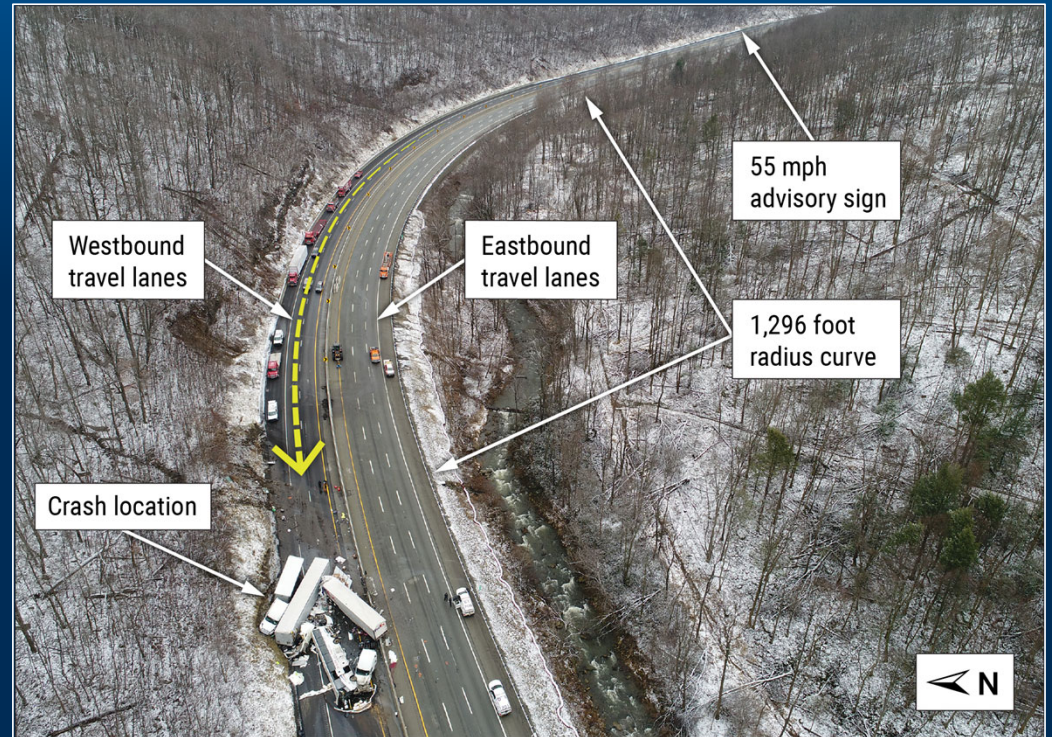
Interstate 70/76 – Mt. Pleasant, PA

- January 5, 2020; 3:30am
- Slight precipitation
- Mountainous interstate curve with 55mph advisory speed
- Motorcoach entered curve at 77mph
- Excessive steering input from motorcoach
- Motorcoach overturned
- Initial position of rest blocked both lanes and shoulders

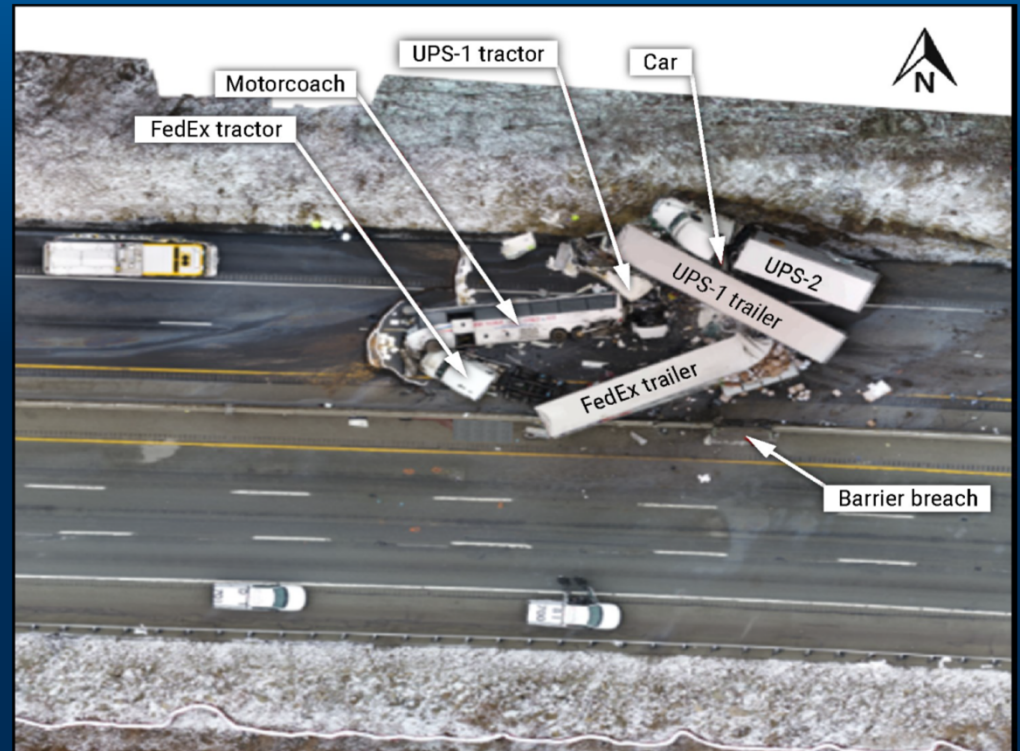
Subsequent Crashes

Vehicles Involved (in order)

- FedEx truck
- UPS truck (UPS-1)
- Car
- UPS truck (UPS-2)

Resulting Injuries

- 5 fatal
- 50 injured

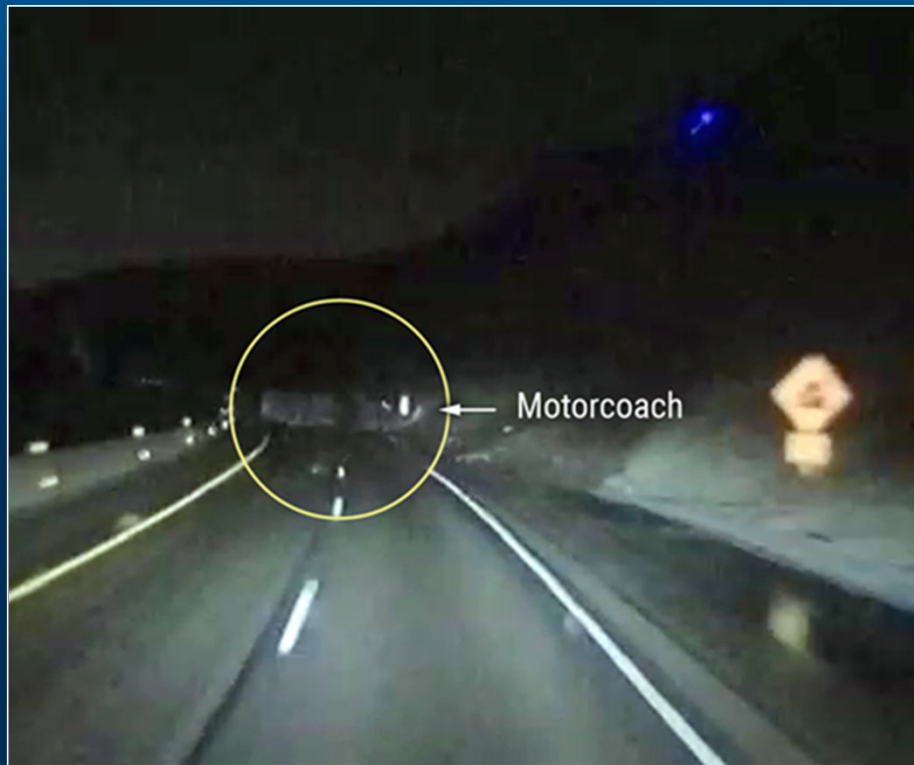
- FedEx-1, UPS-1, and UPS-2 all equipped with Collision Avoidance System –including AEB
- FedEx driver described overturned motorcoach as a “black wall”
- NTSB Finding: Circumstances of the impact for each of the three trucks were likely outside the capabilities of the collision avoidance system on the vehicles

NTSB Finding: Connected vehicle technology, if installed on the vehicles involved in the crash, could have provided information about the overturned motorcoach in the roadway to the FedEx truck, UPS-1, UPS-2, and the car, so that the drivers could be alerted to the hazard they were approaching, and the automated vehicle systems might have prevented the crashes involving those vehicles

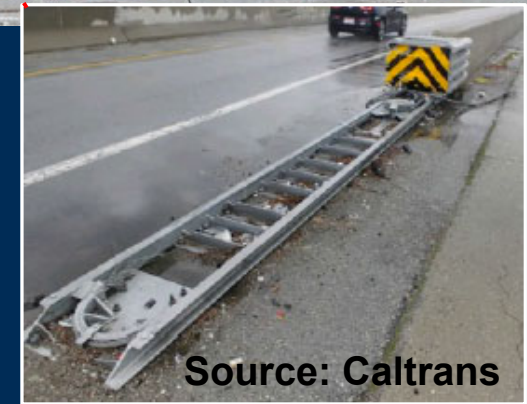
Crash attenuator was collapsed and nonoperational prior to the crash

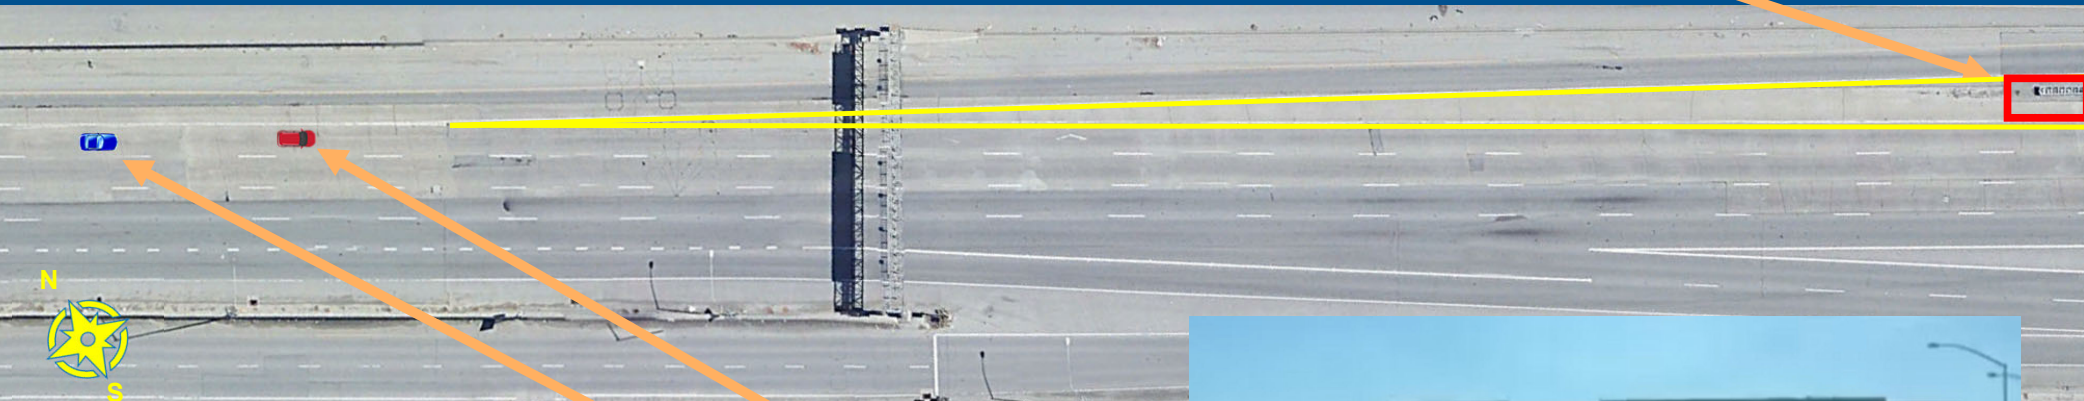
Time to crash: 7.9 seconds
Speed: 64.3 mph
Lead vehicle: 83.7 feet
Distance to crash: 748 feet

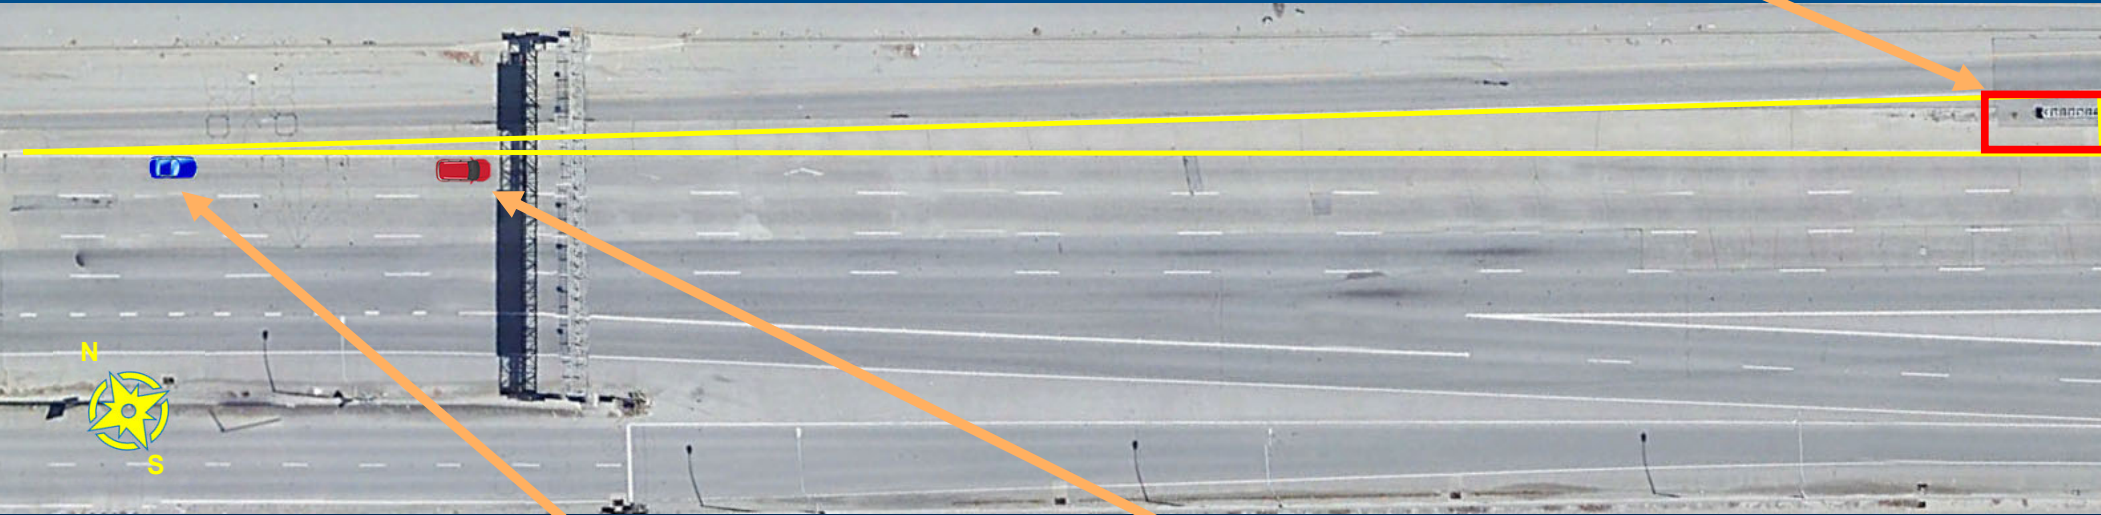
Time to crash:	5.9 seconds
Steering:	5.6 degrees left
Speed:	64.1 mph
Lead vehicle:	82 feet
Distance to crash:	560 feet
Indication:	Hands-off steering wheel

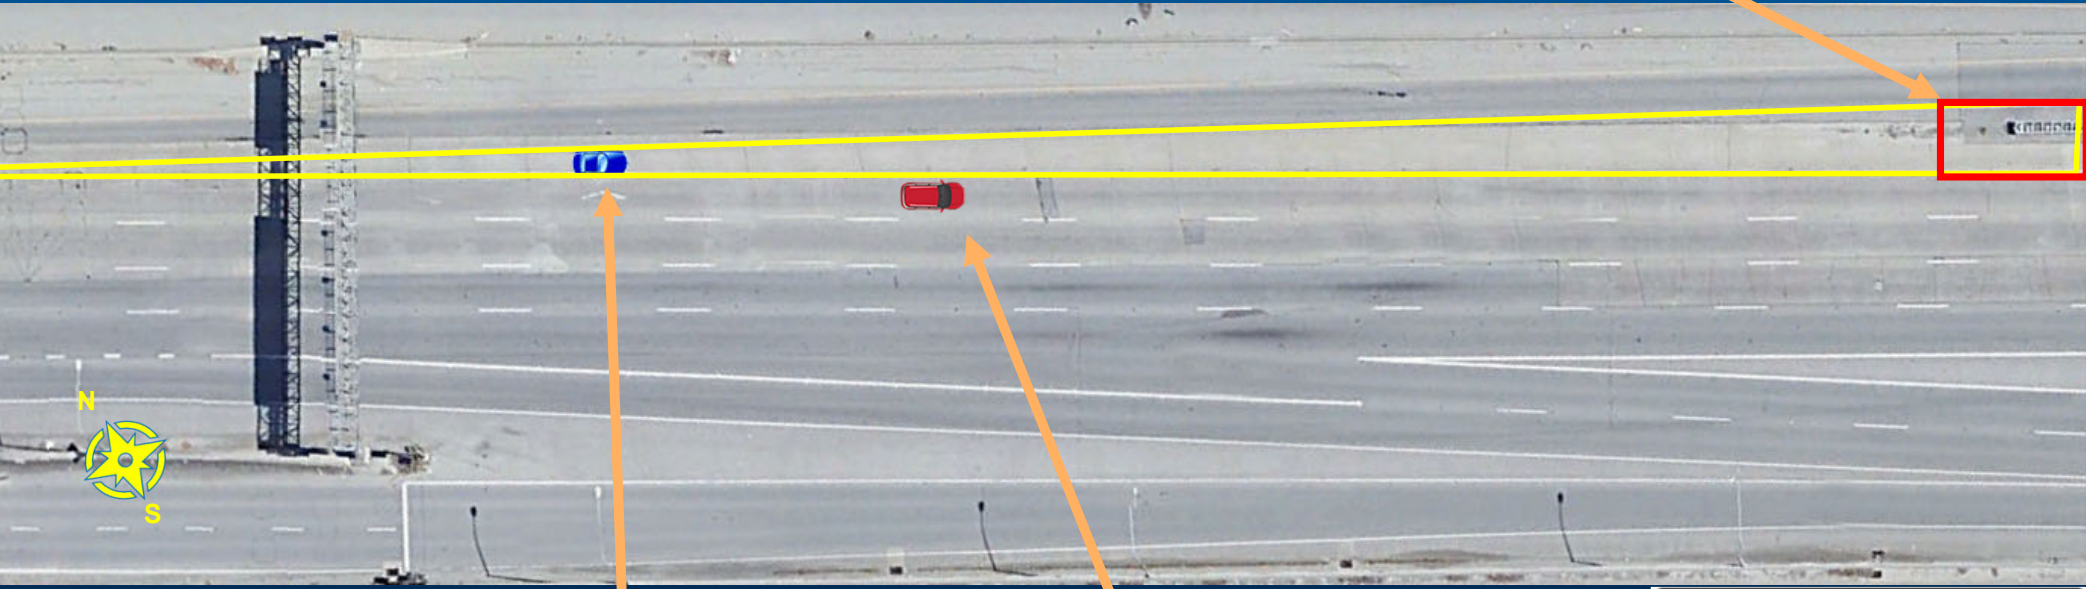
Time to crash: 3.9 seconds
Speed: 61.9 mph
Lead vehicle: None detected
Distance to crash: 375 feet
Vehicle begins to accelerate
Hands-off steering wheel indicated

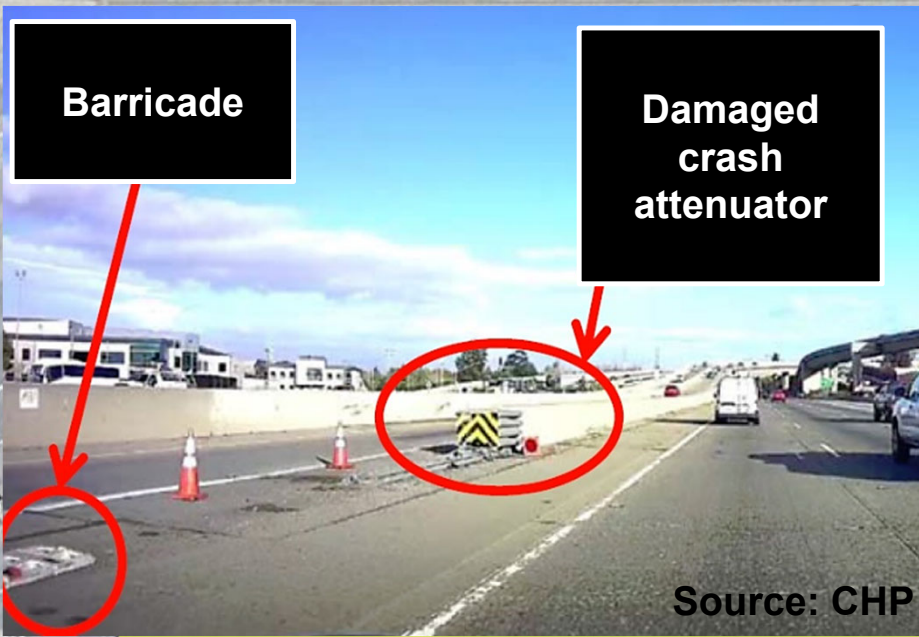
Damaged crash attenuator

Barricade and cones placed in advance of attenuator prior to crash

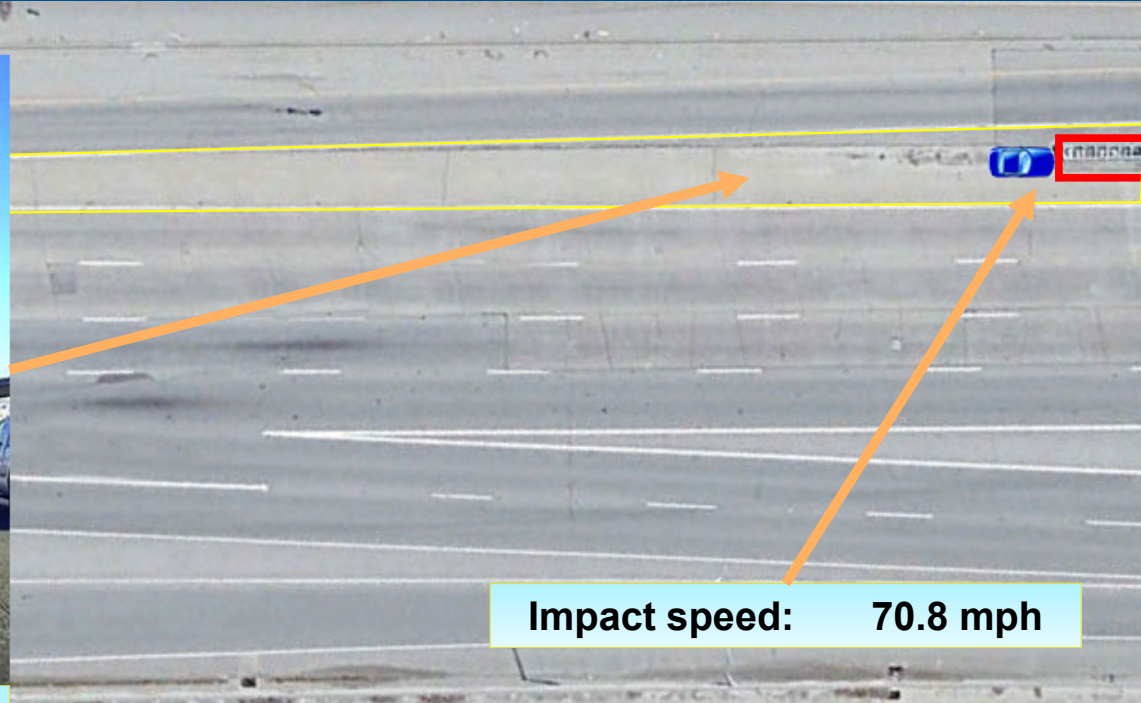
Impact speed: 70.8 mph

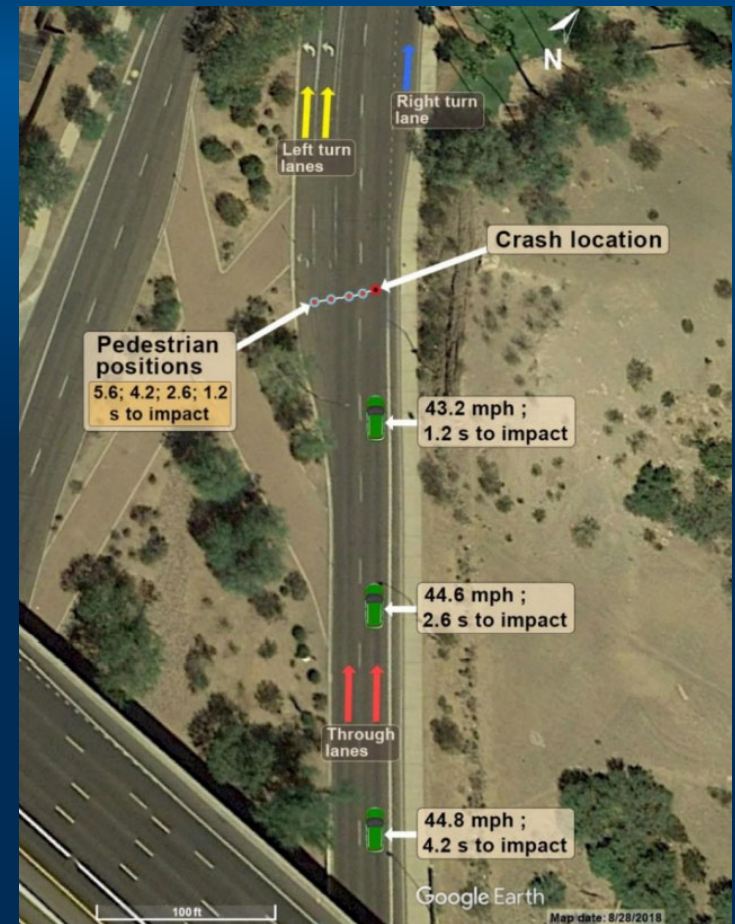
- 3/18/18, 9:58pm
- 2017 Volvo XC90 SUV operating as an ADS test vehicle
- Operator in driver's seat of SUV monitoring ADS
- Pedestrian crossing street not at designated cross walk while pushing a bicycle
- Pedestrian struck by SUV and fatally injured
