Flight Helmet Cords Can Impede Egress

■ Understand the hazard of direct-to-airframe cord connections

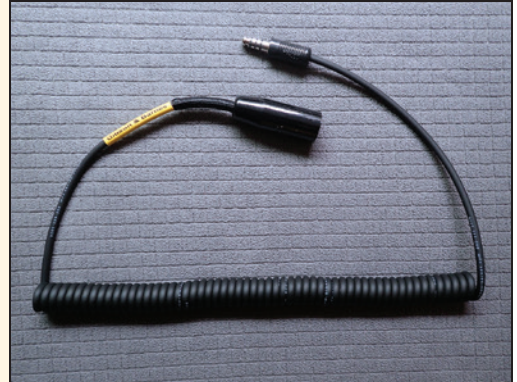
Figure 5. Exemplar intermediate cord.

- **Ensure that you and your passengers understand and are proficient with the egress procedures for the aircraft that you are operating before you take off.**
- **Use a compatible intermediate cord between the ICS cord and the airframe ICS port to facilitate a clean separation during egress. The intermediate cord is a cord connecting to the airframe ICS port on one end and to the ICS cord on the other end, allowing the ICS cord to be disconnected in the direction of egress.**
- **Ensure that ICS cords are secured from potential snagging or entanglement with components such as flight controls.**
