SEO.O.G. REPORT NO.: 2018-056-2

Reference: **FIRE INCIDENT INVESTIGATION**
MV CHIPOLBROK MOON – VOYAGE 72
VESTAS REF. NO. 18/120

ON BOARD the Hong Kong flagged multi-purpose heavy-lift vessel
"CHIPOLBROK MOON" of Hong Kong

While she was berthed with her port side to the Port of Houston "City Docks" in order to investigate in connection with the fire incident in cargo hold #3 port side which reportedly occurred in the night time from May 22nd to May 23rd 2018 whilst berthed at the Industrial Terminal (Dock 1 West)

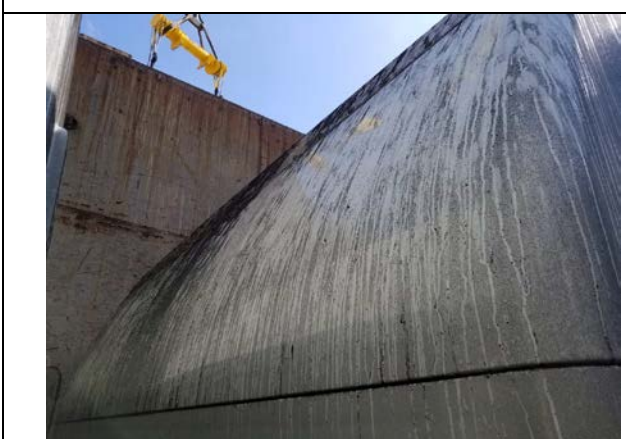
Thereby, eight (8) nacelles were found in extremely dirty condition, more precisely covered with black soot from all sides. Apparent damage to those units was not noted but had to be properly ascertained once discharged. The lower hold was, besides four (4) Vestas hubs, loaded with steel pipes and construction parts at its forward and aft entrance areas which posed a potential trip hazard due to restricted visibility at that time. For that reason, the Harris County Fire Marshal continued the inspection in the lower hold without the other attending parties but reported that one (1) hub was severely damaged outside and inside by fire (serial no. 18020106 as noted later)

View onto rear end nacelle – unit covered in black soot

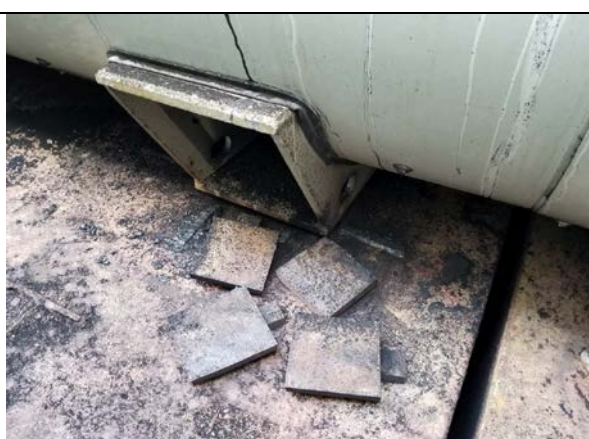
All stopper plates found cut cargo hold #3 port side

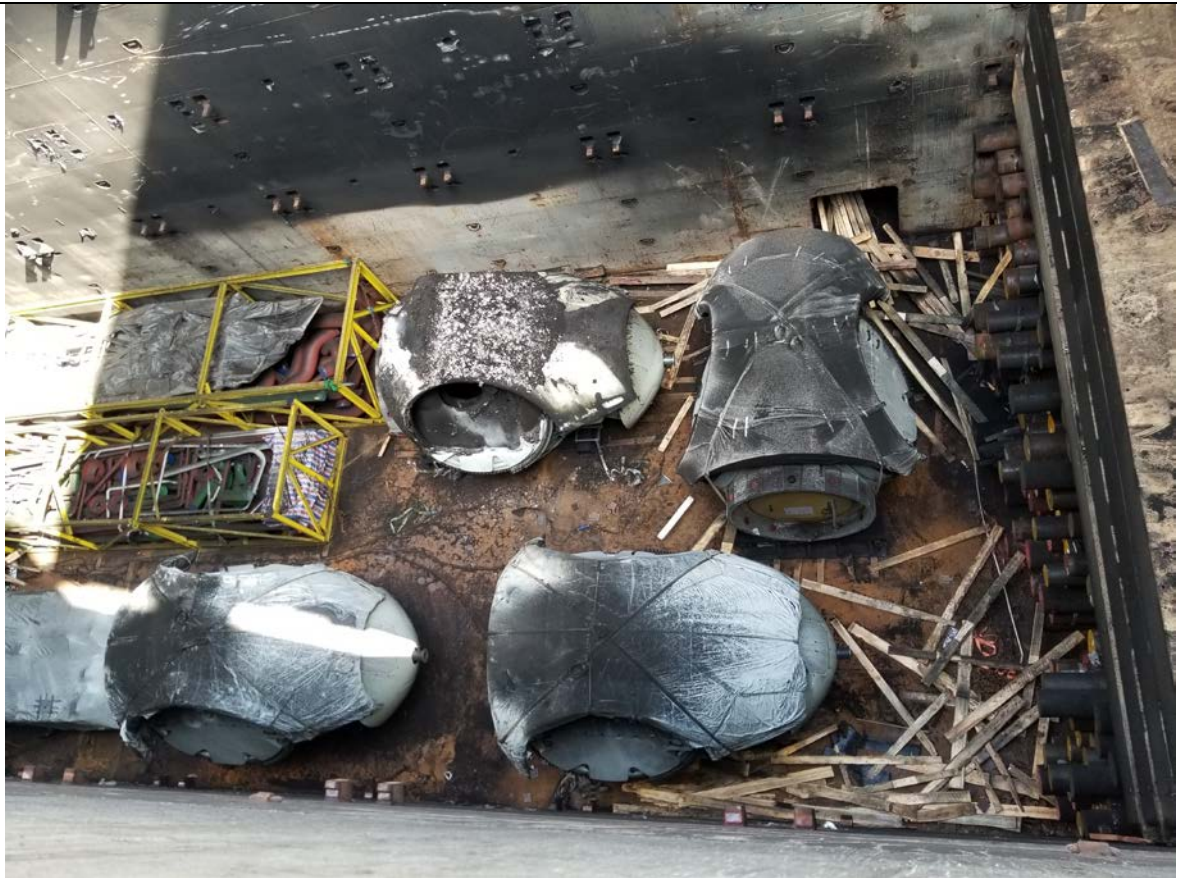
View into fire affected lower cargo hold #3 port side; burnt hub #18020106 in upper left corner of picture

- All blade flange transport covers to most part molten (plastic running from top downwards)
- Wrapping material around spinner shells on top of hub found to most past burnt
- Spinner shells could not be inspected as covered by remains of wrapping material
- Electrical & hydraulic equipment inside main housing found covered with black soot
- Unit in general found extremely dirt and covered with black soot

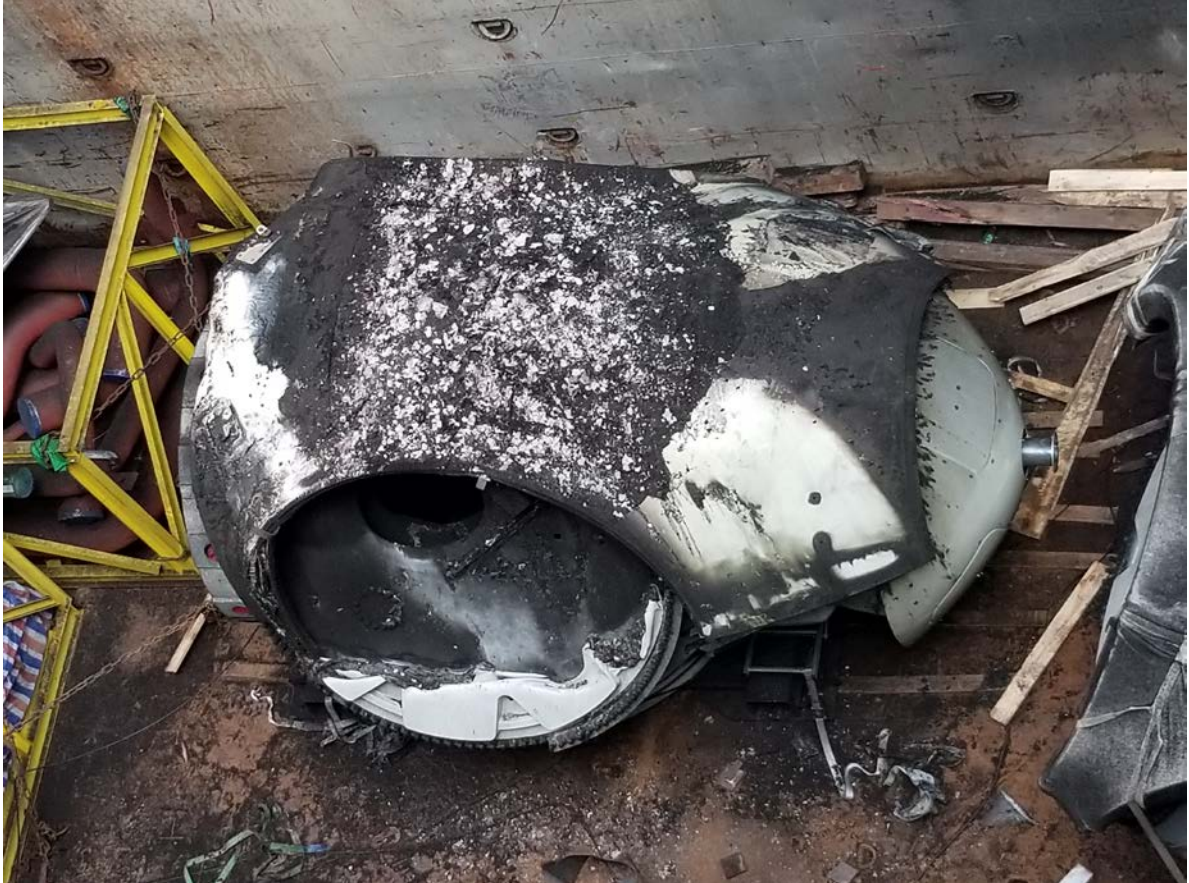
View on top of burnt hub #18020106 whilst stowed in lower cargo hold #3 port side

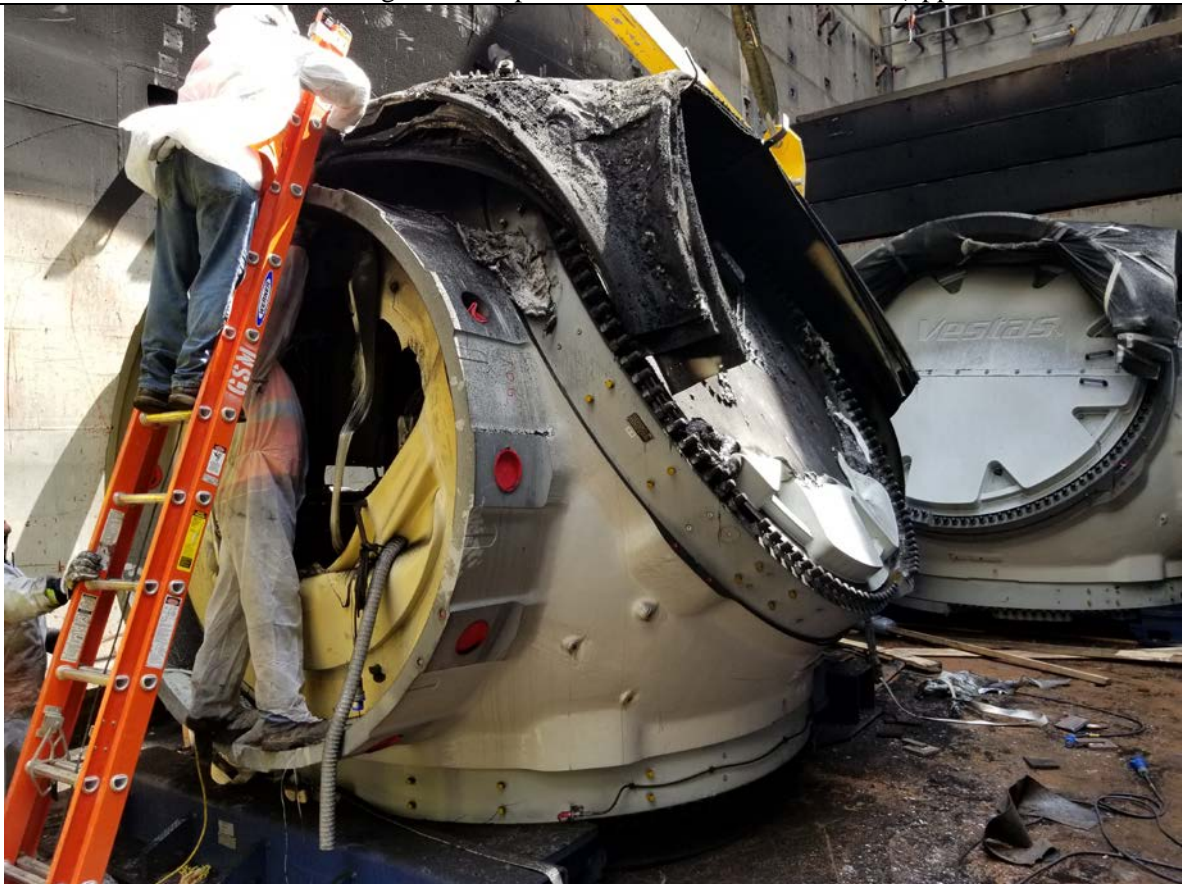
Damaged hub # 18020106 (rigging for discharge)

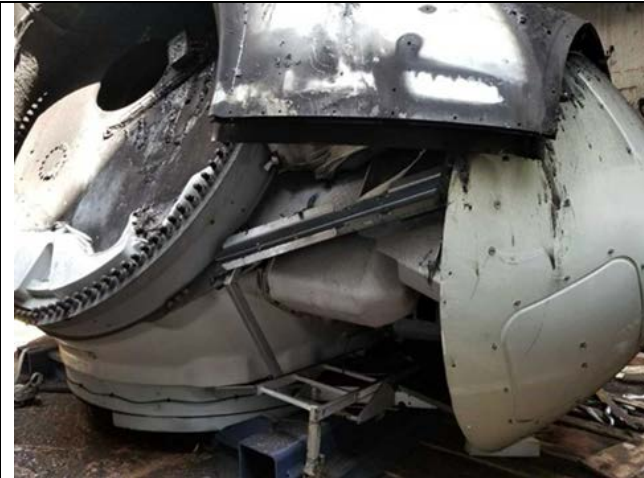
Side view onto damaged hub # 18020106

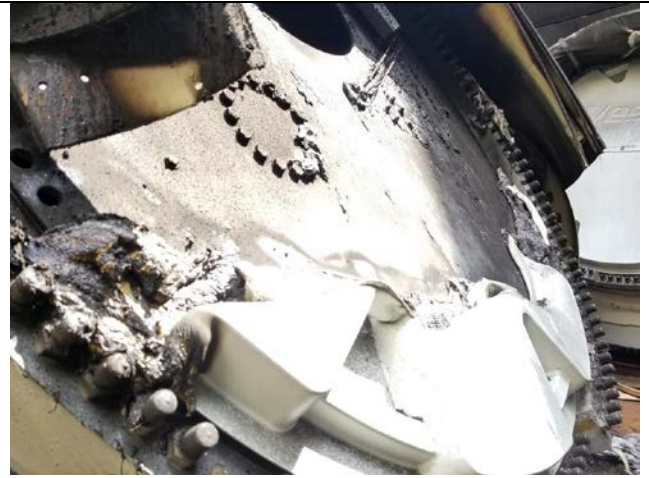
Damaged hub # 18020106 – blade flange cover molten

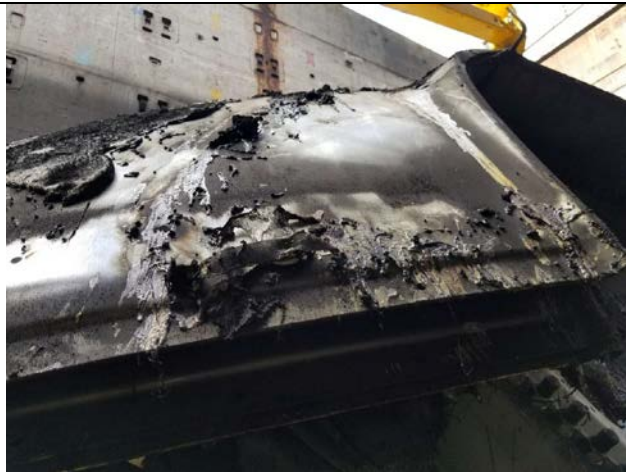
Damaged hub # 18020106 – view onto spinner shells

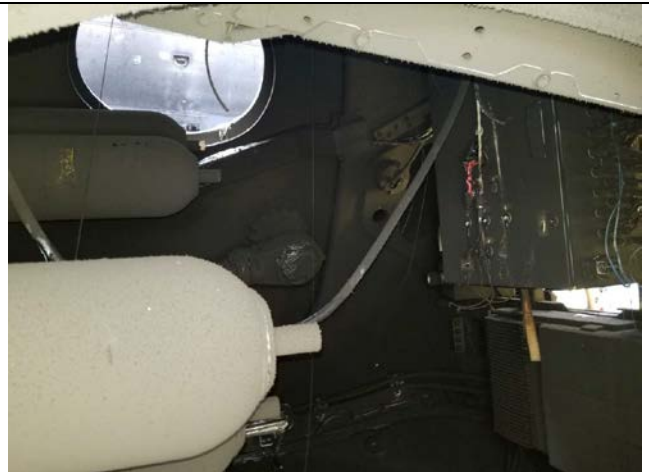
Damaged hub # 18020106 – view inside main housing

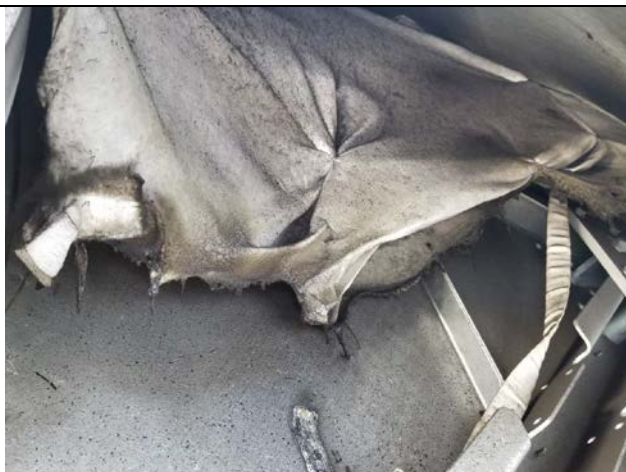
Damaged hub # 18020106

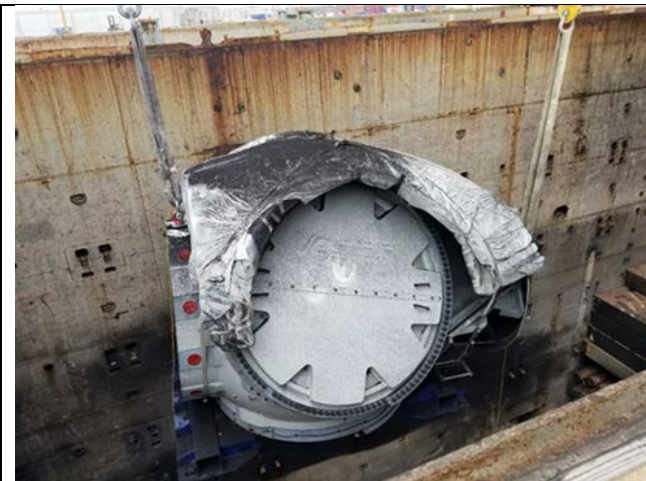
- Units found extremely dirty and covered with black soot
- No heat affects on plastic transport covers or spinner shell wrapping material noted
- Units found in apparent undamaged condition

Hub #18020101 – discharged in very dirty condition

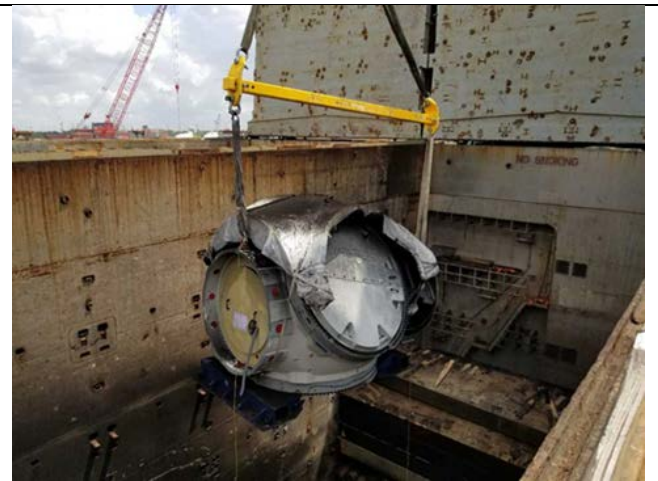
Hub #18020100 – discharged in extremely dirty condition

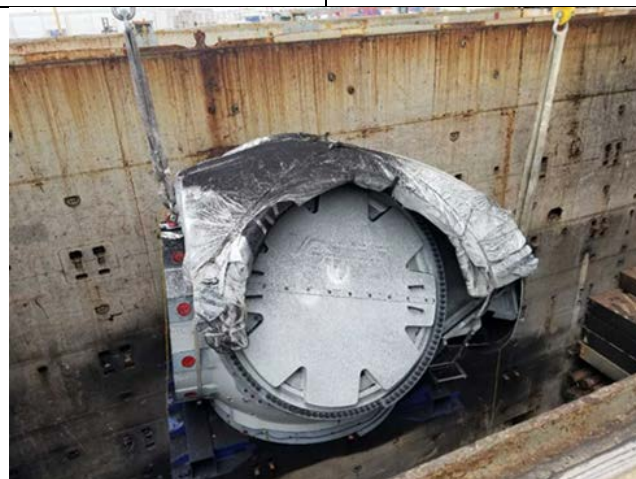
Hub #18020102 – discharged in very dirty condition

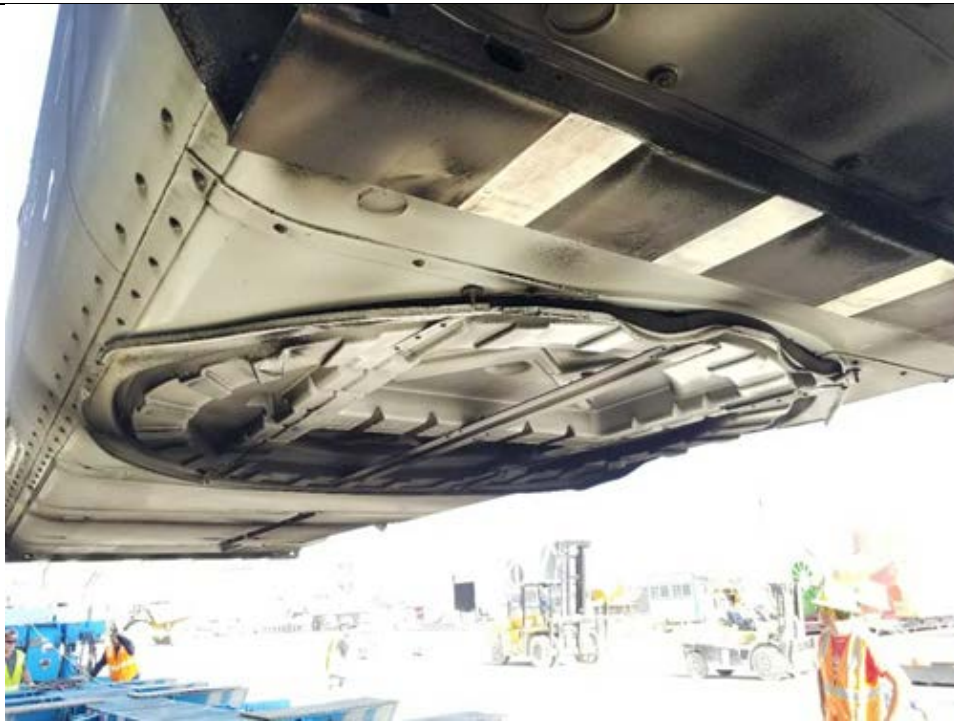
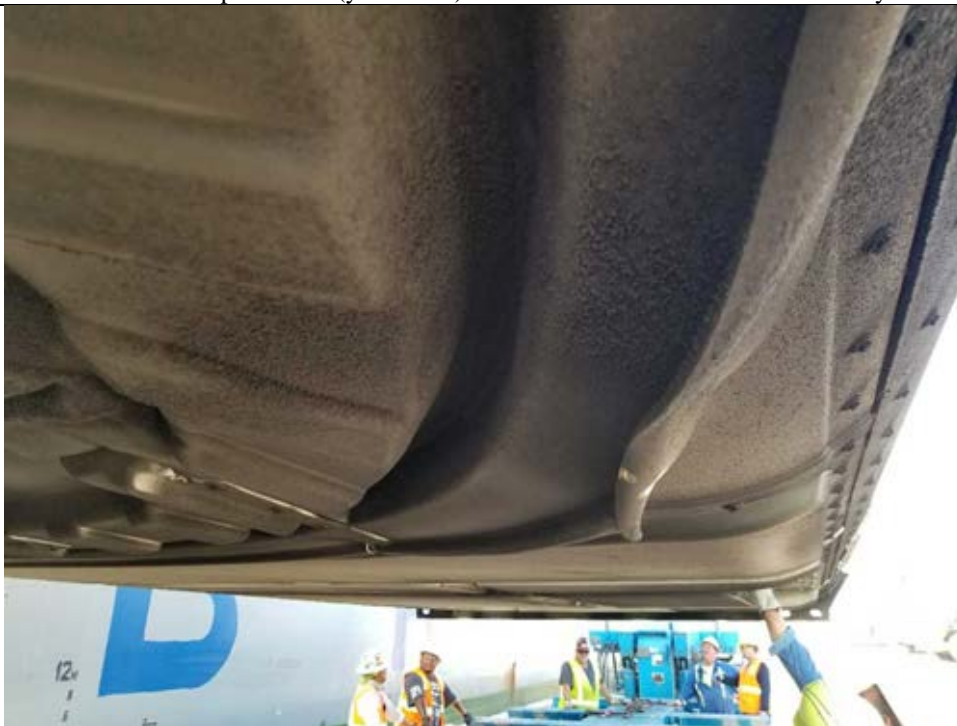
- Units found extremely dirty and covered in black soot
- Bottom transport cover (yaw cover) of nacelle #18030052 deformed / wavy – very likely caused by heat in lower cargo hold during fire one deck below. This unit was stowed directly above burnt hub #18020106

Bottom transport cover (yaw cover) of nacelle #18030052 deformed / wavy

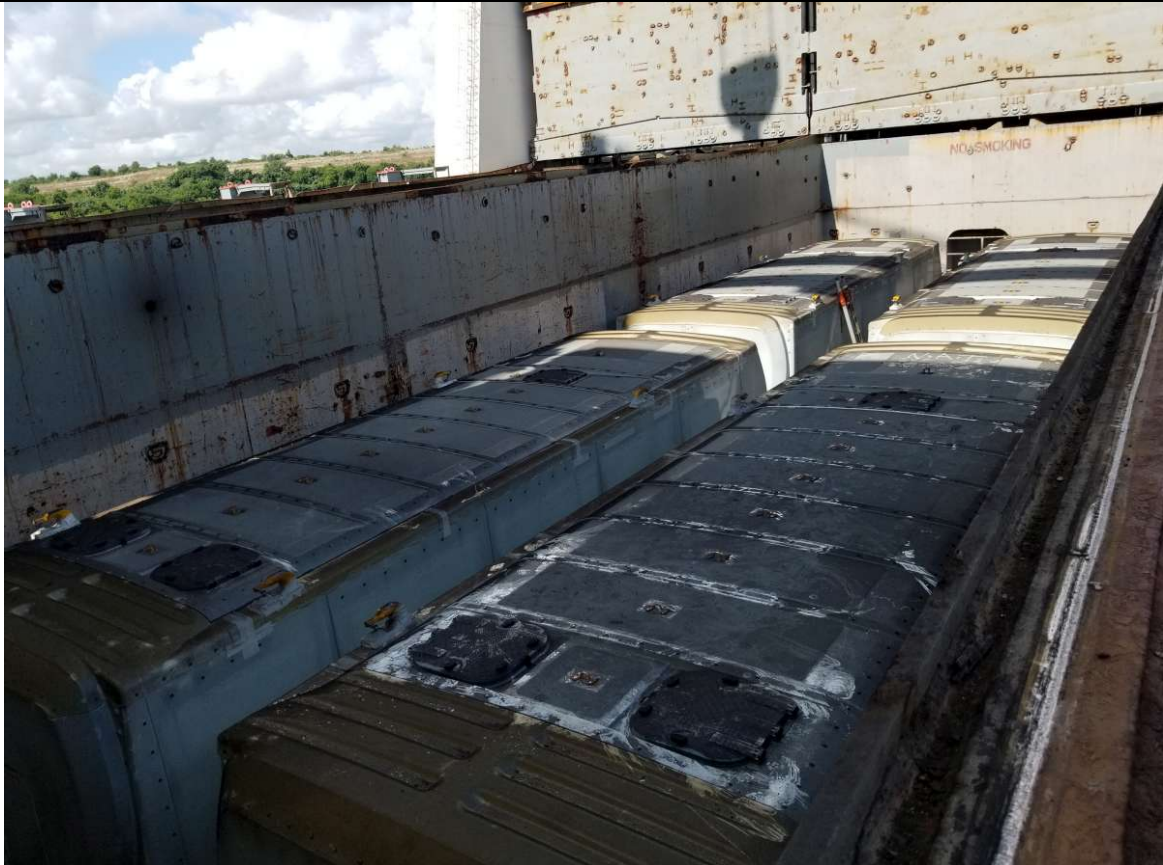
View on top of burnt hub #18020106 whilst stowed in lower cargo hold #3 port side

As noted by the attending Chief Investigator Mr. [REDACTED] during the initial inspection on board MV Chipolbrok Moon, the burnt hub #18020106 was stowed underneath a gap between two lower tween-deck pontoons. As per statement of the involved crew members during the interview, the cutting of stoppers in cargo hold #3 port side was completed at the lower tween-deck level on May 22nd at 23:10 hrs. The gang then shifted from the port side cargo hold into the starboard side cargo hold compartment. The inspecting parties are certain that falling hot blistering slag must have fallen onto hub #18020106 in the lower hold. It is likely that the cutting gang had already shifted into the starboard side cargo hold when the fire started.

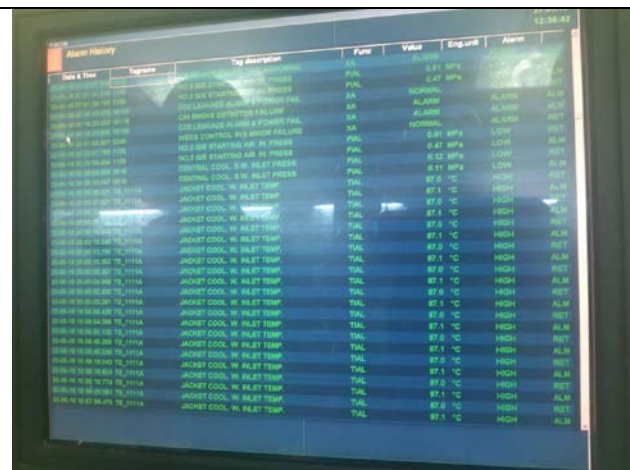
After the interview, the abovementioned persons proceeded into the ship's engine control room to investigate for the exact time of CO₂ release into cargo hold #3. The control panel indicated that the release occurred on May 23rd at 00:18 hrs as stated by the captain.

Control panel indicates release of CO₂ into the cargo hold on May 23rd 2018 at 00:18 hrs

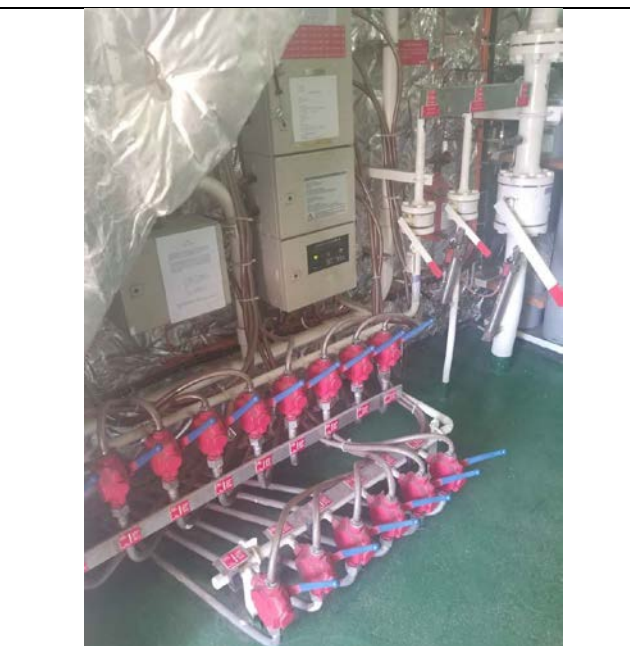
Control panel indicates release of CO₂ into the cargo hold on May 23rd 2018 at 00:18 hrs

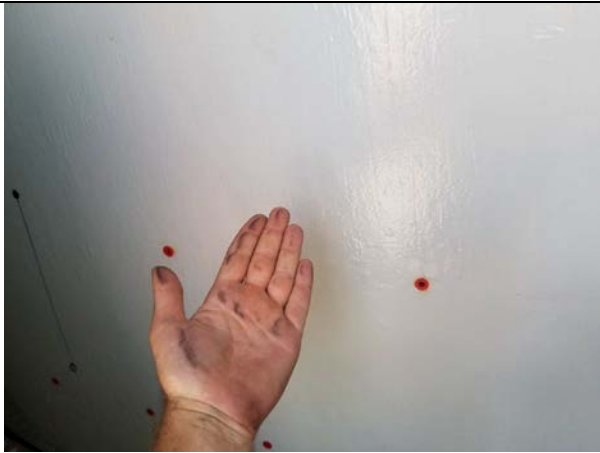
The technicians confirmed that these units were indeed contaminated from inside and that damage to electronic components as well as a contamination of greased parts cannot be excluded

Interior covered with fine black soot (wipetest failed)

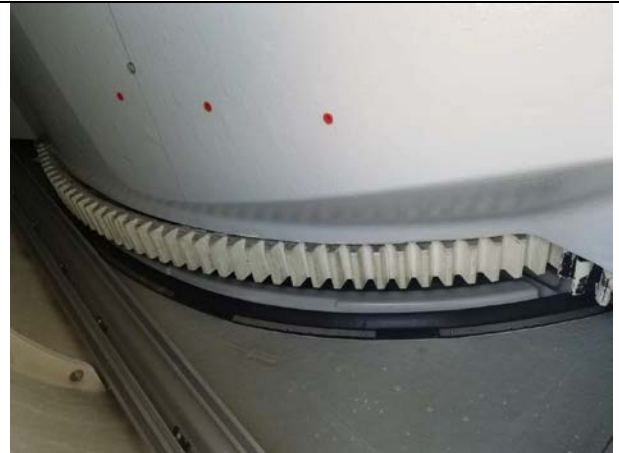
Contamination of greased parts could not be excluded

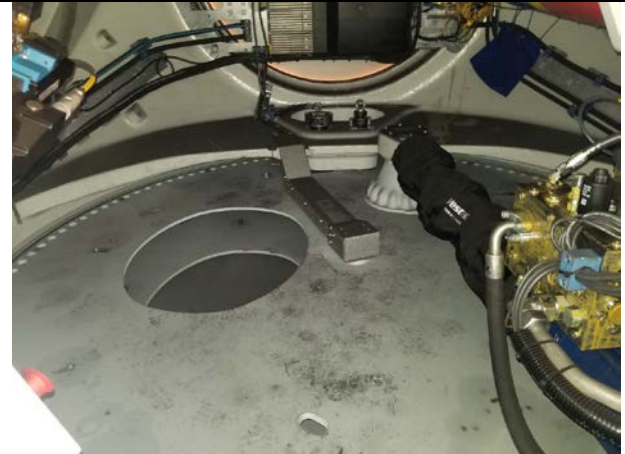
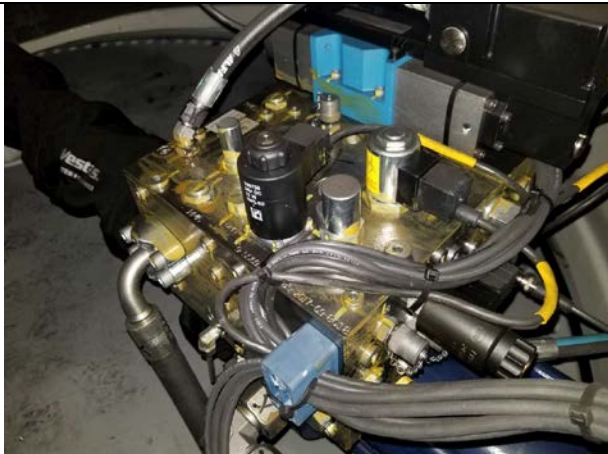
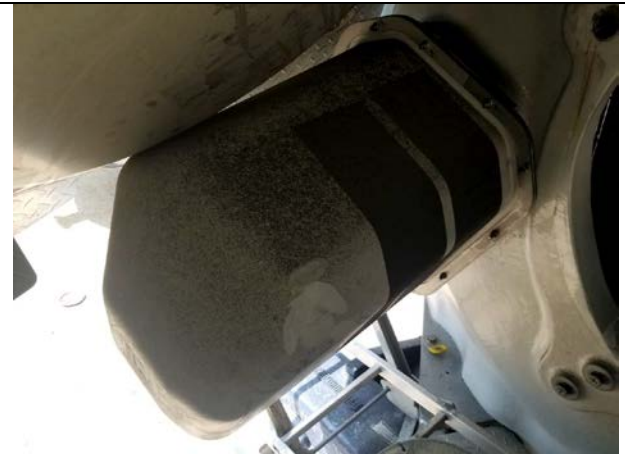
After the inspection of nacelles, the fire affected hubs were inspected by the abovementioned persons. One hub had been opened by the attending Vestas technicians to ascertain the interior condition. Same as the affected nacelles, the hub interior was contaminated with fine black dust

View into contaminated hub (stowed in fire affected hold)

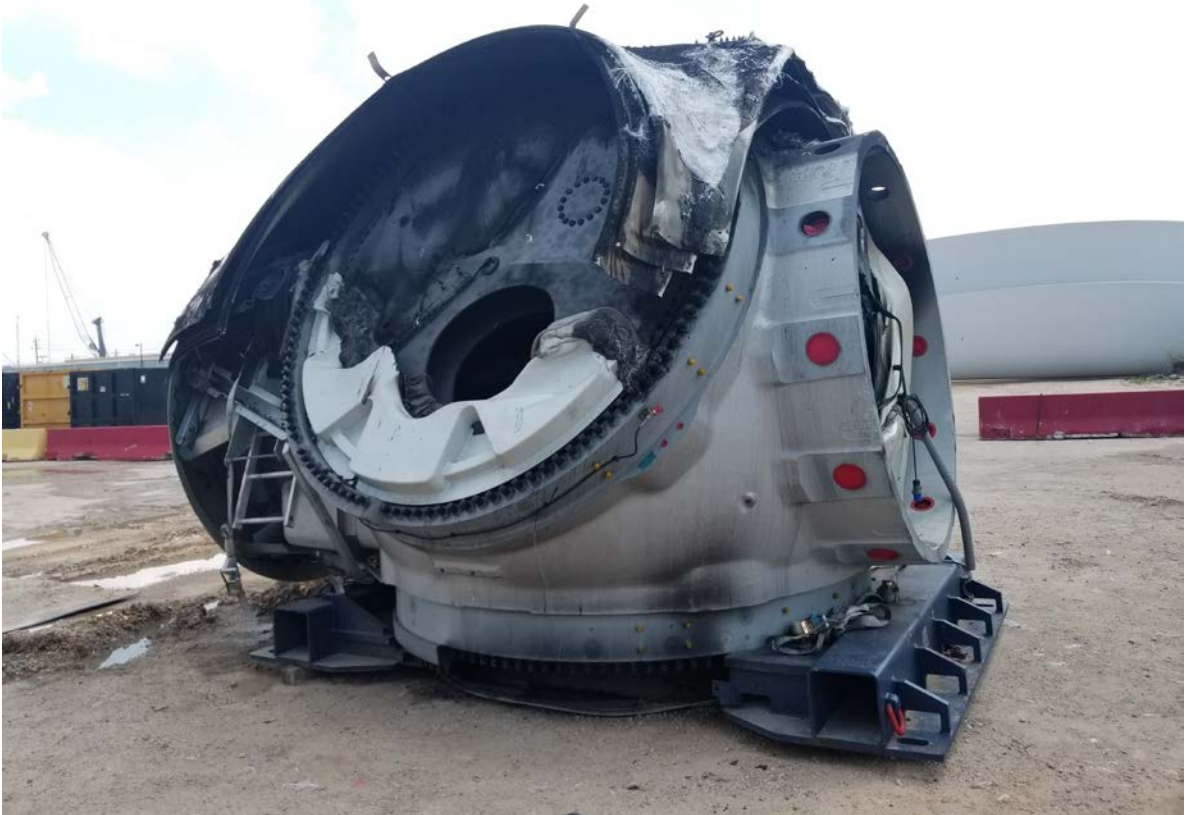
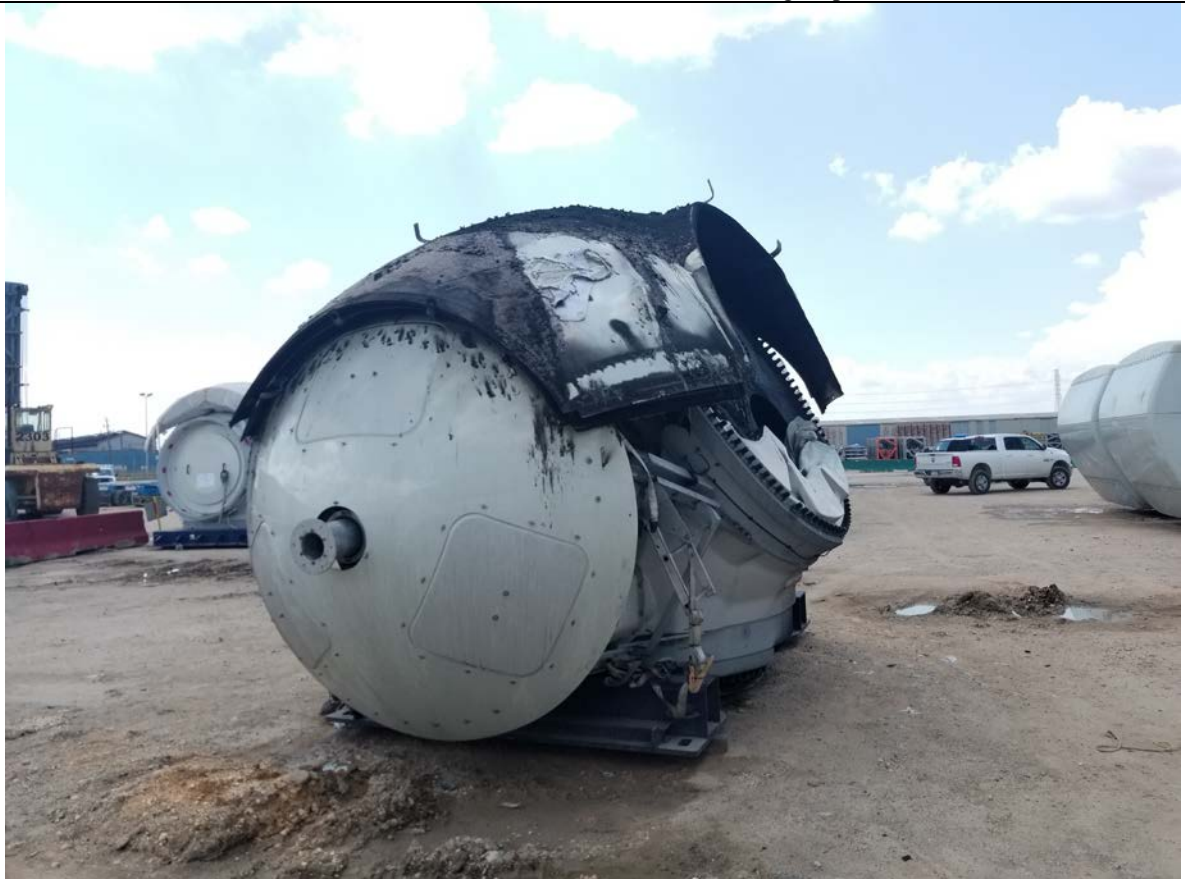
The burnt hub #18020106 was thoroughly inspected by the abovementioned persons with the help of the attending Vestas technicians. As described before, the unit was found with burnt spinner shells and transport flange covers. Furthermore, molten plastic was found inside the unit, indicating that the fire must have raged inside to unknown extent. Electric components as well as hydraulic hoses and wirings were found covered with soot.

It is yet uncertain whether the hub #18020106 must to be considered as constructive total loss. As per statement of Vestas technicians on site, the unit could not be refurbished without great effort and that the fire – evolved temperature unknown – may have had a quality decreasing affect on the structural integrity of the main housing.

Burnt hub #18020106 at Free Trade Zone during inspection

Therefore, we advise to have to the unit inspected by appropriate Vestas mechanical engineers for a qualified statement regarding the extent of damage.

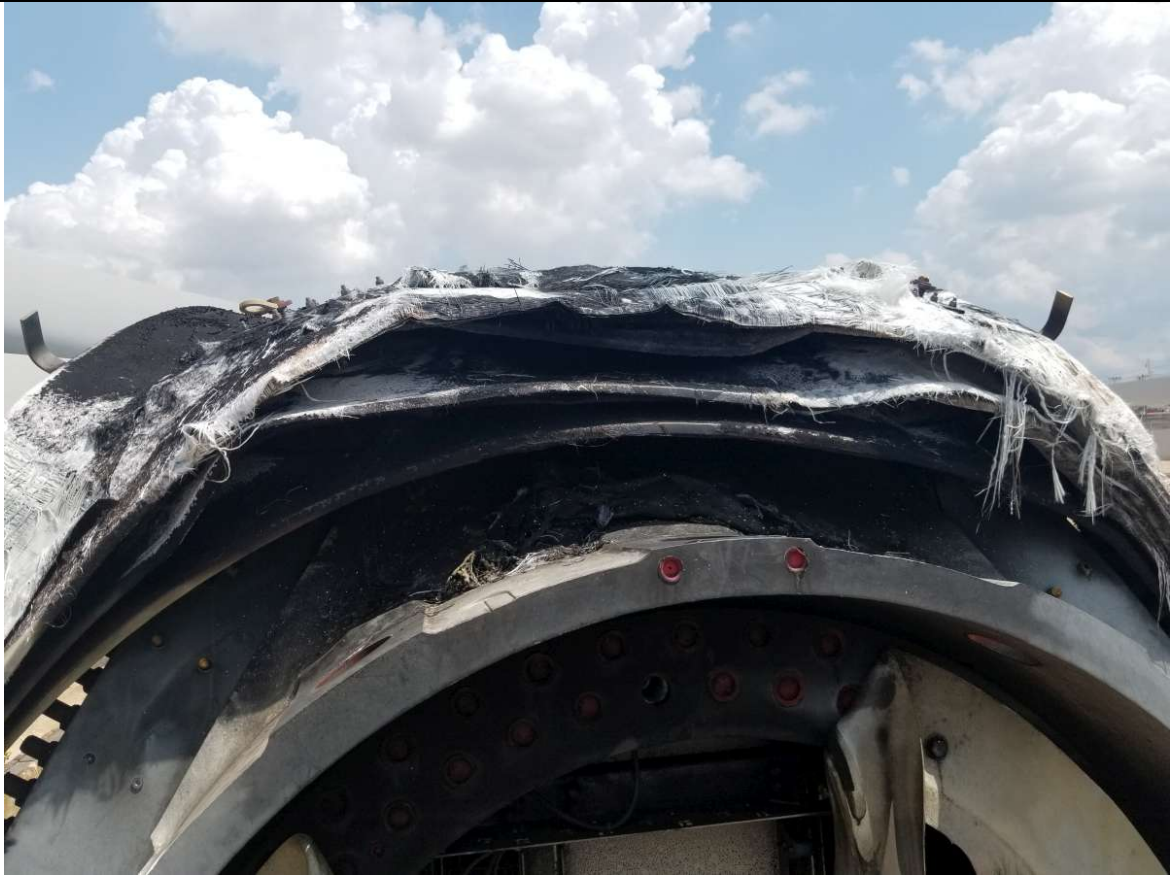
Deformed spinner shells of burnt hub #18020106

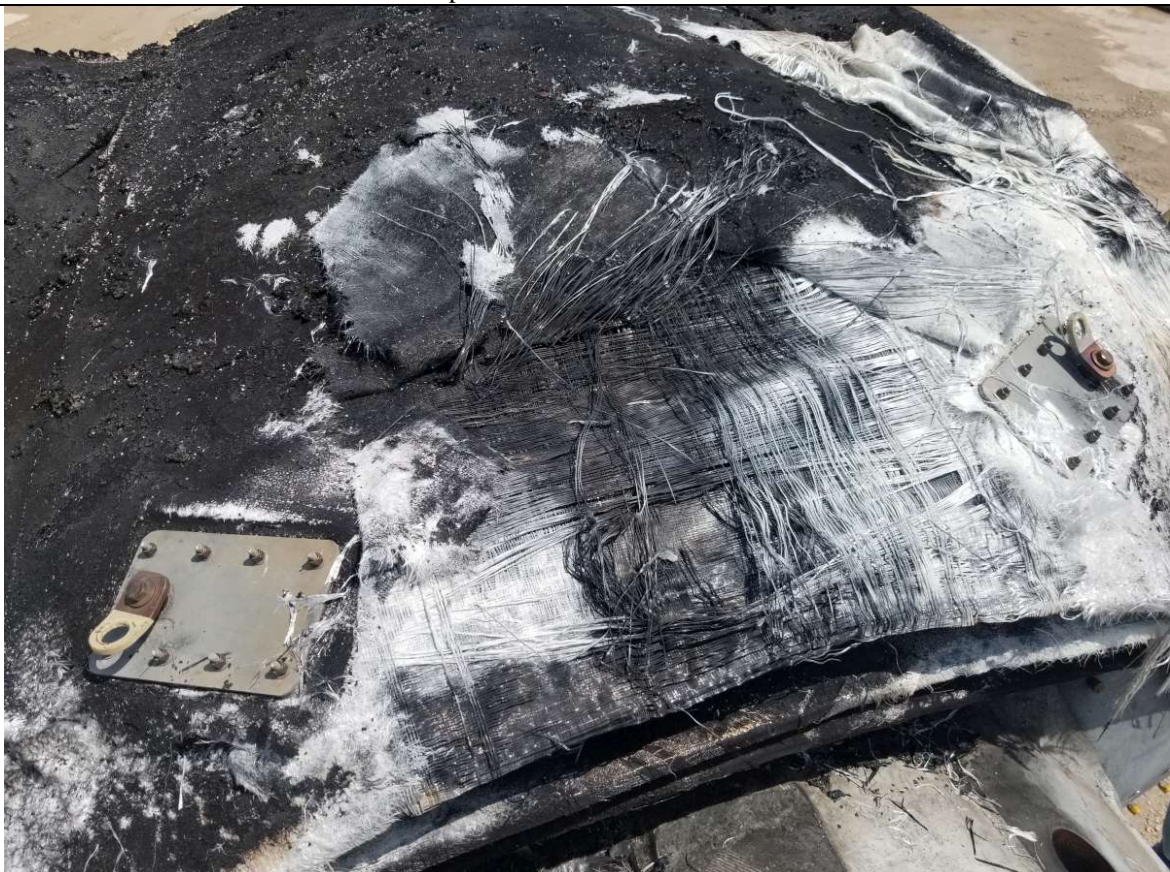
View onto top of burnt hub #18020106 at Free Trade Zone during inspection

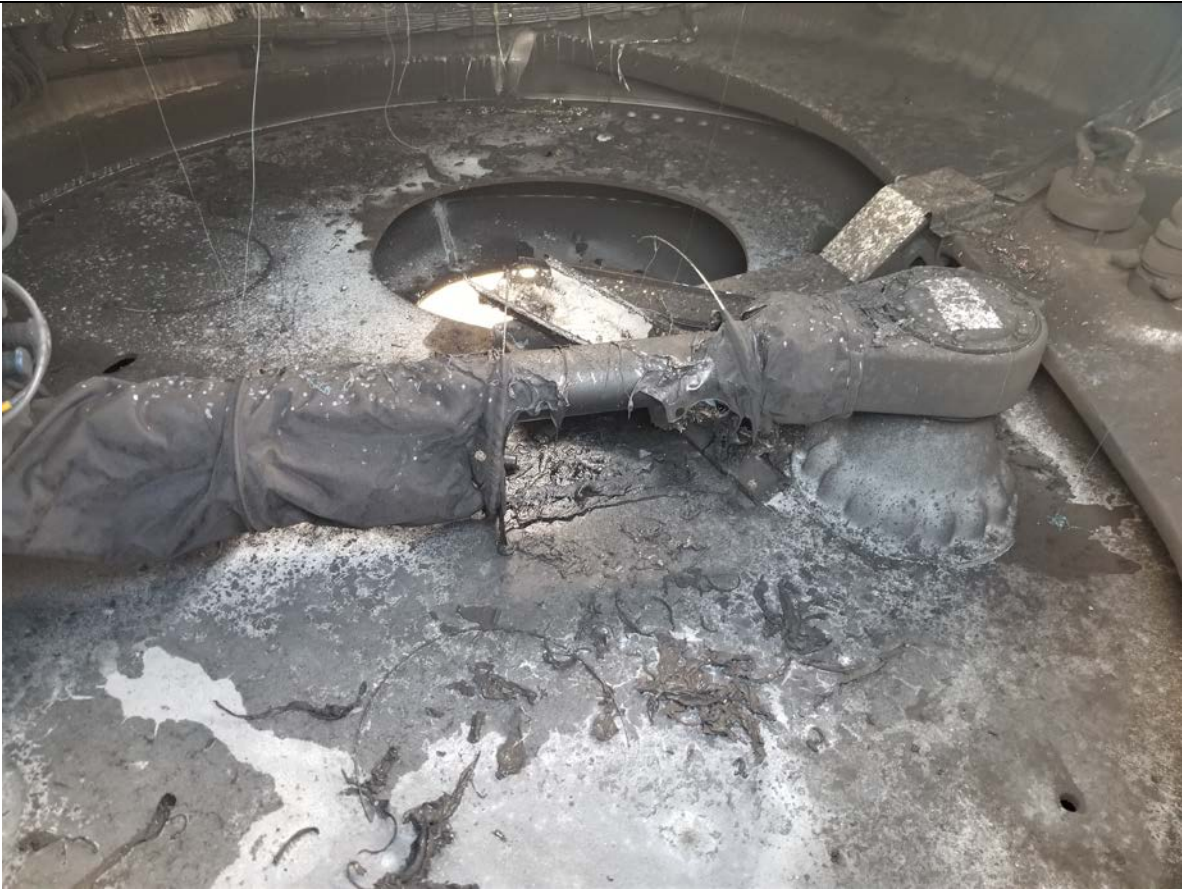
View inside burnt hub #18020106
