Analysis of fire damage to hub #18020106 in the Port of Houston

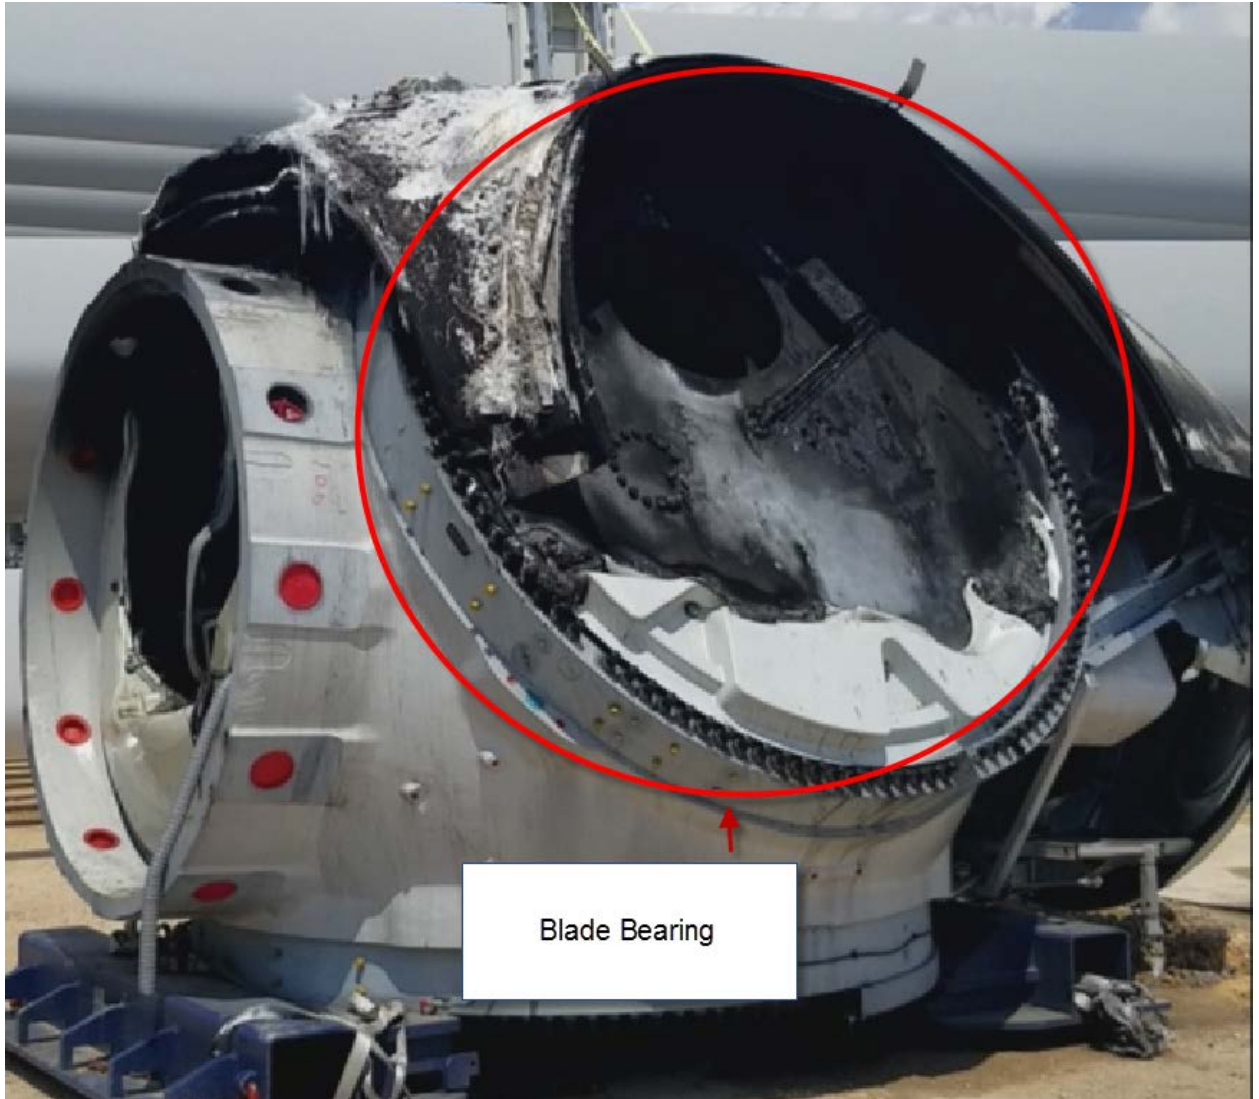
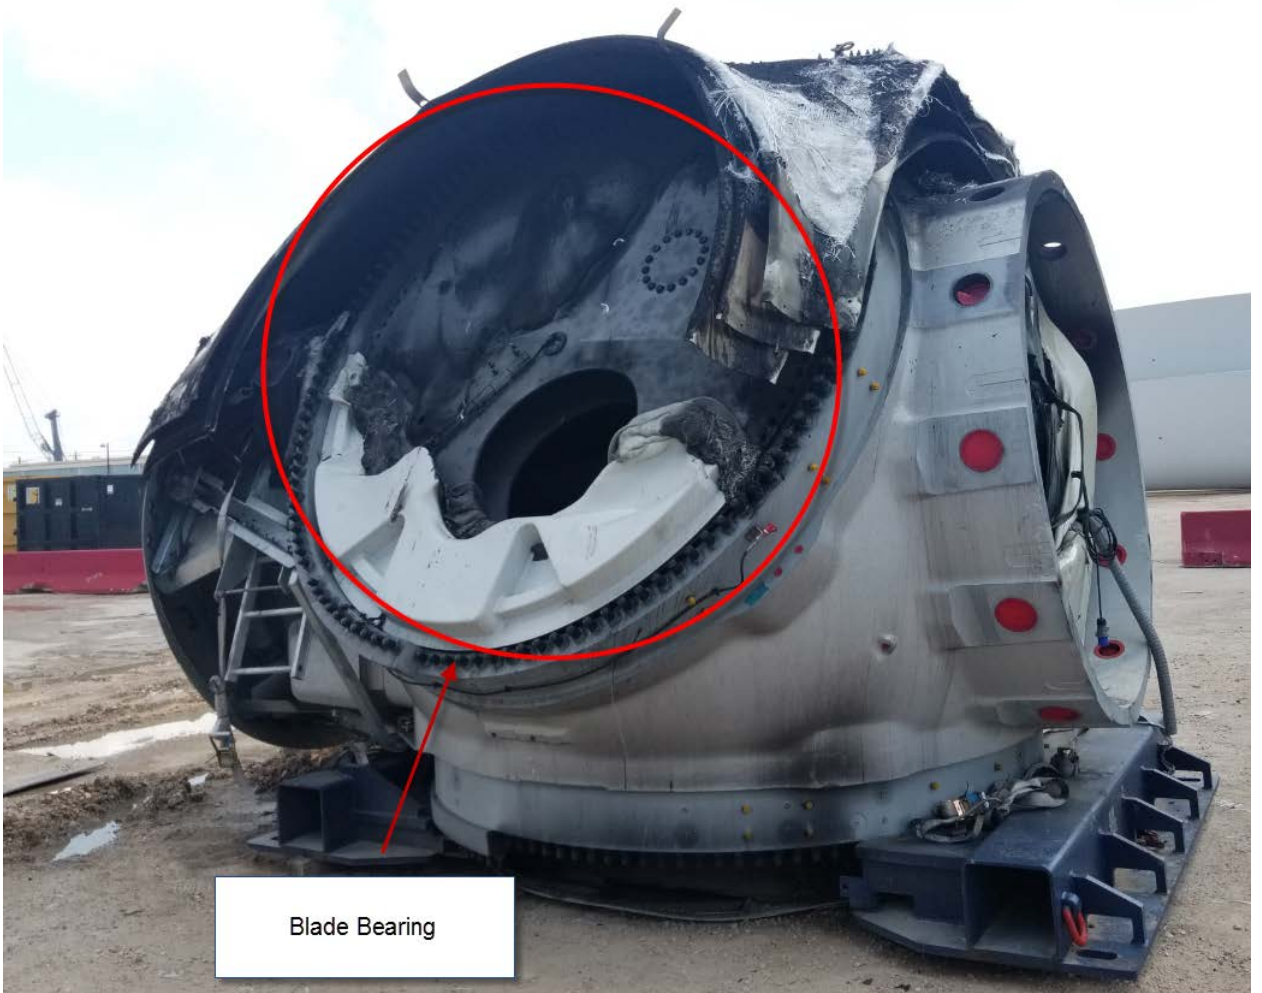
Blade Bearing

1. At least two of the three blade bearings and stiffener plates are damaged to the point of requiring replacement. Aside from the heat damage to the bolts and exterior of the bearing, the internal bearing components are potentially damaged as well.

Based on the pictures provided to me by Construction personnel, this hub should be scrapped and not be refurbished. This is based on the following observations:

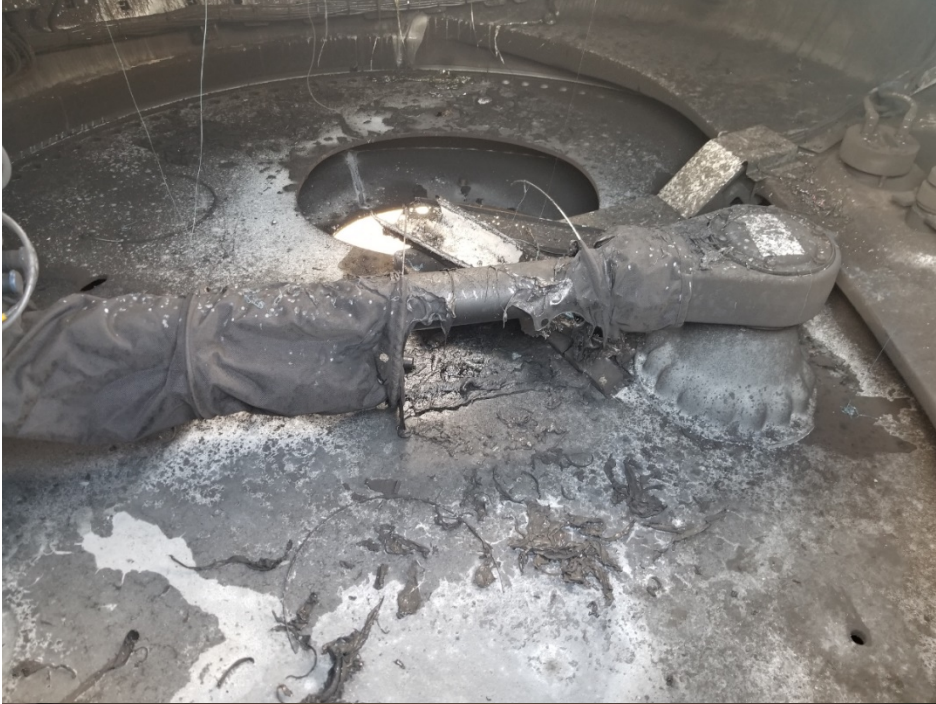
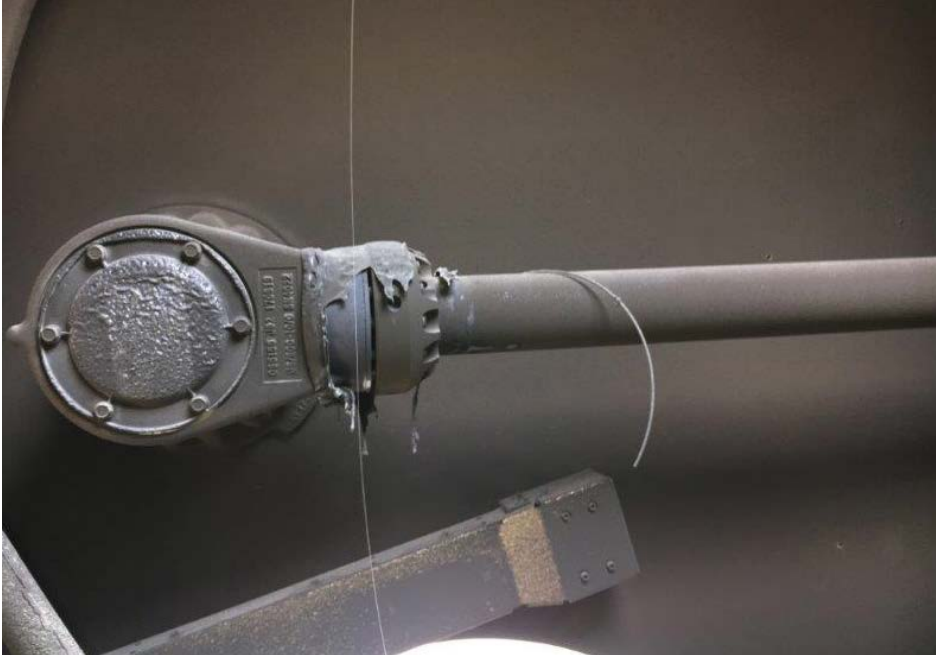
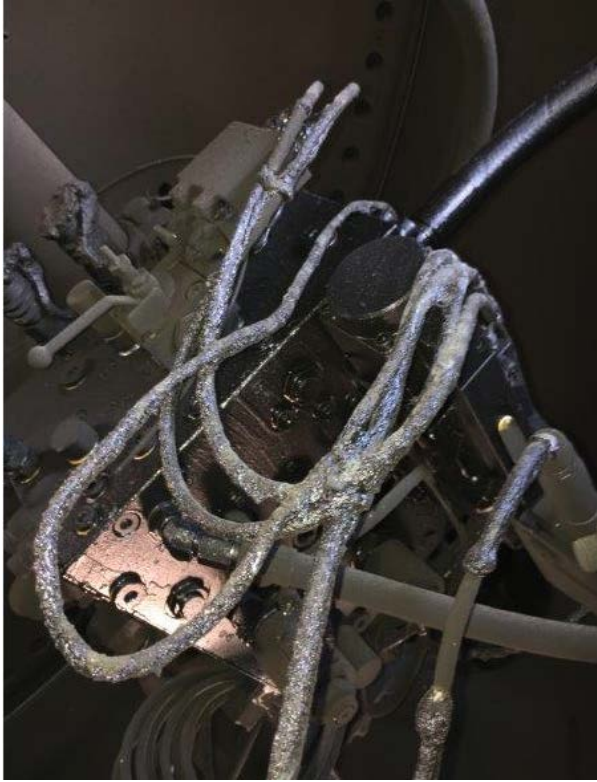
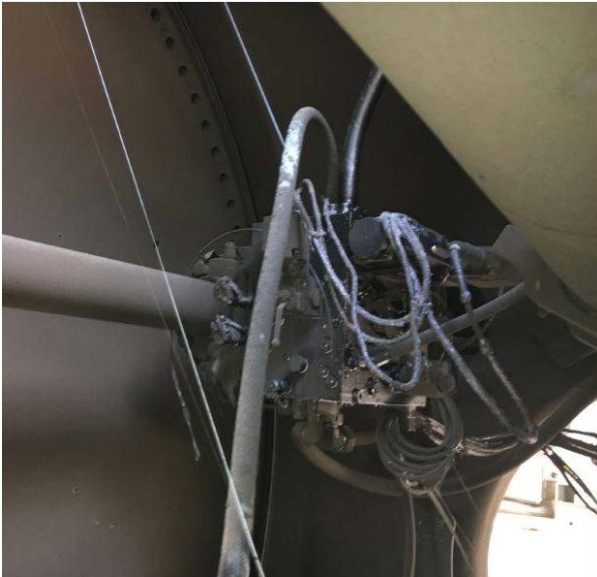
2. Hydraulic manifold, pitch ram, torque arm and hoses, wires and sensors on each damaged blade are also damaged to the point of requiring replacement.

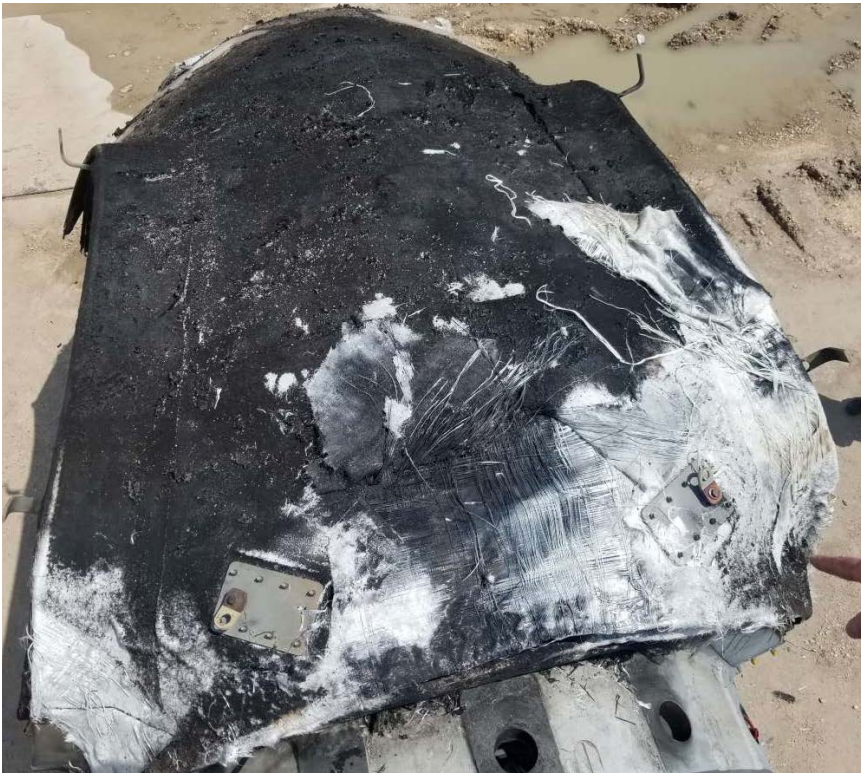
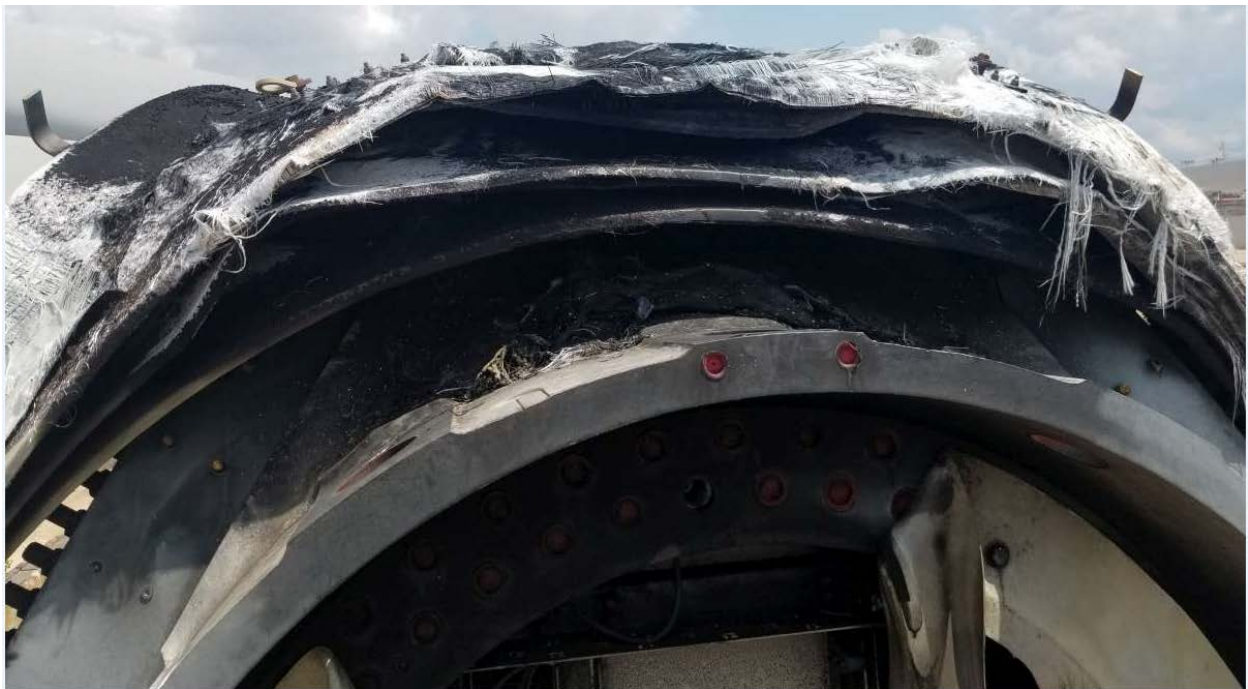
3. All three spinner shells have been burned and must be replaced.

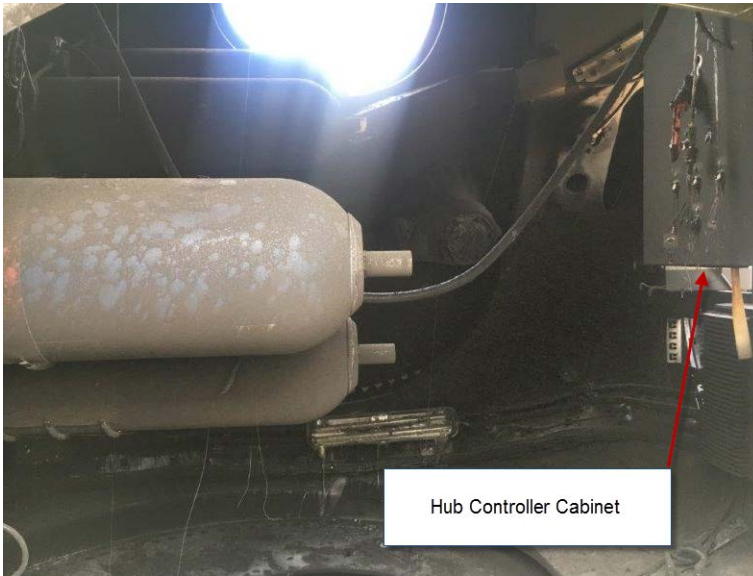
Hub Controller Cabinet

4. The Hub controller cabinet is burned and must be replaced.
