Accident Investigation Party Submission
NTSB Accident Investigation: DCA16MM001
SS El Faro

Date of Accident: October 1, 2015

Operator: TOTE Services, Inc.

Date: August 31, 2017

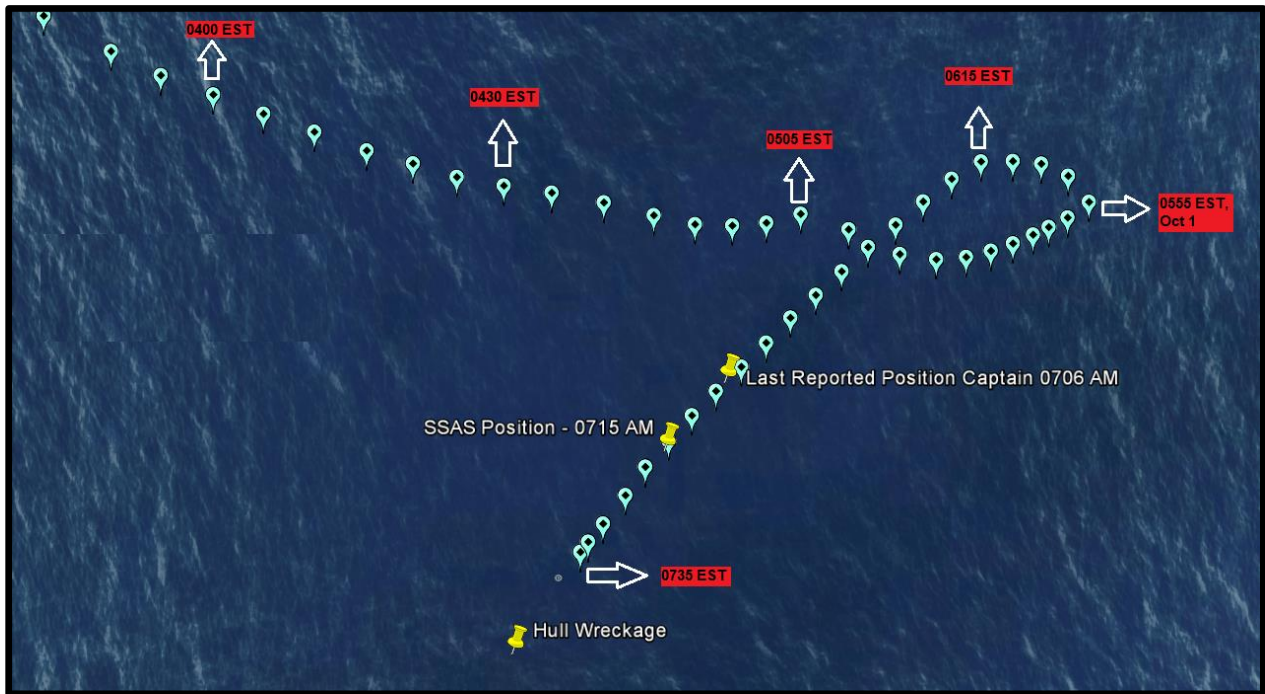
Figure H: Track Line Final Hours of Voyage 185S

As set forth in more detail below, based on Professor Munsch’s calculations and analysis, it appears very likely that, shortly after 0600 on October 1, 2015, after the vessel lost propulsion, the vessel’s cargo hold ventilation openings (at the top of the baffle plate) were periodically submerged at extreme rolls, heave, and pitching, resulting in large amounts of water entering cargo hold number 3. These ventilation openings progressively continued to be submerged with greater frequency over time, ultimately leading to flooding of cargo hold number 3 (and 2A) and loss of the vessel.

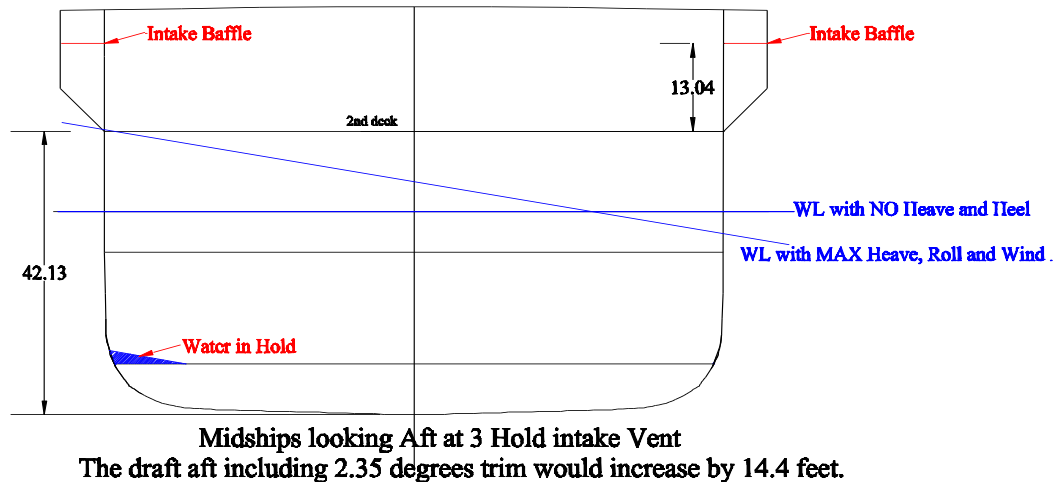
Figure K: Water in Hold Diagram at October 2015 – 0400 EST

0430: By 0430, the vessel is experiencing wind speeds of approximately 70 knots, off the port beam, resulting in a wind heel to starboard (to 6.0 degrees starboard). Wave heights have increased to approximately 29.2 feet. The vessel pitching, fore and aft, continues to increase (5.6 degrees extreme). Increasing amounts of water continue to enter the second deck as described above, and continue to enter cargo hold 3. By 0430, Professor Munsch estimates that approximately 35 long tons of water could have entered cargo hold 3. Due to the list of the vessel, and the location of the bilge alarms inboard of the side of the vessel by approximately 20 feet, the bilge float would not likely be raised for a sufficient period of time to actuate the bilge alarm. Water entering the hold accumulates on the starboard side, further increasing the vessel's heel (contributing to 0.65 degrees heel to starboard).

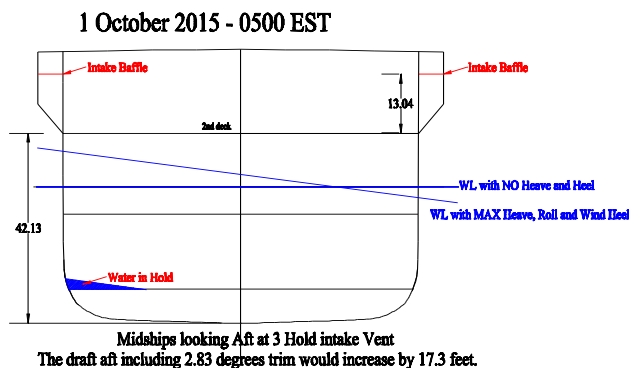
Figure L: Water in Hold Diagram at October 2015 – 0500 EST

above, and continues to enter cargo hold 3. By 0500, Professor Munsch estimates that approximately 46 long tons of water could have entered cargo hold 3. Water entering the hold accumulates on the starboard side, thereby slightly increasing the vessel's heel (contributing to 0.75 degrees heel to starboard). Due to the heel of the vessel, and the accumulation of water on the starboard side of the hold, the bilge alarm is not likely to actuate for the reasons described above.

A visual depiction of the midship section of the vessel at 0500, at extreme rolls, heave, and wind heel is provided in Figure L below. Figure L does not depict the effect of pitching fore and aft. The Cargo Hold ventilation opening (baffle plate) is further aft from amidships, and therefore the distance from the top of the baffle to the waterline would be less than depicted in the figure when the vessel pitches aft. Similarly, in the figure above, aft of amidships, when the vessel pitches aft, the second deck would routinely be awash on the starboard side of the vessel at extreme heave, roll and wind heel. The approximate distance between the waterline and the top of the baffle plate, for various points along the voyage, is depicted in Figure L below.

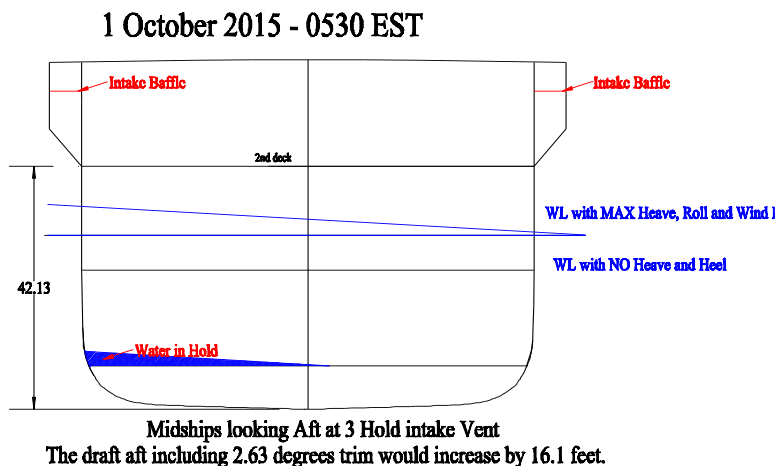
Figure M: Water in Hold Diagram at October 2015 – 0530 EST

0530: By 0530, the vessel is experiencing a slight decrease in wind speeds to approximately 66.4 knots, and the vessel is headed more directly into the wind. The change in wind profile decreases the wind heel to approximately 1.1 degrees. Wave heights are approximately 29.2 feet. The vessel pitching, fore and aft, continues (5.26 degrees extreme). Increasing amounts of water continue to enter the second deck as described above, and continue to enter cargo hold 3. By 0530, Professor Munsch estimates that approximately 59 long tons of water could have entered cargo hold 3. Water entering the hold accumulates on the starboard side of the hold, thereby increasing the vessel's heel (contributing to 0.97 degrees heel to starboard). Based on Professor Munsch's analysis, due in part to the reduction in heel of the vessel and continued accumulation of water, water in the hold is at or close to triggering the bilge alarm in the vicinity of the bilge well. (Appendix B (Prof. C. Munsch), pp.42, 52).

A visual depiction of the midship section of the vessel at 0530, at extreme rolls, heave, and wind heel is provided in Figure M below. Figure M does not depict the effect of pitching fore and aft. The Cargo Hold ventilation opening (baffle plate) is further aft from amidships, and therefore the distance from the top of the baffle to the waterline would be less than depicted in

the figure when the vessel pitches aft. Similarly, in the figure above, aft of amidships, when the vessel pitches aft, the second deck would routinely be awash on the starboard side of the vessel at extreme heave, roll and wind heel. The approximate distance between the waterline and the top of the baffle plate, for various points along the voyage, is depicted in Figure M below.

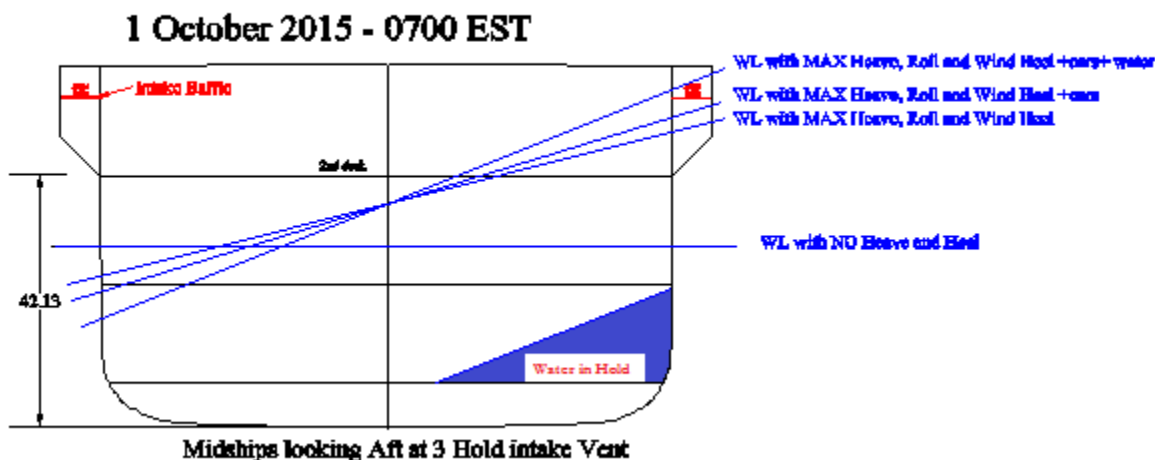
Figure N: Water in Hold Diagram at October 2015 – 0700 EST

0700: At 0700, the vessel remains beam to the winds (estimated to be 66.5 knots) and waves (estimated to have increased to approximately 30.2 feet). By 0700, the vessel's heel is estimated by Professor Munsch to be around 13.7 degrees to port. At approximately 0711, the Master of the *El Faro* informs the DP that the vessel's list is approximately 15 degrees. (MBI Ex.266, p.478). By this point, as the vessel rolls an average 4.5 degrees per roll, the cargo hold ventilation openings (top of the baffle plate) submerge by approximately 4 feet on each roll. On extreme heave roll, heave, and wind heel, the baffle plates are submerged by approximately 11.25 feet. Professor Munsch estimates that, by 0700, there is up to 305 long tons of water in cargo hold 3.¹⁴ Of the 13.7 degrees heel to port, 5.5 degrees is attributable to wind heel, 5.0 degrees attributable to water in the hold, and 3.2 degrees is attributable to the shifting weight of the automobiles to the port side. (Appendix B (Prof. C. Munsch), pp.50, 52).

A visual depiction of the midship section of the vessel at 0530, at extreme rolls, heave, and wind heel is provided in Figure N below.

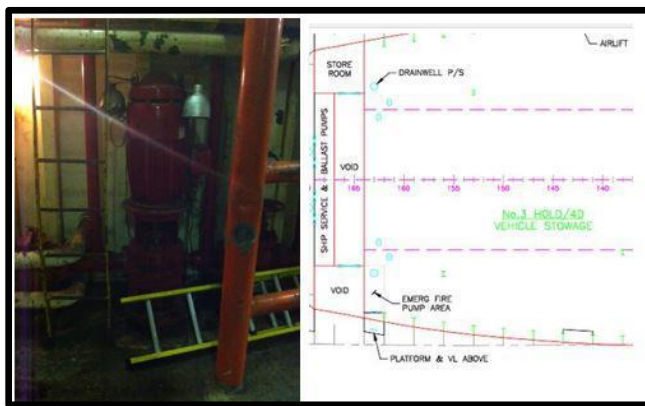
Figure Q: *El Faro's* Emergency Fire Pump and Motor

The *El Yunque's* emergency fire pump configuration was similar to the *El Faro's*, but there were important differences. The emergency fire pump and piping on both vessels were in the starboard aft portion of cargo hold 3, and both vessels had bumpers around the pump to protect the system from damage. On the *El Faro*, but not the *El Yunque*, there was a steel framed platform above the vicinity of the emergency fire pump piping and overboard suction that was used when coming down the outboard cargo access scuttle. (Gay MBI, 2/8/17, pp 556-557). The steel framed platform above the firemain piping extended from the outboard sideshell of the vessel, inboard to the vicinity of the pump; the platform also extended, fore and aft, approximately 4 feet from the aft bulkhead. (Gay MBI, 2/8/17, pp 556-557). In addition, unlike the *El Yunque* which had a piping arrangement that went forward and then outboard to the skin of the ship, the *El Faro's* piping configuration likely went directly from the pump outboard to the skin of the ship without going forward. (Gay MBI, 2/8/17, pp 556-557).
