1 **NATIONAL TRANSPORTATION SAFETY BOARD**

6  
7 Investigator in Charge Factual Report

9 Place : Port Richey, Florida  
10 Date : January 14, 2018  
11 Vessel : MV *Island Lady*  
12 NTSB No. : DCA18FM010  
13 Investigator : Brian Young  
14 IIC-OMS

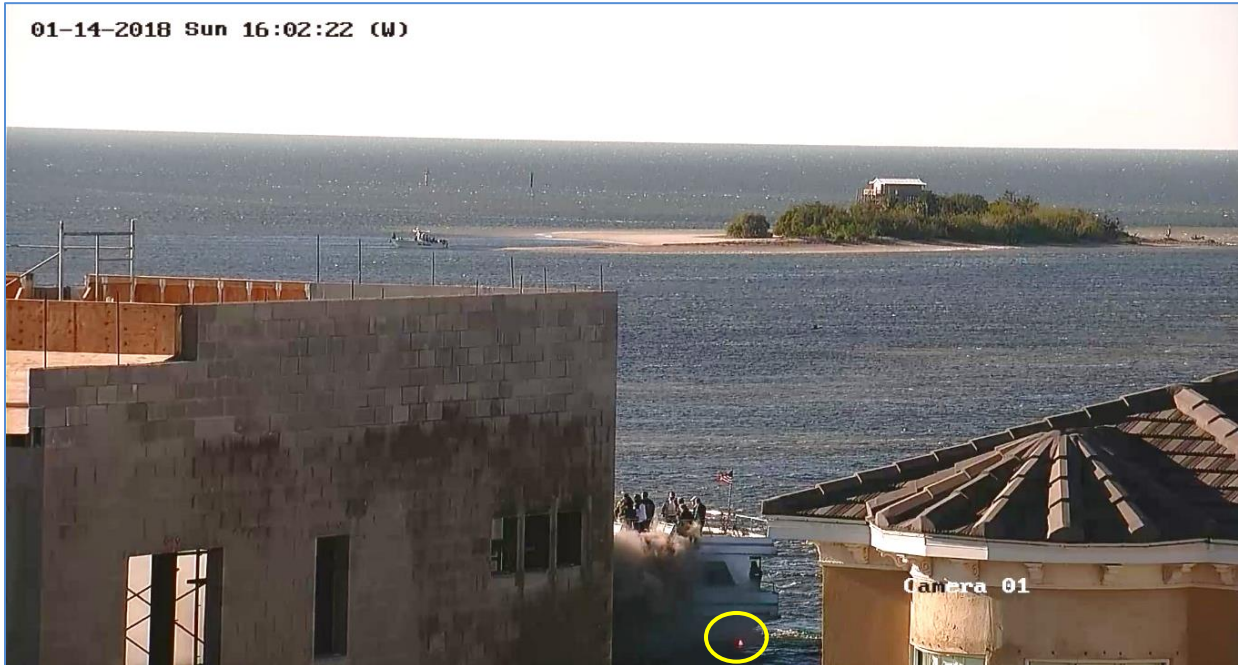
6  
7 Figure 6. Still image from home surveillance video footage, with the stern of the *Island Lady*  
8 visible between two houses. Fire emanating from the port side of the stern is circled in  
9 yellow. (Video image provided by witness)

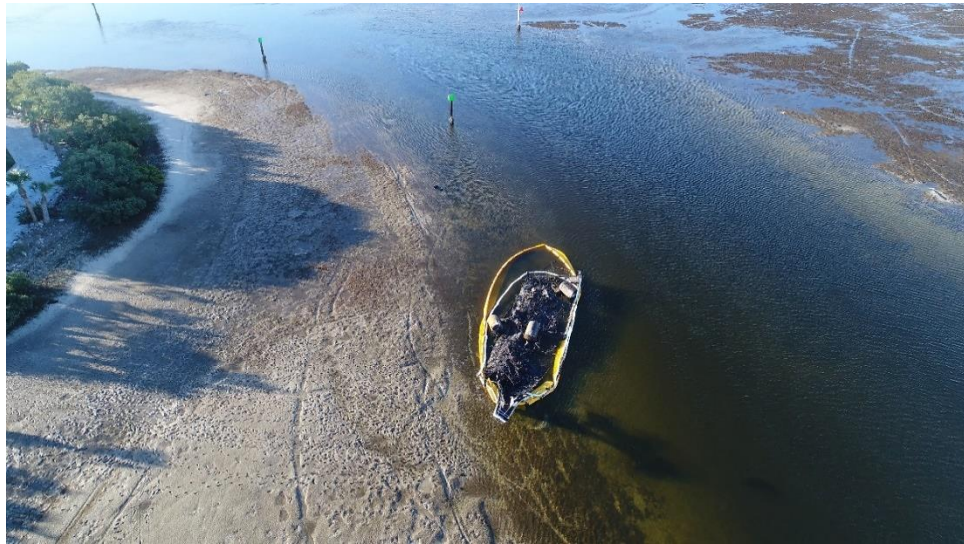
15 As a result of the fire damage, the *Island Lady*, insured for \$450,000, was declared  
16 a constructive total loss.<sup>41</sup> Everything above the waterline was destroyed. The only remains  
17 were the two fire-damaged engines, two damaged generators, remnants of various piping  
18 systems and valves, railings around the vessel, deck chairs, and three cylindrical fuel tanks.

1  
2 Figure 8. Post-fire wreckage of *Island Lady* seen from above. (Image from Titan Marine &  
3 Environmental)  
4

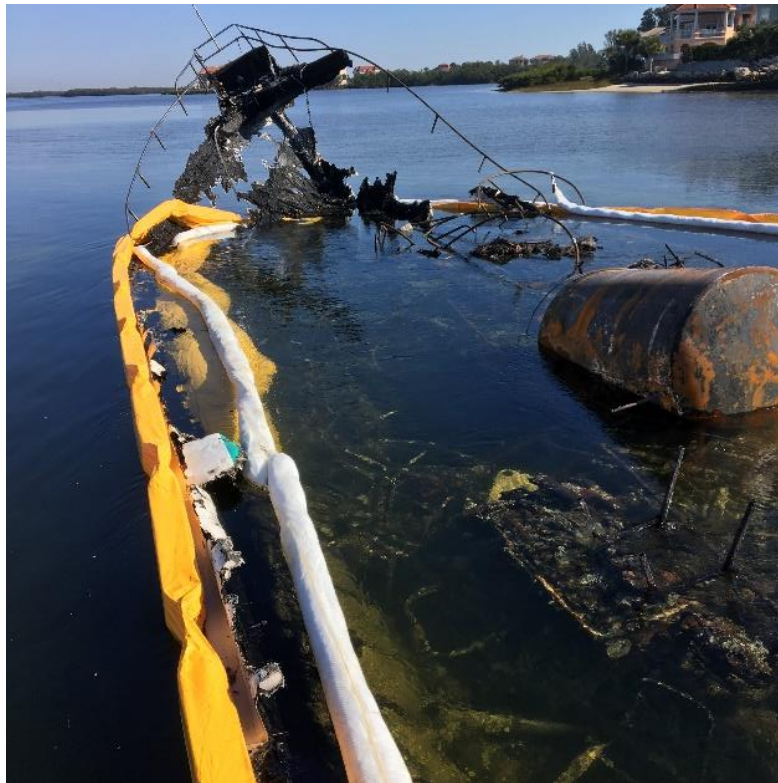
5  
6 Figure 9. Looking toward the *Island Lady's* destroyed bow.  
7  
8

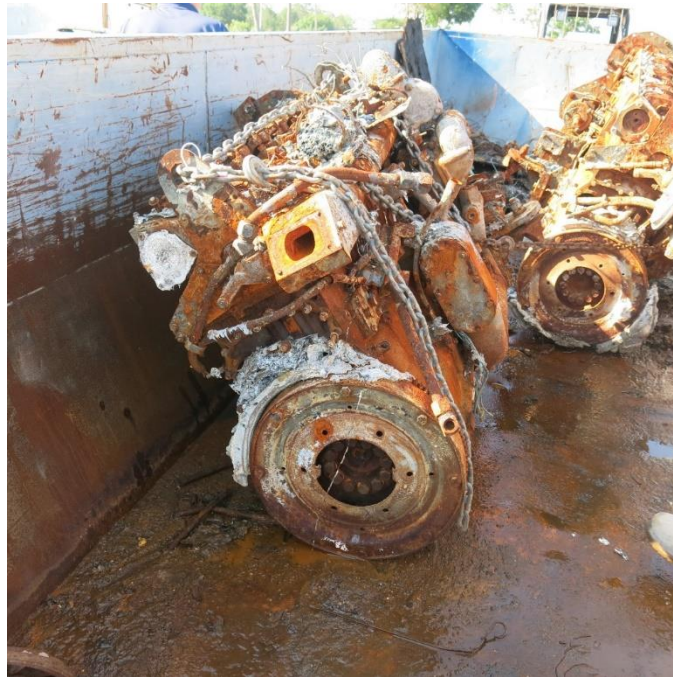
1 A salvage team recovered the remnants of the *Island Lady* during February 10–15,  
2 2018. The components were transported to a secure facility, where NTSB and Coast Guard  
3 investigators examined them in May 2018. About 98 percent of all aluminum, bronze, copper,  
4 and brass parts—which included the heat exchanger body, after-cooler housings, front gear  
5 cover, flywheel hosing, raw-water pump housings, base and valve cover, oil pan, and other  
6 smaller housings—was missing due to extreme heat.

9 Figure 10. Port engine at storage facility after removal from *Island Lady*.

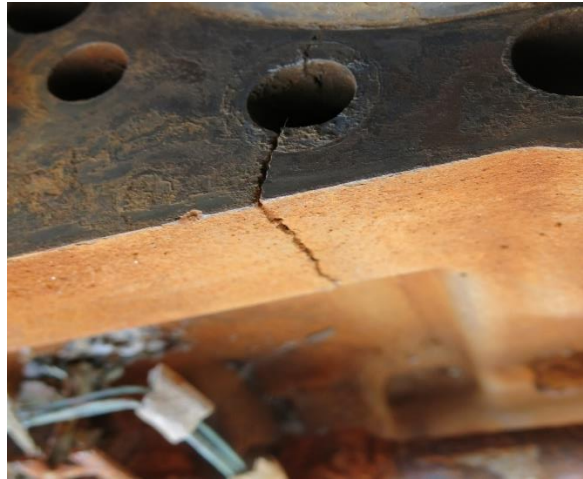
10  
11 A service technician and a service manager from Ring Power—an authorized service  
12 company for Caterpillar—disassembled the port engine. A crack was discovered between  
13 the 4th and 5th cylinder on the port engine’s inboard side (**figure 11**). The crack was visible  
14 starting at the no. 5 cylinder’s liner through the water passage and about 8 inches down the  
15 side of the block.

2 Figure 11. Close-up of crack in the block between cylinders 4 and 5 from the *Island Lady's*  
3 port engine.  
4

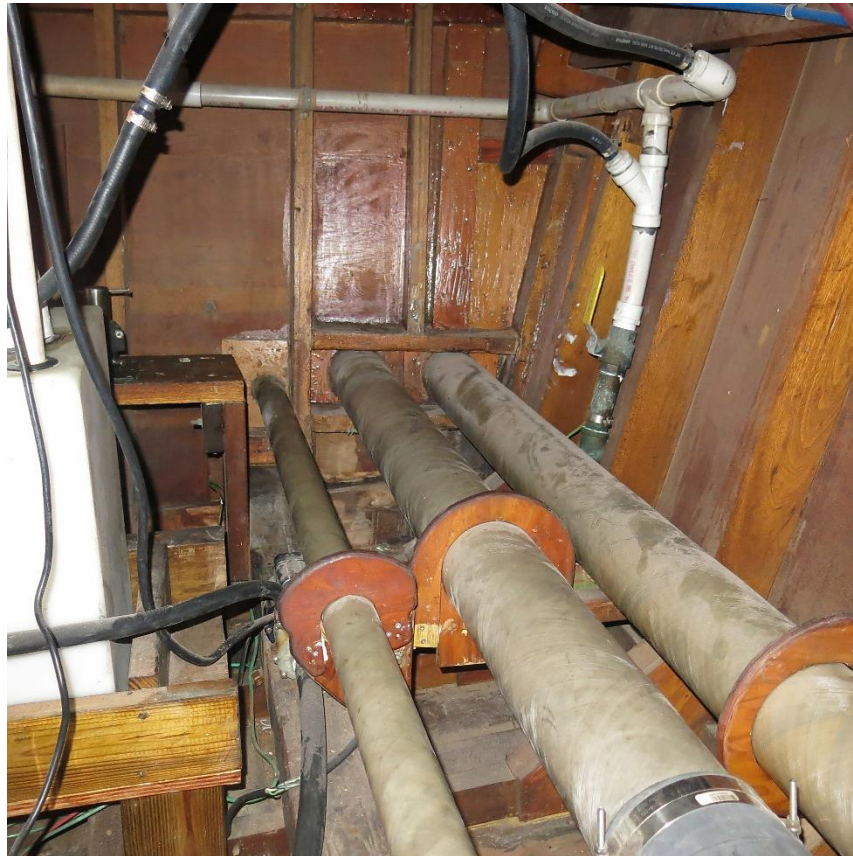
1 According to the vessel specifications obtained from the original owner, the exhaust  
2 tubing was Vernatube™ Exhaust Tubing, which was a resin-impregnated glass filament  
3 wound tubing. The manufacturer stated that it was made exclusively with a fire-retardant  
4 resin formulated for high temperature applications and exceeded values for the class of  
5 materials designated as “self-extinguishing” per ASTM –D-635, UL94V-O, and the US  
6 Navy/USCG MIL-R-21607 and MIL-R-7575.<sup>56</sup> The exhaust tubes were held in place by  
7 wooden supports and were in direct contact with the wooden bulkheads between the engine  
8 room and the lazarette.<sup>57</sup> No fire detection or suppression systems were located in the  
9 lazarette, nor were they required to be.

11 Figure 16. Engine exhaust pipes transiting through the lazarette space aboard a sister vessel  
12 to the *Island Lady*.

1 According to Caterpillar data, exhaust temperatures on an engine operating at full power are  
2 about 750°F, and about 450°F at idle. The maximum operational temperature for an epoxy  
3 glass fiber reinforced tube is 300°F before the polymers degrade. Investigators obtained the  
4 purchase receipt to determine the properties of the replacement tubing. The tubing was  
5 Novaflex marine hard-wall water exhaust tubing, which the manufacturer stated met  
6 standards for marine wet-exhaust applications.

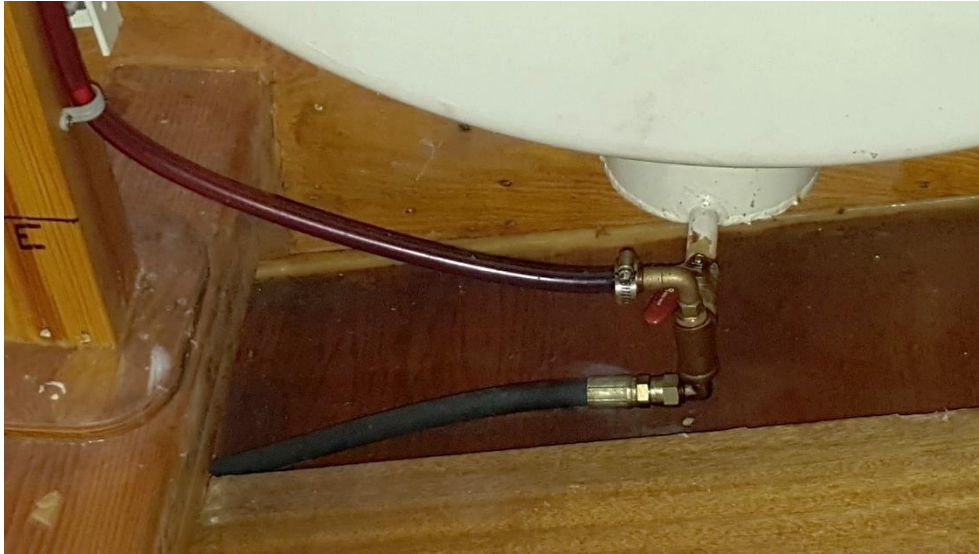
11           In March 2017, during a Coast Guard vessel examination of the *Island Lady*, the  
12 inspector found the fuel valves in the open position and photographed them (**figure 17**). The  
13 inspector told the crew to close the valves, and later looked for a regulation regarding the  
14 use of plastic tubing and manual valves for level indication. He was unable to find the  
15 regulation and did not document the finding on a form CG-835, Notice of Merchant Marine  
16 Inspection Requirements in accordance with 46 CFR 2.01-10.

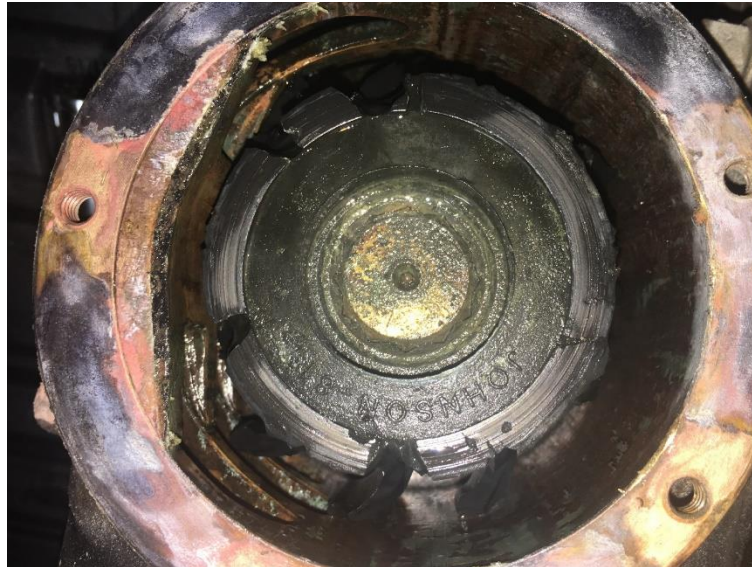
4 According to the monthly maintenance reports, the impellers of the raw water pumps  
5 for both main engines were replaced in May 2017. Investigators obtained pictures that the  
6 engineer had taken of the pump housing and rubber impeller during the replacement. No  
7 records were available to show the number of hours or days of operation on the impellers.  
8 Investigators obtained photos, taken by the engineer in connection with the replacement, of  
9 water leaking from the pump housing (**figure 20**) and of one of the old pump housings and  
10 rubber impellers before replacement (**figure 21**). At least six of the 12 vanes were missing

5 Figure 20. Raw-water pump and impeller from *Island Lady* during May 2017 replacement.

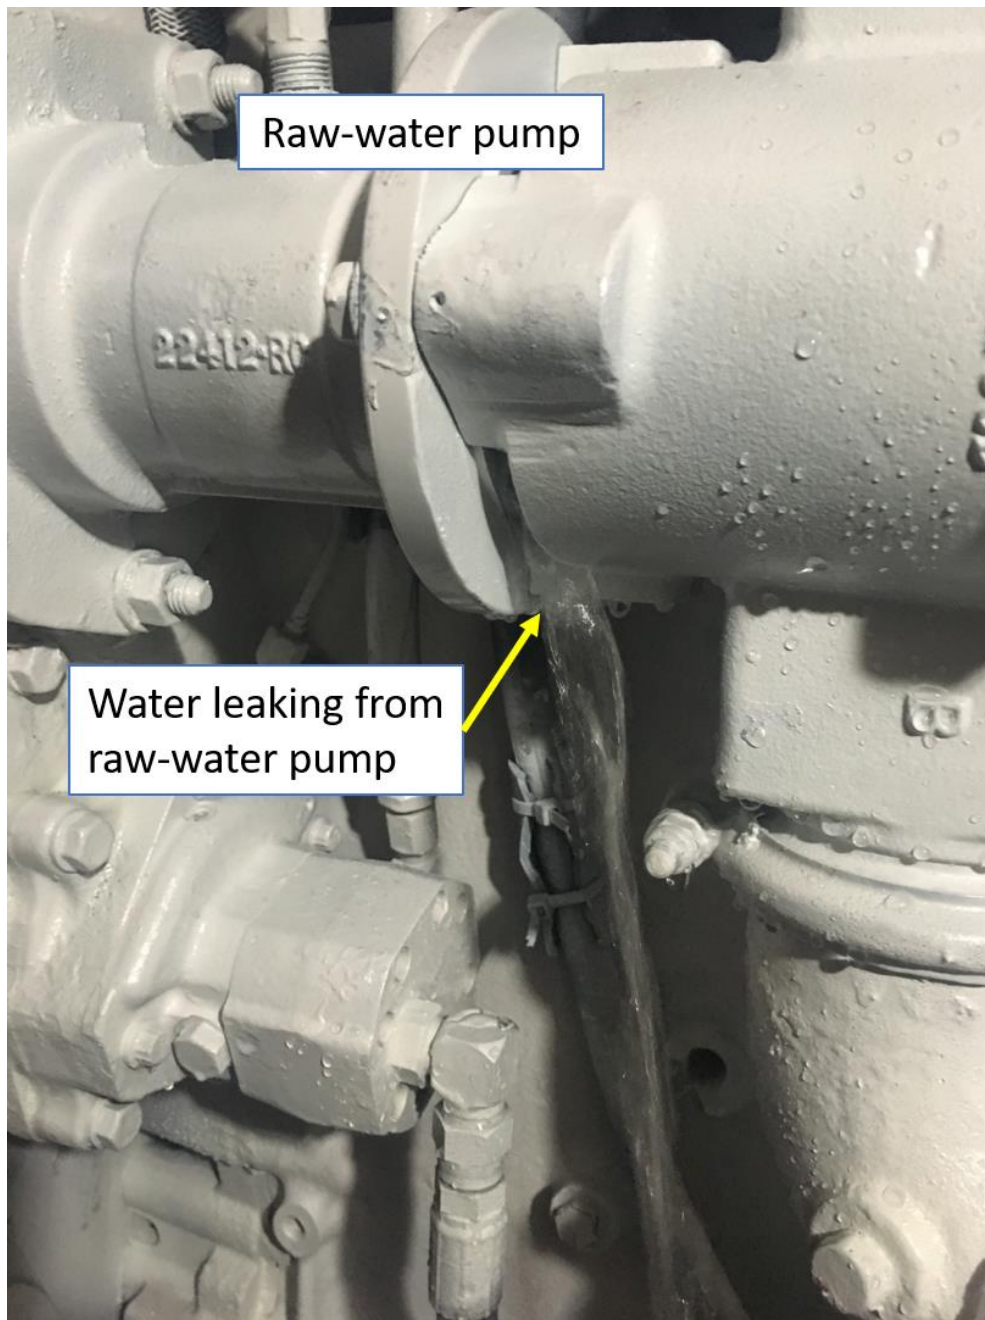
- 1
- 2 Figure 21. Water leaking from the *Island Lady's* raw-water pump before its May 2017
- 3 replacement, photographed by the engineer.

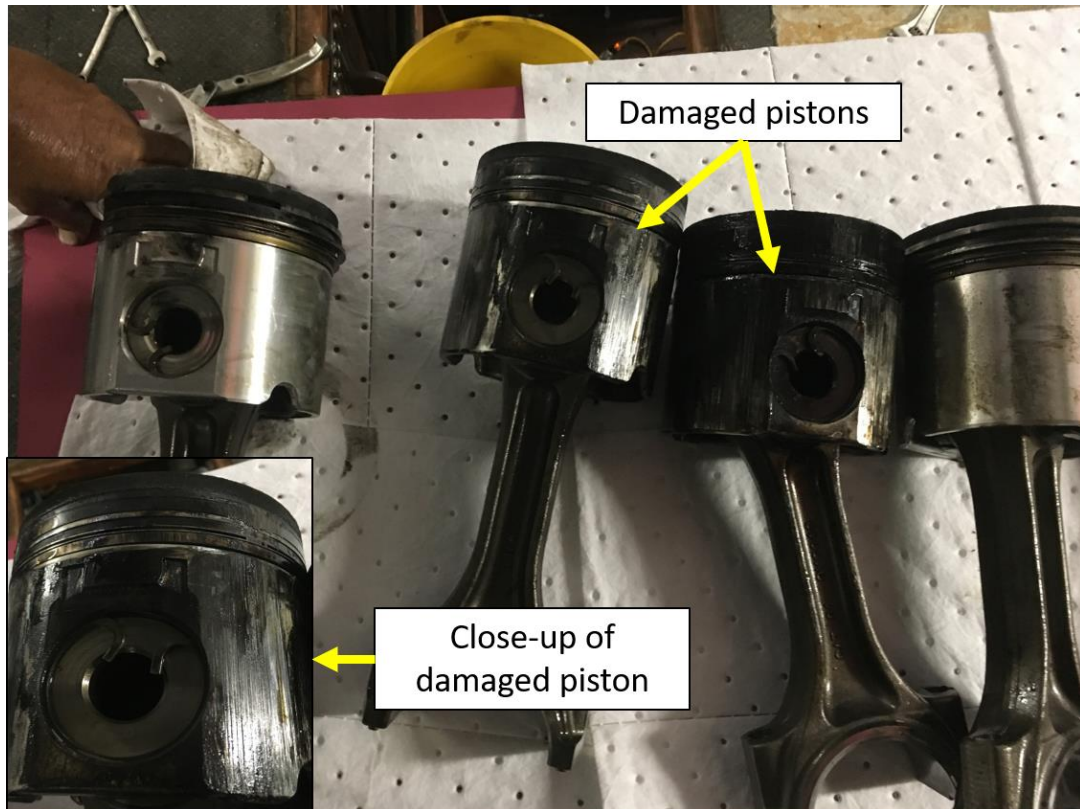
1  
2 Figure 23. Removed pistons from the *Island Lady's* starboard engine during March 2017  
3 overhaul, photographed by the engineer.

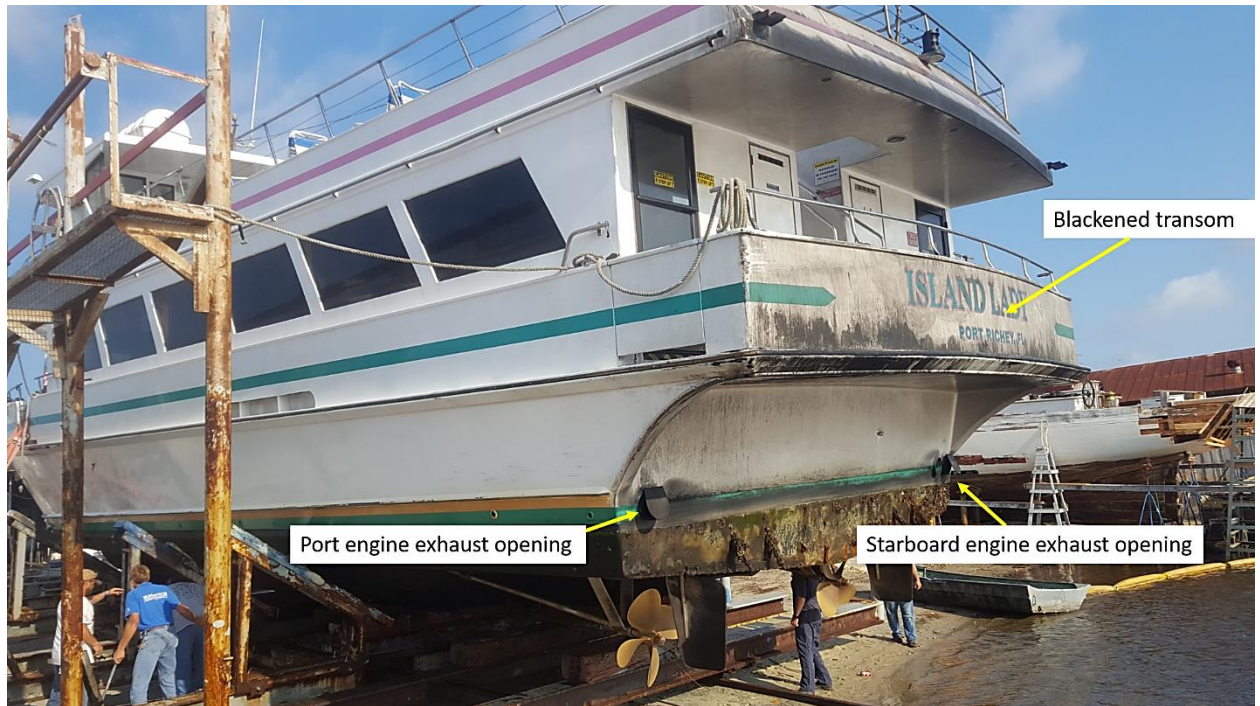
4  
5 The engineer told investigators that after the vessel was purchased, the engines were  
6 "rolling coal," meaning that they were producing black smoke. As a result, the vessel's  
7 transom was blackened (**figure 24**), and the engineer said that the company called "a bunch  
8 of people" to determine the reason for the excessive smoke, but nobody was able to provide  
9 an answer. Investigators found the results of an internet search on the company computer of  
10 "diesel fuel leaking into exhaust."

1  
2 Figure 24. Stern of *Island Lady* while in drydock April 2017. (Photo by Coast Guard)  
3
