## **EXPERT REPORT**

**THE SINKING OF THE *EL FARO* - ENGINEERING FACTORS**

**JOHN DALY**

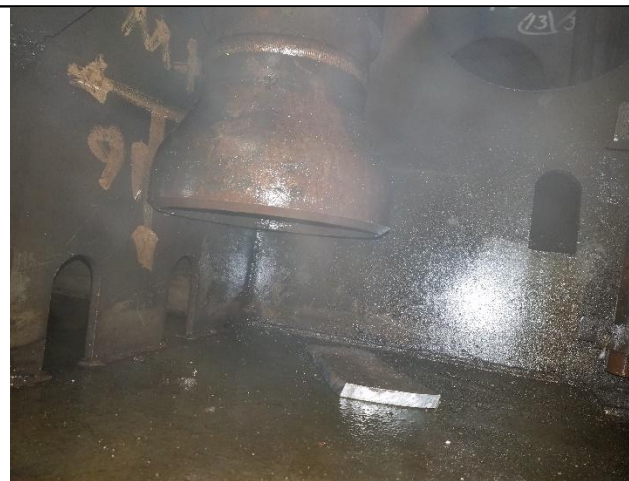
**Lube oil pipe suction bell inside SS EL YUNQUE main lube oil sump**

- The engineers continued to add oil after regaining propulsion, but lost lube oil pressure due to the lube oil pipe suction bell becoming exposed due to extreme vessel motion. In my opinion, this appears to be the most likely scenario, given the weather conditions on scene.

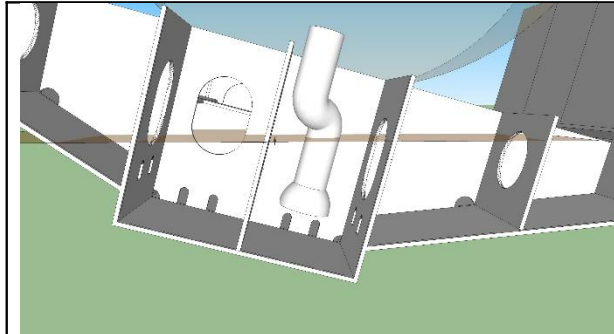
My modeling of the turbo generator sumps indicated that the oil level would not have been visible in the sump’s lube oil sight glass, if the vessel had an 18-degree starboard list. This may have been the extent of the “problems with lube oil levels” mentioned in the transcripts while the vessel had a starboard list. Operating a generator (or any rotating machinery) with no indication that there is lube oil in the sump is never done (in normal situations). Not being able to verify a lube oil level would have been extremely troubling to the vessel’s engineers. It is possible, or even likely, that no problems relating to turbo generator lube oil pressure occurred, such as low lube oil pressure alarms activating and stand- by pumps starting and that the problem was the visual verification of the oil level in these machines.

**Main Sump viewed from aft with starboard list. Oil level at suction bell increased relative to oil level with zero degree list.**

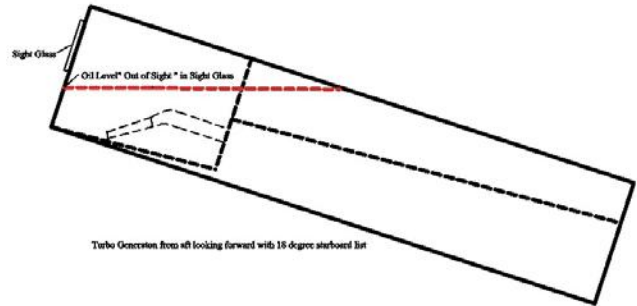
**Turbo Generator Sump viewed from aft with starboard list. Oil level decreased over LO pump suction nozzle and oil level not visible in sight glass.**

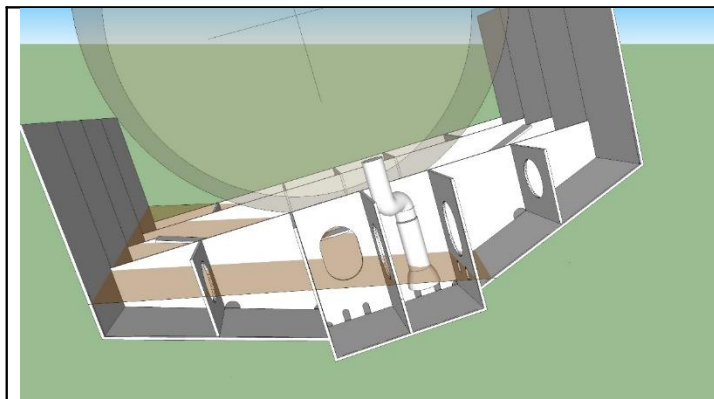
**Main Sump viewed from aft with port list. Oil level at suction bell decreased relative to oil level with zero degree list.**

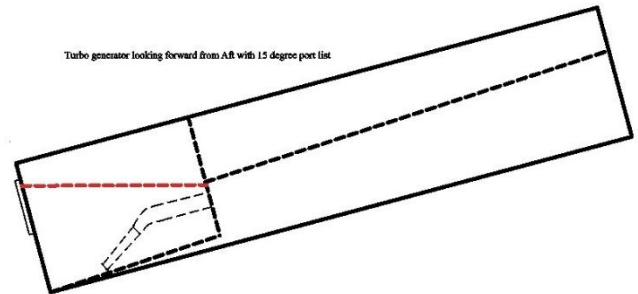
**Turbo Generator Sump viewed from aft with port list. Oil level increased over LO pump suction nozzle and oil level visible in sight glass.**

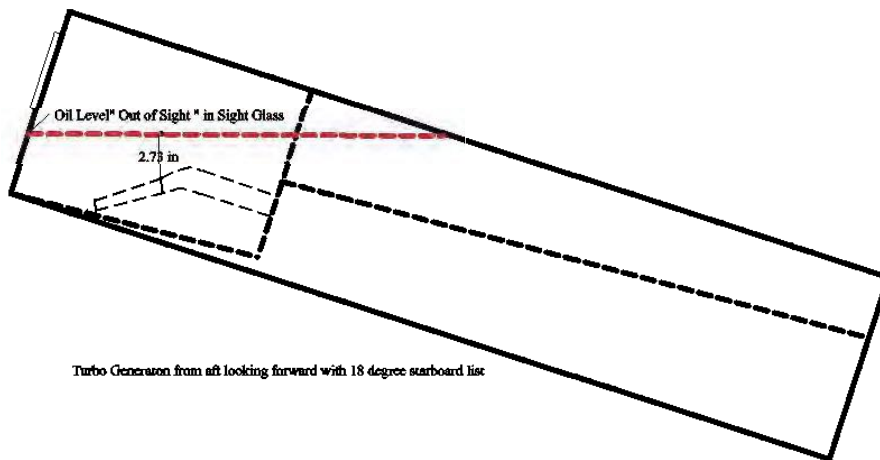
Turbo Generator Looking Forward with 15 degree Starboard List. Oil Level is "Out of Sight" in Sight Glass
