**ACCIDENT INVESTIGATION PARTY SUBMISSION**  
**BY**  
**RIPLEY ENTERTAINMENT, INC.**

National Transportation Safety Board  
Investigation No.: DCA18MM028  
July 19, 2018 incident involving Stretch Duck 7

February 14, 2020

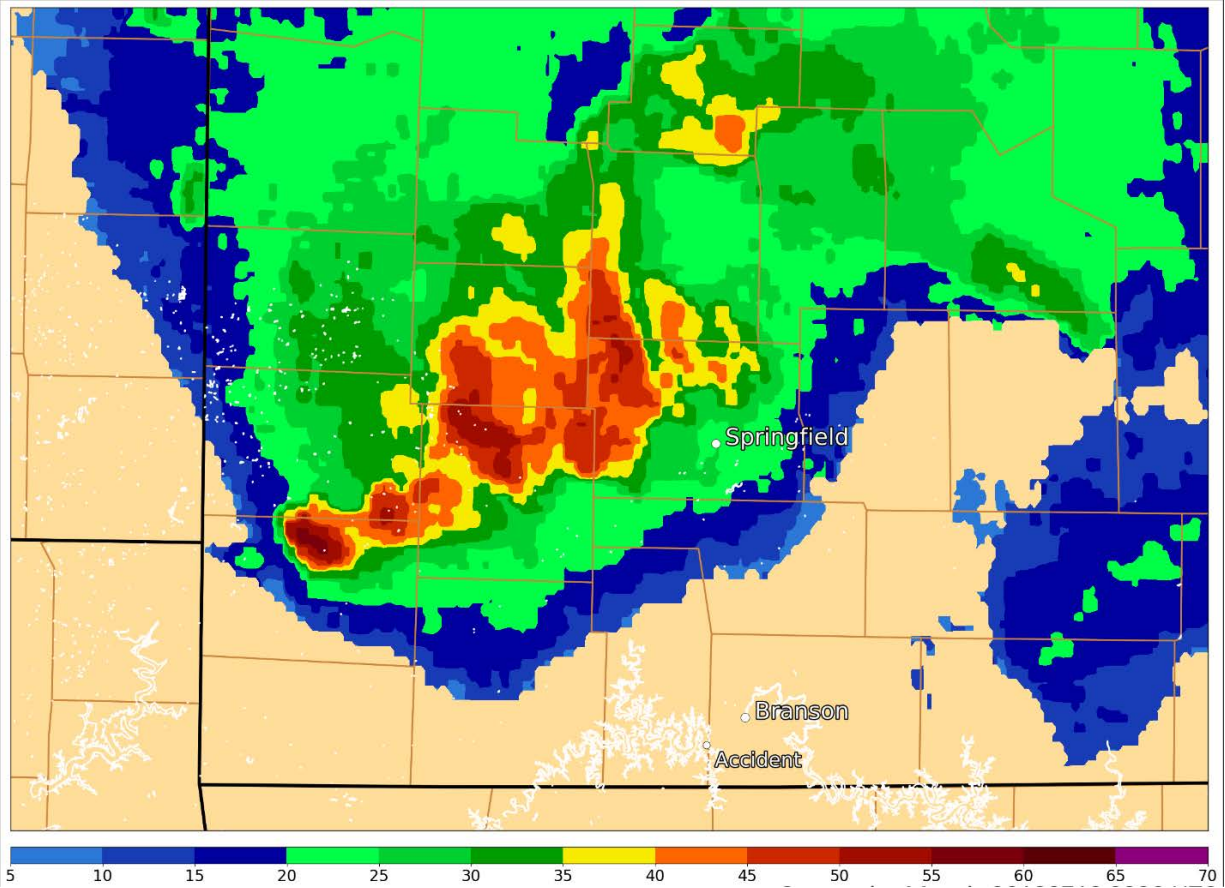
**Figure 1**

As shown above, the main part of the storm system that would naturally appear to present the most operational concern for mariners and others (i.e. red/orange) is depicted approximately 45-50 miles away from the accident site.

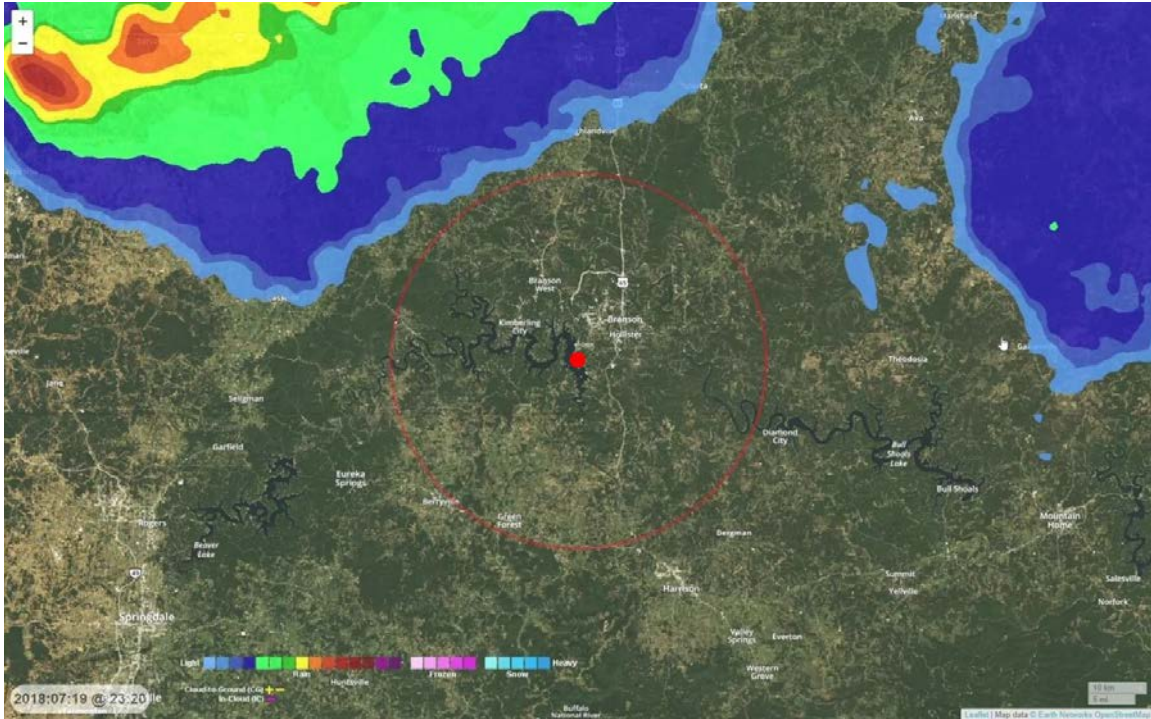
**Figure 2**

Below is a depiction of radar images sent from WDT to Earth Networks that were “geolocated” to the StreamerRT platform, and at the earliest, this radar image would have been displayed on Earth Networks was 6:25 PM. See Draft NTSB Meteorology Report, Figure 51.

As shown above, the main part of the storm system that would naturally appear to present the most operational concern for mariners and others (i.e. red/orange) is depicted approximately 50-55 miles away from the accident site, at 6:25 PM.

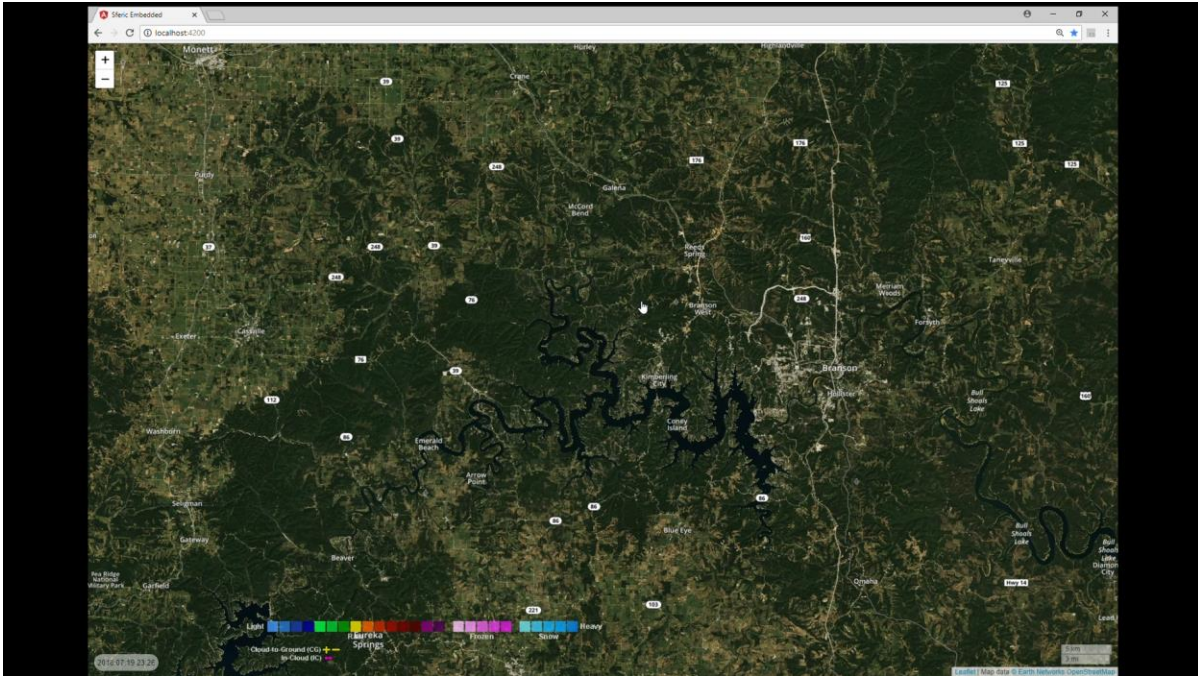
**Figure 3**

In connection with this investigation, Earth Networks produced a StreamerRT file entitled “2hoursWith5minInterval.mp4”. This image below is a screenshot of that file, timestamped on the StreamerRT, as “2.18.7.19.2326” (which is 6:26 PM).

As shown above, no portion of the weather system is depicted on the StreamerRT monitor. Under this graphic, the main part of the storm system that would naturally appear to present the most operational concern for mariners and others (i.e. red/orange) is depicted (off this screen) to be at least 50-55 miles away (possibly further) from the accident site, at 6:26 PM.

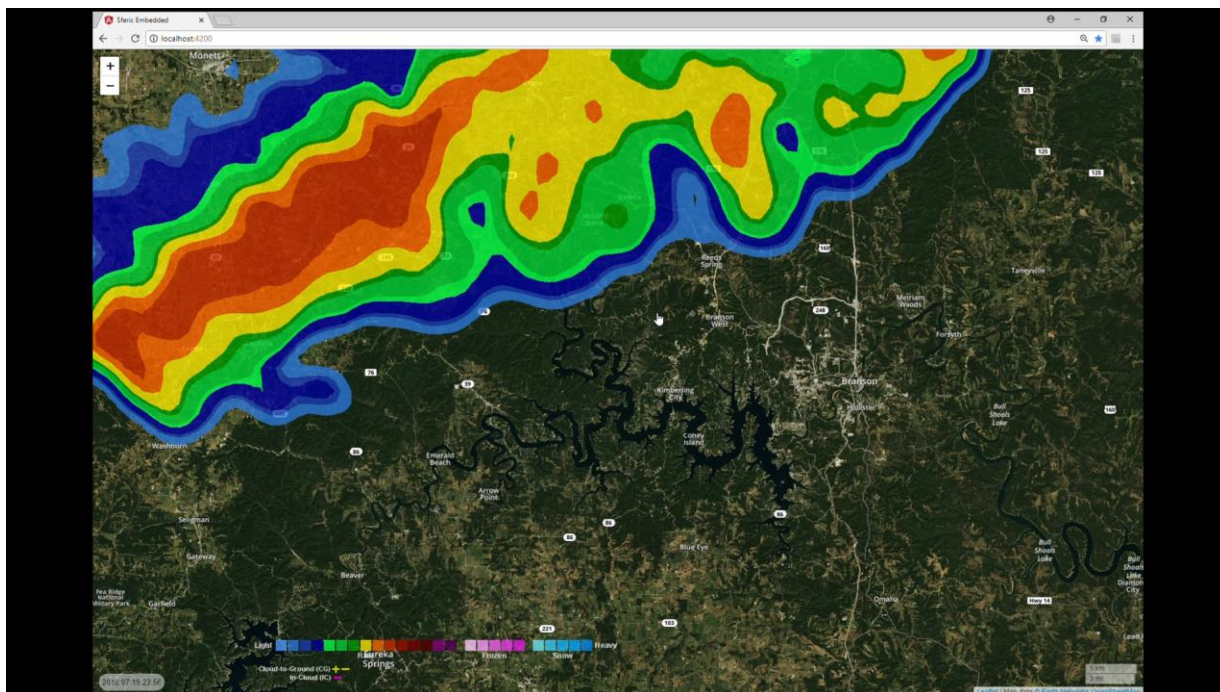
**Figure 4**

The weather radar data produced by Earth Networks, and depicted via StreamerRT, shows the system even further away. This image below is a screenshot of that file produced by Earth Networks in the investigation, timestamped on StreamerRT, as “2.18.7.19.2356” (which is 6:56 PM).

As shown above, at 6:56 PM, the main part of the storm system that would naturally appear to present the most operational concern for mariners and others (i.e. red/orange) is depicted to be at least 25-30 miles away from the accident site.

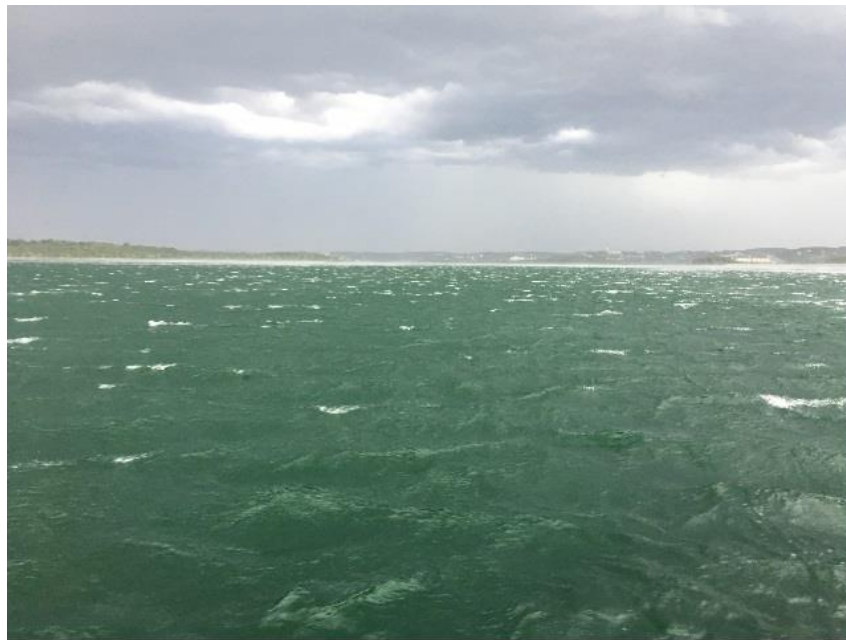
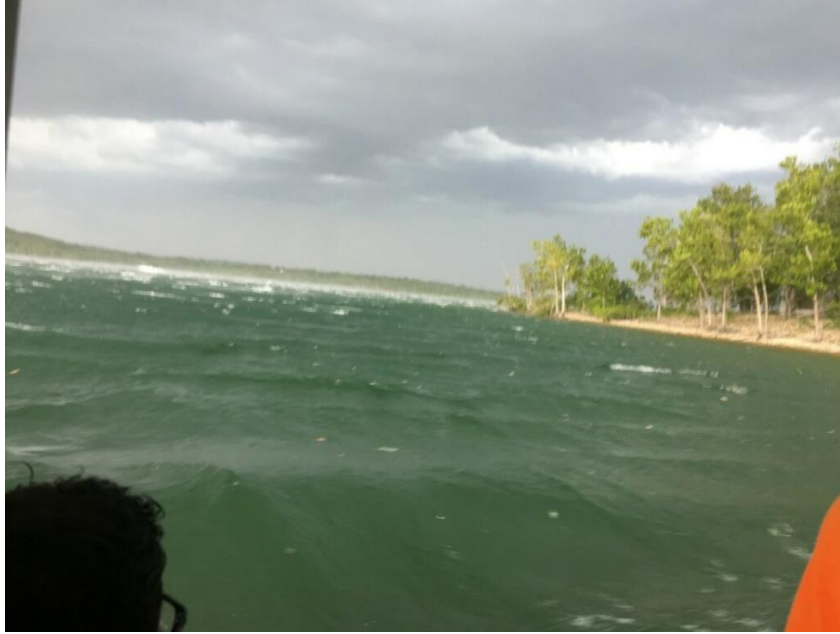
The driver of Stretch Duck 17 similarly noted, "Once we got on the water and got around the island, you could see a front way, way off, I mean, as far as my eyes could see, I could see something and my [Weather Channel app], I went on there and they didn't -- he didn't show that it was -- it looked like it was in the other side of the Ozarks....[o]n my phone, that's what it looked like." NTSB Marotti at 17-18 (emphasis added). Below are photographs taken by the driver of Stretch Duck 17, as they departed the lake around 7:00 PM.

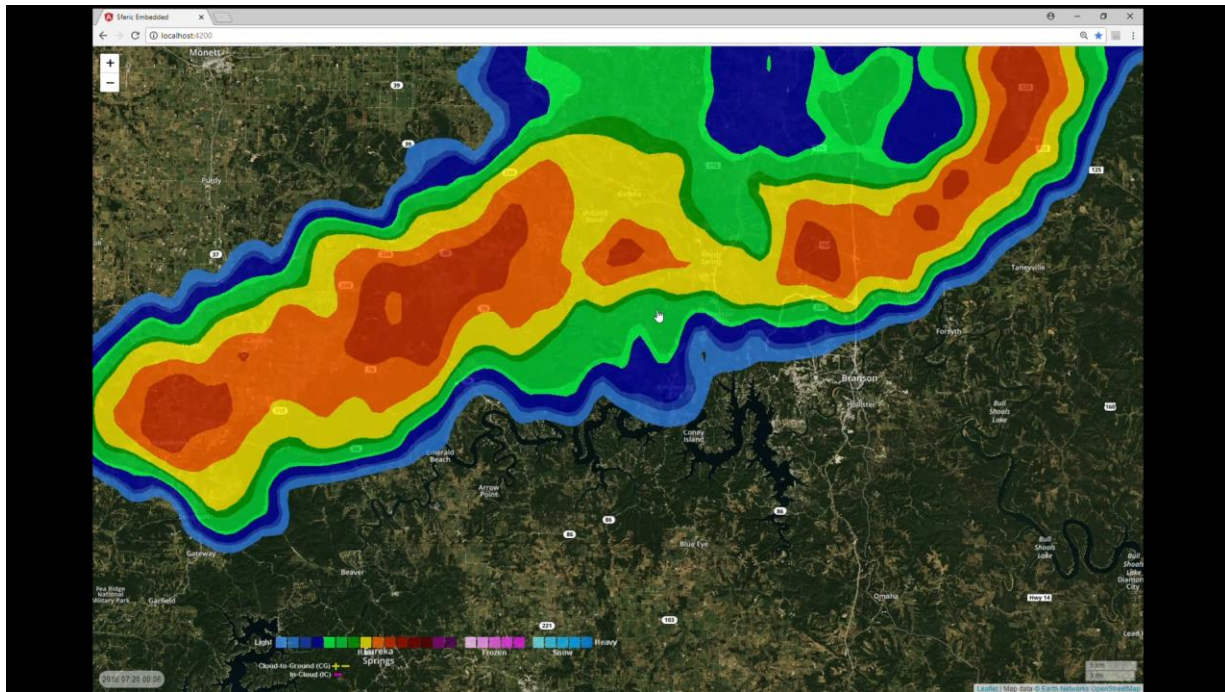
**Figure 7**

The weather radar data produced by Earth Networks in the investigation, and depicted in the StreamerRT, depicts the system even further away. This image below is a screenshot of that file produced by Earth Networks in the investigation, timestamped on the StreamerRT, as “2.18.7.19.0006” (which is 7:06 PM).

As we know from the investigation, by 7:06 PM, the Stretch Duck 7 was in heavy seas and 60+ mph winds, and beginning to take on water, yet the radar images available, as shown above depict the main part of the storm system that would naturally appear to present the most operational

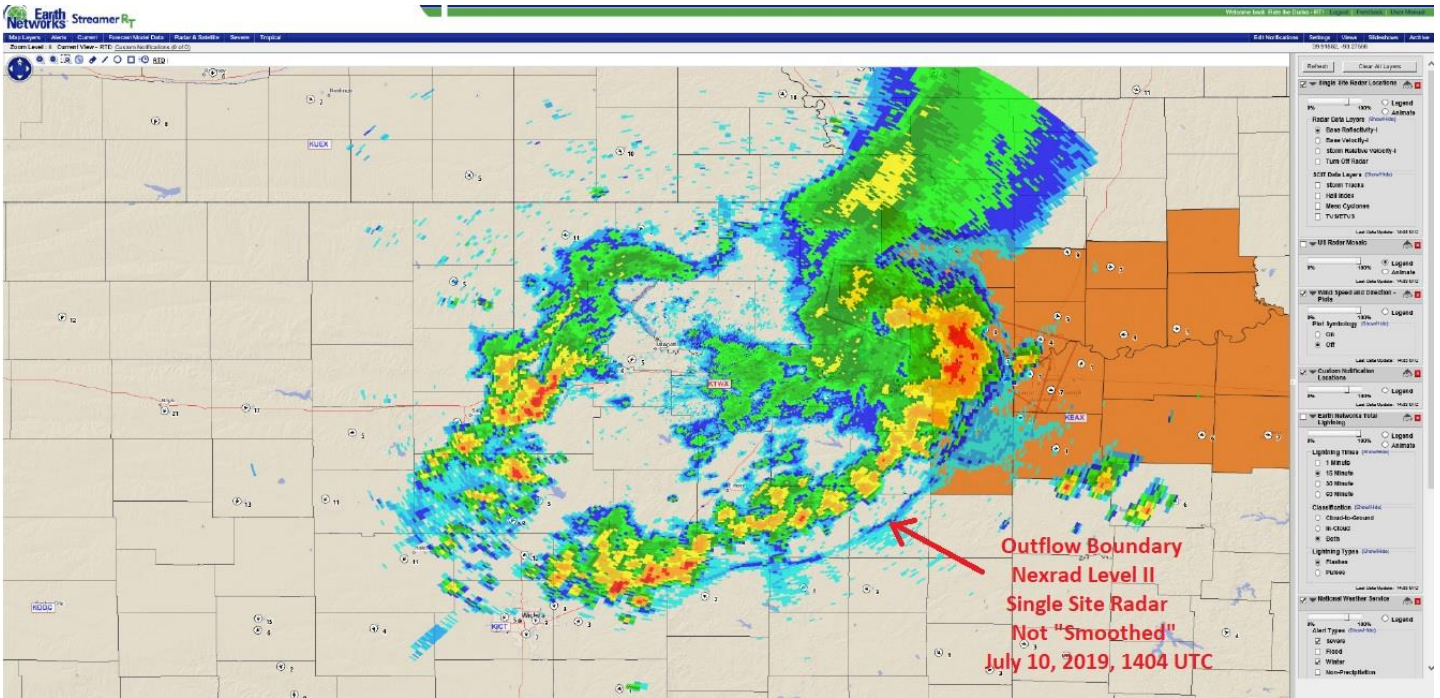
U.S. National Weather Service, Single Site Radar Image Not Smoothed

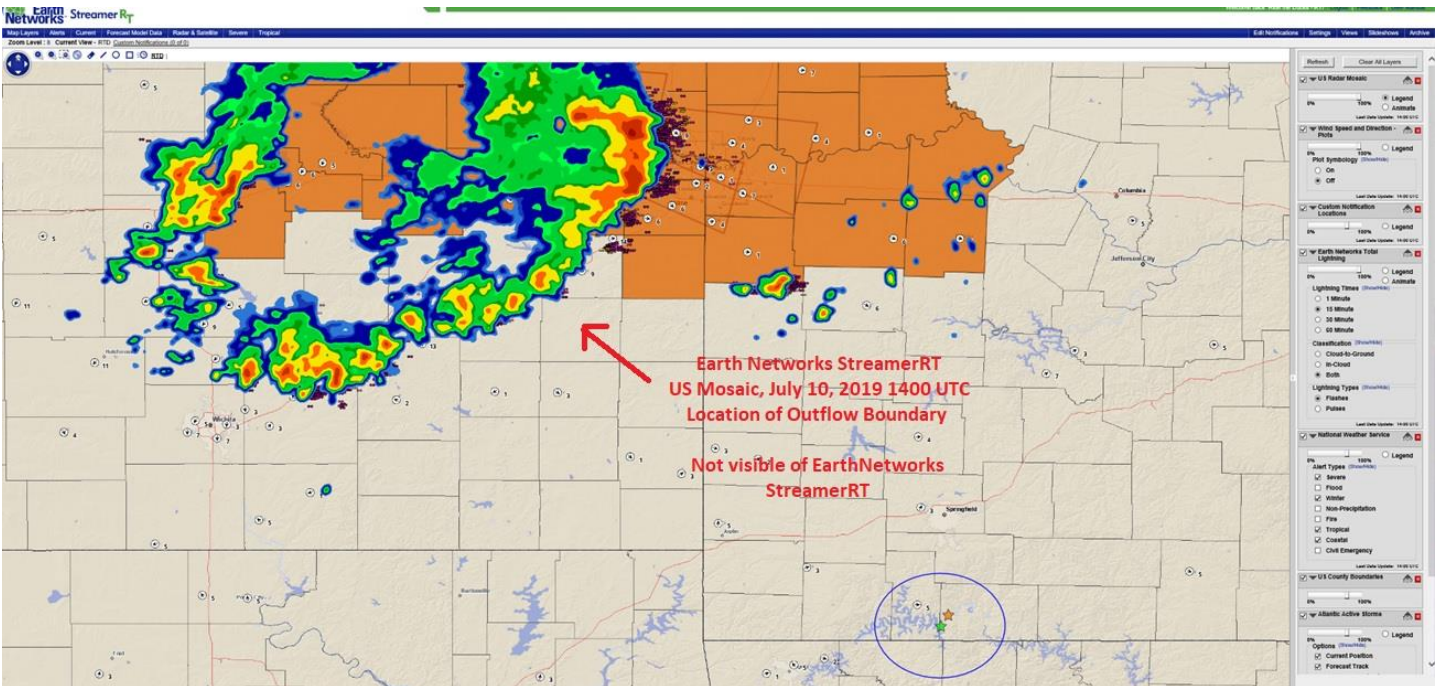
Effects of Smoothing - US Mosaic As Displayed on EarthNetworks, StreamerRT
