Subject: Todd Brown_Under Water Hull Preliminary

Per request, please see below the preliminary Underwater Machinery & Hull survey of the M/V "Todd Brown"

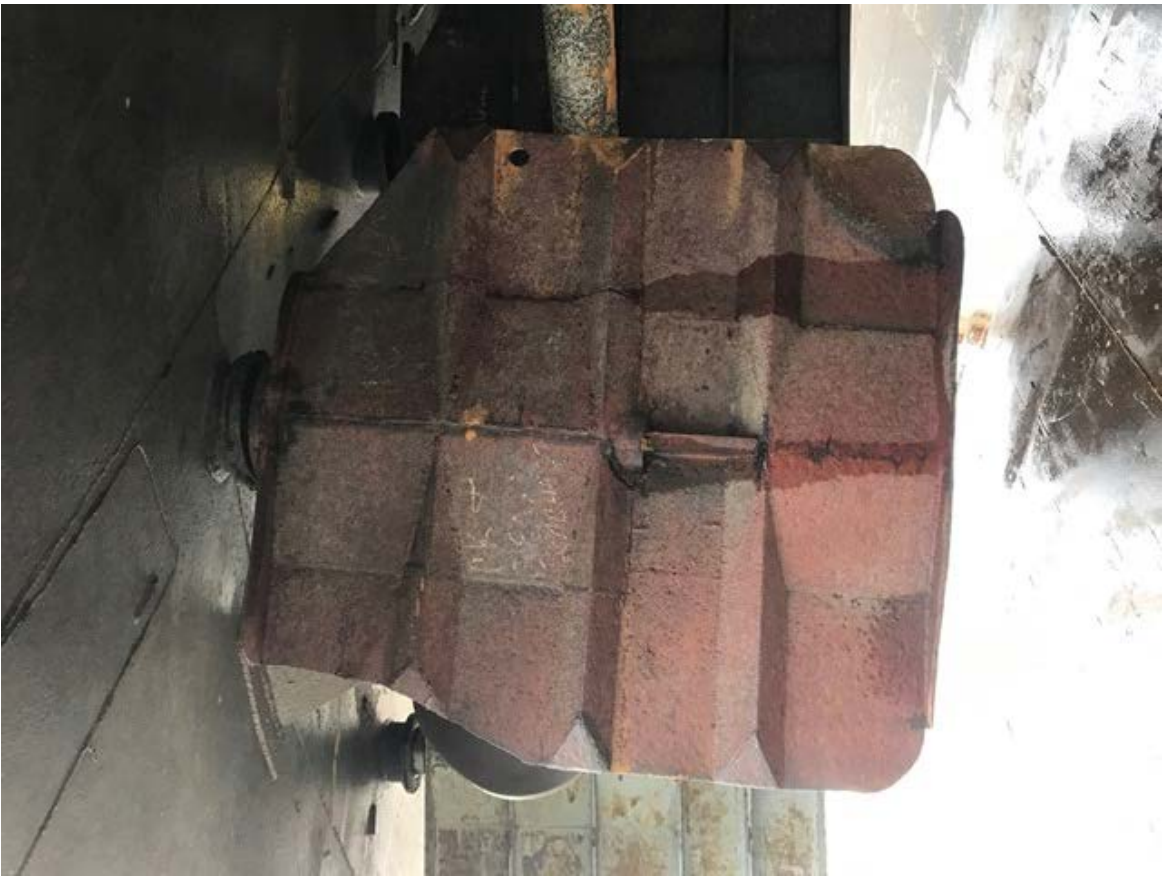
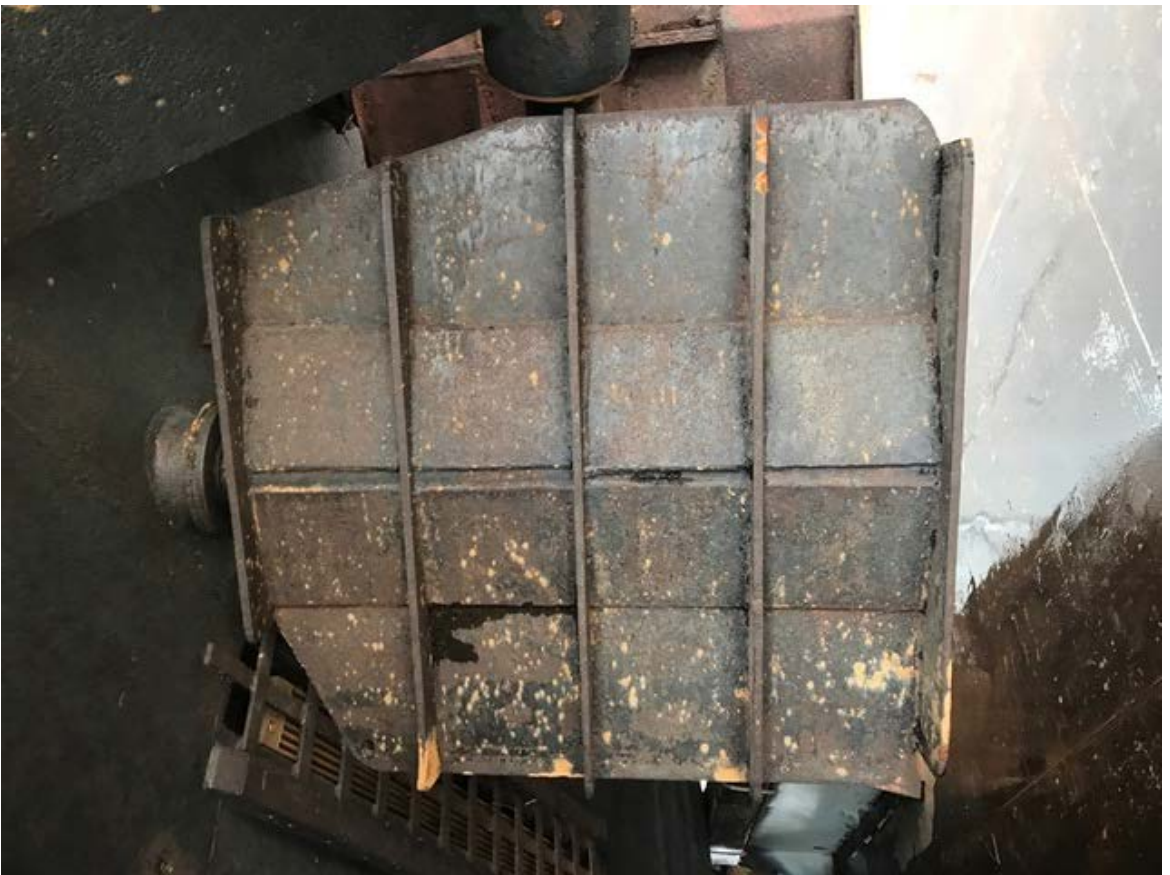
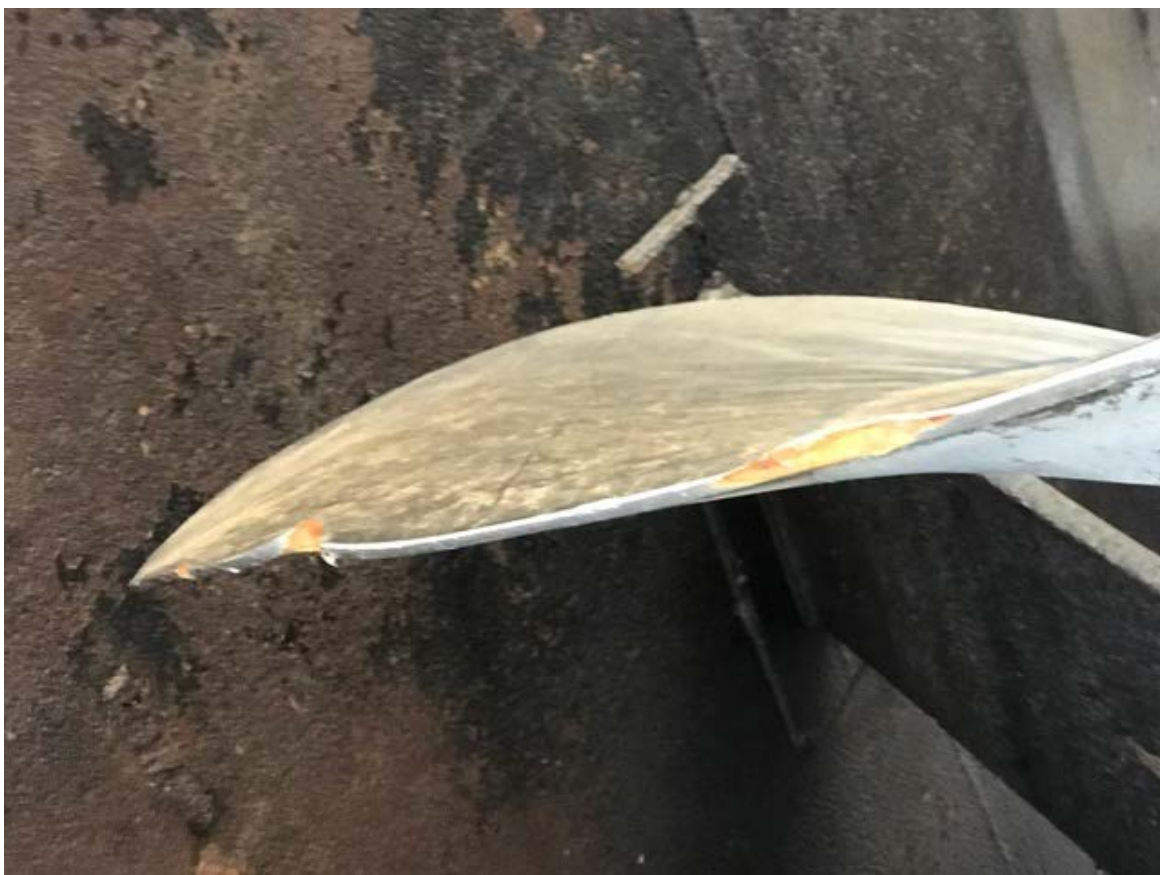
There is no new excessive damages noted in way of the hull.
Under water machinery damages noted as follows:

- in way of the starboard outboard flanking rudder, the entire rudder is distorted aft approximately 0 - 1.5" for height. Rudder contains multiple scattered fractures and distortions as well - RECOMMEND - Renew starboard out board flanking rudder & rudder shaft

- all port wheel flukes contain minor abrasions and distortions from 0 - 1/2" with the 12 o'clock fluke distorted forward 0 - 1.25" over an area of 4" x 18" with a 0 - 1/2" tear distorted forward and aft 0 - 1" - Recommend - Remove and renew or refurbish port wheel

- the aft upper 12" of rudder is distorted inboard 0 - 1.5" over an area of 12" x 6" - RECOMMEND - Heat & Fair
- the forward lower 12" of rudder is distorted inboard 0 - 1.5" over an area of 12" x 6" - RECOMMEND - Heat & Fair

- in way of the port outboard flanking rudder, the entire rudder is distorted aft approximately 0 - 1.5" for height. Rudder contains multiple scattered distortions as well - RECOMMEND - Renew port out board flanking rudder & rudder shaft

Although there is no visible damages, the undersigned recommends both port and starboard shaft to be rolled and dyed to test for straightness due to possible excessive strain from the rolling hitch used to flip and lift the vessel
