NATIONAL TRANSPORTATION SAFETY BOARD
Vehicle Recorder Division
Washington, DC 20594

On-Board Video Factual Report

Location: Philadelphia, Pennsylvania
Date: July 7, 2010, 14:37 Eastern Daylight Time (EDT)
NTSB Number: DCA10MM025

On Wednesday July 7, 2010, the empty 250-foot sludge barge *The Resource*, towed alongside the 78.9-foot towing vessel *M/V Caribbean Sea*, allided with the anchored 33-foot amphibious small passenger vessel *DUKW 34* in the Delaware River near Philadelphia, PA. The *DUKW 34*, operated by Ride the Ducks, carried 35

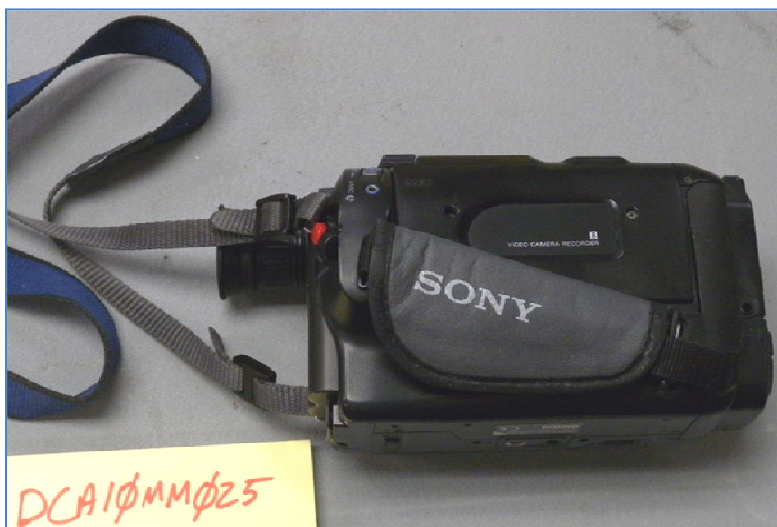
Figure 1. Recovered Sony Handicam.

Despite arriving at the lab damp from the submergence in river water, the recorder did not display any other mechanical damage. The tape was extracted from the cassette, rinsed, and dried (Figure 2). The tape was then reeled on new reels and placed in a donor cassette and digitized.

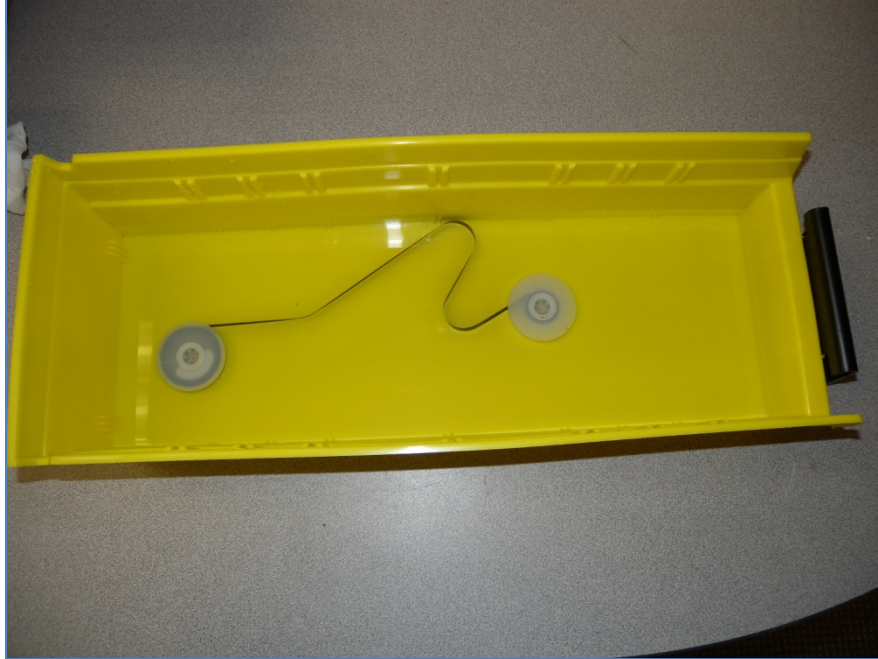
Figure 2. Rinsing the extracted tape.
