NATIONAL TRANSPORTATION SAFETY BOARD

Recorded Data Factual Report

Location: New York, New York

Operator: Seastreak NTSB Number: DCA13MM005

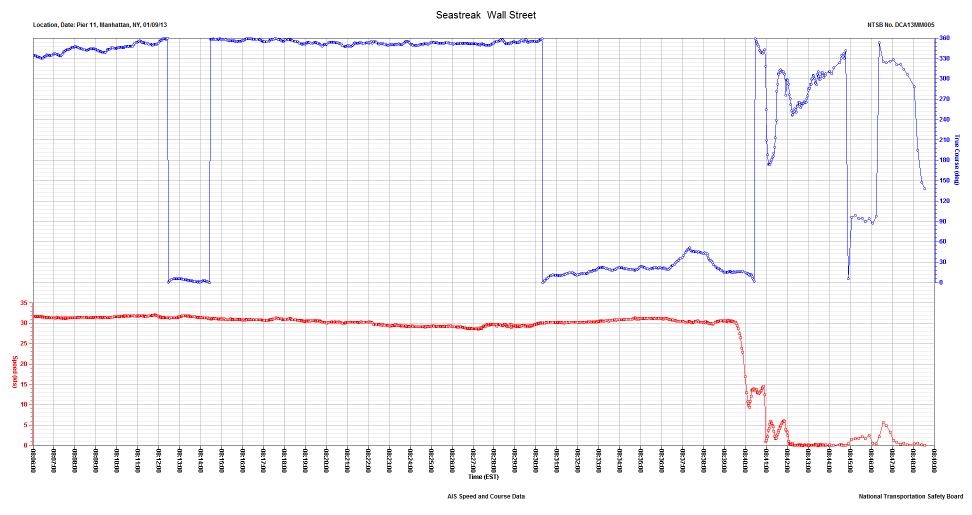
AlS position reports were not recorded on board the *Wall Street*. Recorded AlS position reports, receive d at a number of antennae in the New York area, were provided by the Coast Guard Navigation Center. Figure 1 shows a plot of the parametric data throughout the accident voyage. Figure 2 shows the ground track on satellite imagery of the accident voyage. Red icons indicate AlS position data showing a speed over ground of at least 30 knots. Green icons indicate position data showing a

Figure 1. AIS speed and course data from accident voyage.

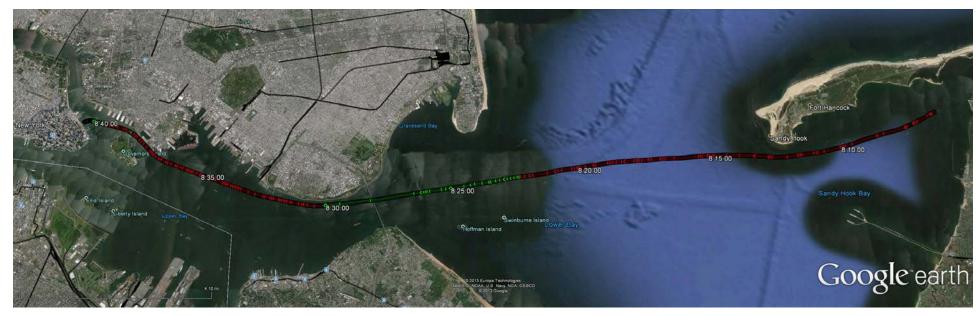
speed over ground under 30 knots. Figure 3 shows the ground track as the *Wall Street* was attempting to dock at Pier 11.

Figure 2. AIS data from accident voyage. Speeds greater than 30 knots are indicated by red icons.

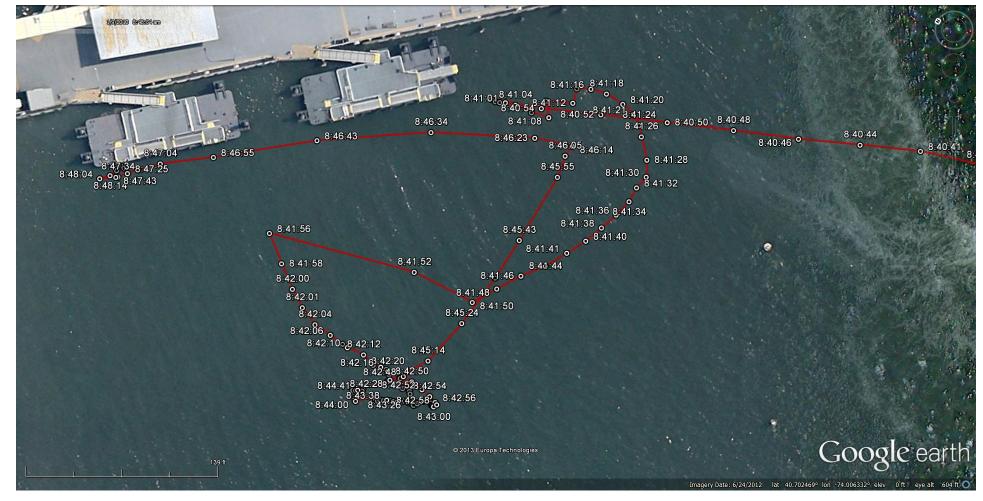
Figure 3. AIS data showing last 7 minutes of the accident voyage.

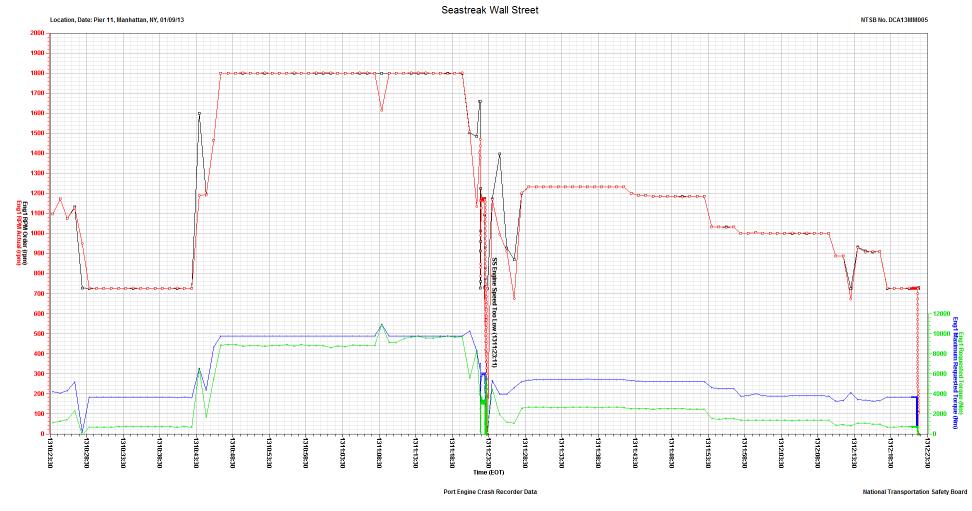
Figures 4 & 5 show all recovered RPM and torque data from the crash recorder for the port and starboard engines. Figures 6 & 7 show RPM and torque data for both engines surrounding the time of the accident. Both engines recorders logged a "SS Engine Speed too Low" message at the time of the accident. According to the engine manufacturer, if engine speed drops below 200 RPM without receiving a stop command, the engines will go into a safety shutdown mode and automatically shut down the engines. According to the electronic engine logs downloaded from each engine, the port engine had experienced 4 "SS Engine Speed too Low" events over the operational history of the engine, the last occurring at engine operating time 1311:23:11. The starboard engine had experienced only 1 "SS Engine Speed too Low" event over the operational history of the engine, occurring at engine operating time 1304:56:36. The engine operating times are logged separately for each engine and reflect only cumulative engine run time. There is no rigorous correlation between engine operating time and time of day without uncertainty.

Figure 4. RPM data from port engine crash recorder.

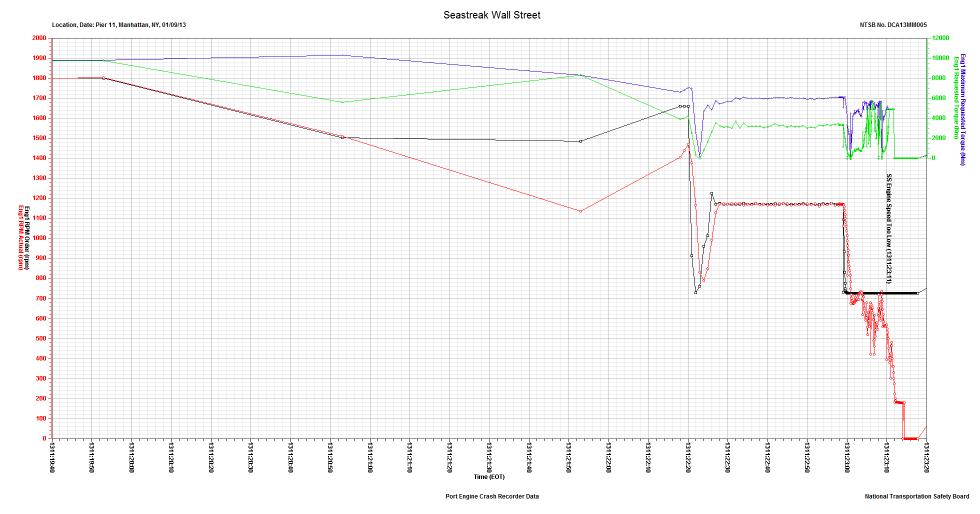
Figure 6. RPM data from port engine surrounding time of accident.

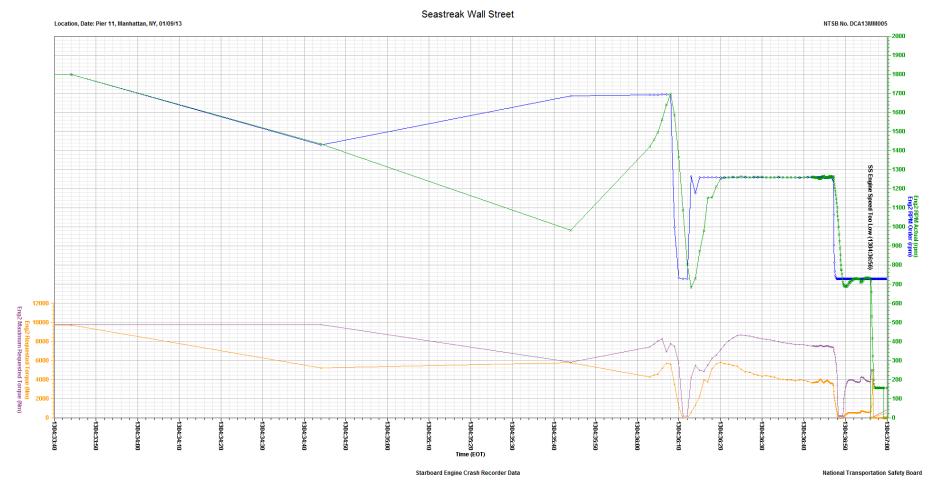
Figure 7. RPM data from starboard engine crash recorder surrounding time of accident.
