NATIONAL TRANSPORTATION SAFETY BOARD
Vehicle Recorder Division
Washington, DC 20594

Tugboat True Heading Study

Specialist's Study Report
By Christopher Babcock

Location: Philadelphia, Pennsylvania
Date: July 7, 2010, 14:37 Eastern Daylight Time (EDT)
NTSB Number: DCA10MM025

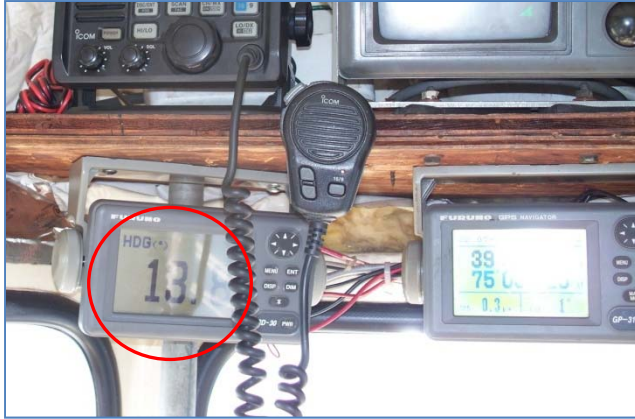
Figures 1 & 2 were obtained from the Coast Guard who boarded the *Caribbean Sea* shortly after the accident on 7 July 2010.² Figure 1 shows the satellite compass reading 13.8°. The GPS display, which contains time, is also visible, however the glare on the screen obscures the time reference on the unit, however Figure 2 contains a legible time reference on the GPS display (1648:53 EDT). Examination of the Exif data from Figures 1 & 2 indicate that the image in Figure 2 was taken 9 seconds prior to the image in Figure 1, thus the satellite compass reading in Figure 1 occurred at 1649:02 EDT.³ The closest AIS position report was transmitted at 1649:04 EDT with a true heading of 13°, within approximately 1 degree from the satellite compass displayed heading in Figure 1.

Figure 1. Satellite compass reading.

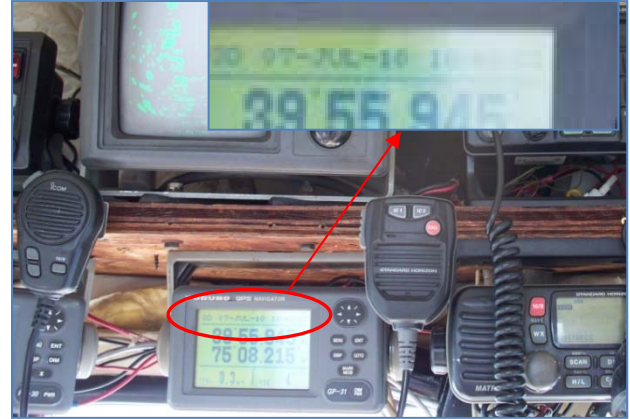
Figure 2. Time reference.

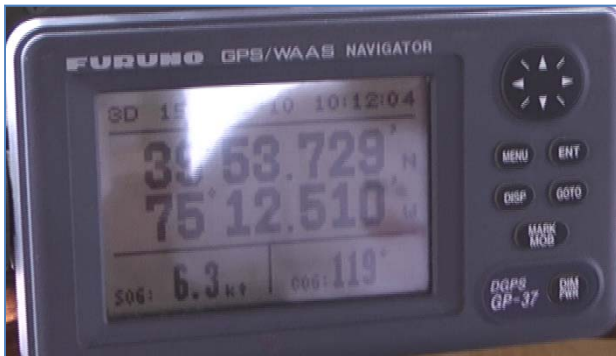
Figures 3 & 4 are image captures taken as a video camera pans over the instrument panel in the lower wheelhouse and show a similar time/heading comparison. The video was from an exemplar voyage on the *Caribbean Sea* on 15 July 2010. The time reference cannot be compared to recorded AIS data, as the AIS dataset from 15 July is from a different source than the Coast Guard and the timestamp of the AIS data is known to have several minutes uncertainty due to the restraints of the recording system; however, position, speed, and course data displayed on the GPS unit can be compared to position data from the AIS dataset to determine the correct position report to compare to the observed heading from the satellite compass (Figure 4).

Figure 3. GPS display.

Table 2 contains the AIS data that is the best match for the position, course, and speed in the GPS display in Figure 3. Satellite compass heading displayed on board the ship is within approximately 1 degree of the heading reported by the AIS transceiver.

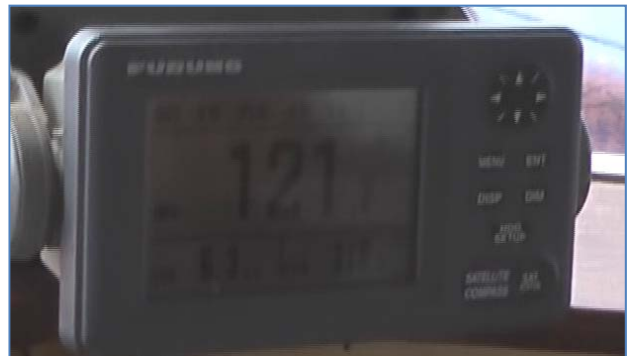
Figure 4. Satellite compass display.

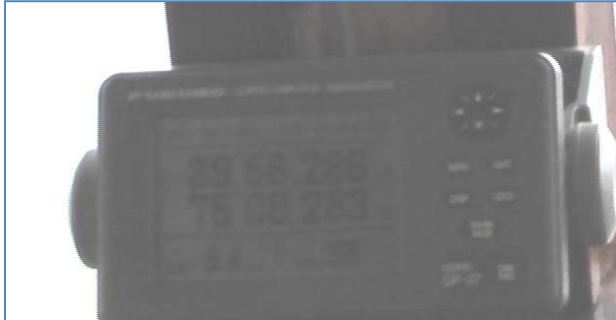
Figures 5 & 6 show another similar comparison. Speed, course, and heading from Figures 5 & 6 were compared with AIS position reports at the same position shown on the GPS receiver in Figure 5.

Figure 5. GPS display.

Table 3 contains the AIS data that is the best match for the GPS display data in Figure 5. Satellite compass heading displayed on board the ship is within approximately 1 degree of the heading reported by the AIS transceiver.

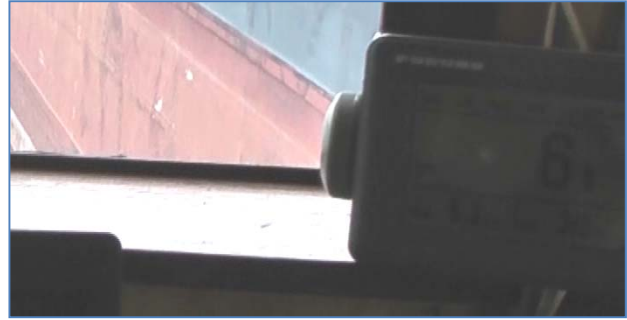
Figure 6. Satellite compass display.

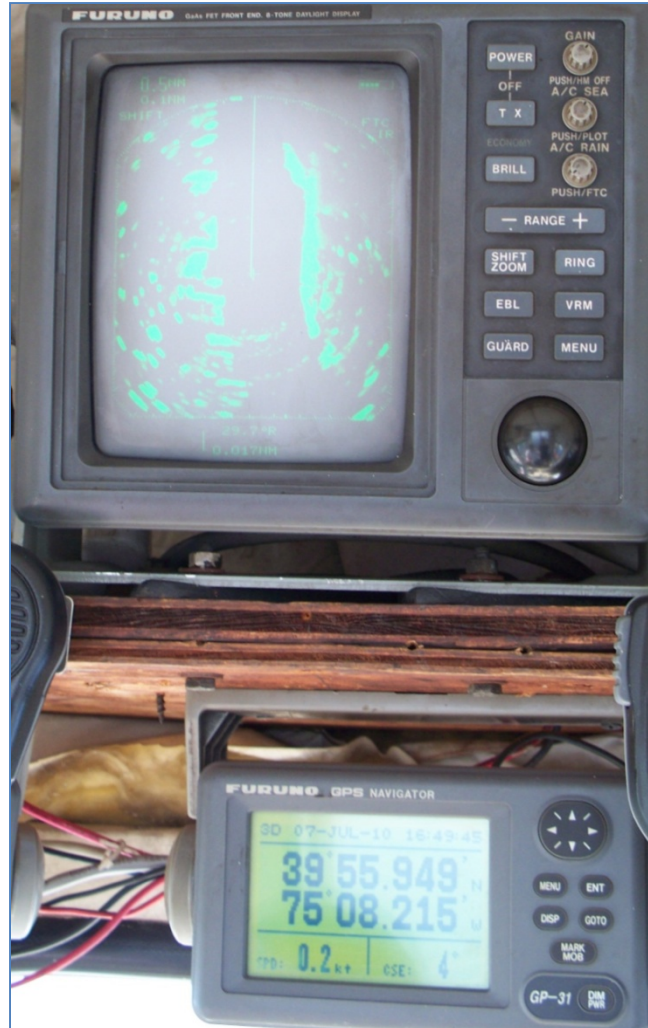
Figure 7 shows an image captured by the Coast Guard upon boarding the *Caribbean Sea* shortly after the accident. The GPS display indicates the photo was taken at 1649:45 EDT.

Figure 7. Radar display and GPS display.

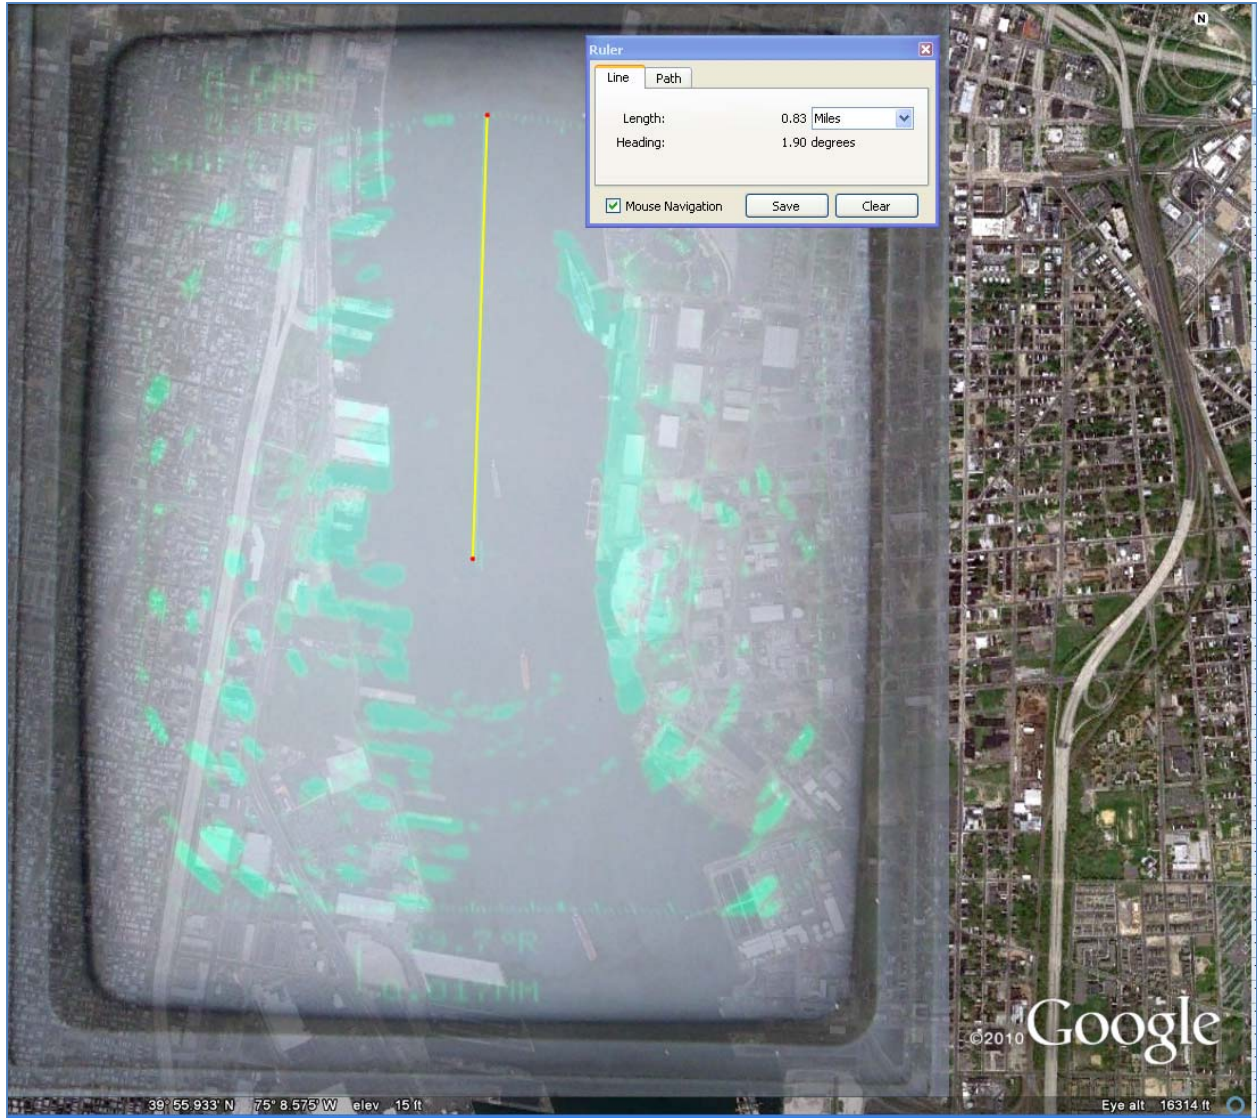
The image in Figure 7 was cropped to show the radar display only. Using the own ship position from the GPS display, the cropped radar display was overlaid into Google Earth, matching the radar returns with shoreside features (Figure 8). The radar operated in heads up mode with the line shown on the radar display indicating the ship's heading. The Google Earth measurement tool was used to determine the true heading of the ship by measuring the true heading of the radar heading reference line. The measurement tool indicated the ship's heading in this case was 1.9° . AIS data provided by the Coast Guard indicates that, for the closest position report at 1649:46 EDT, the true heading was 13° . Satellite compass displayed heading was biased approximately 11° to the right of the derived heading using the radar heading reference.

Figure 8. Radar overlay showing true heading.

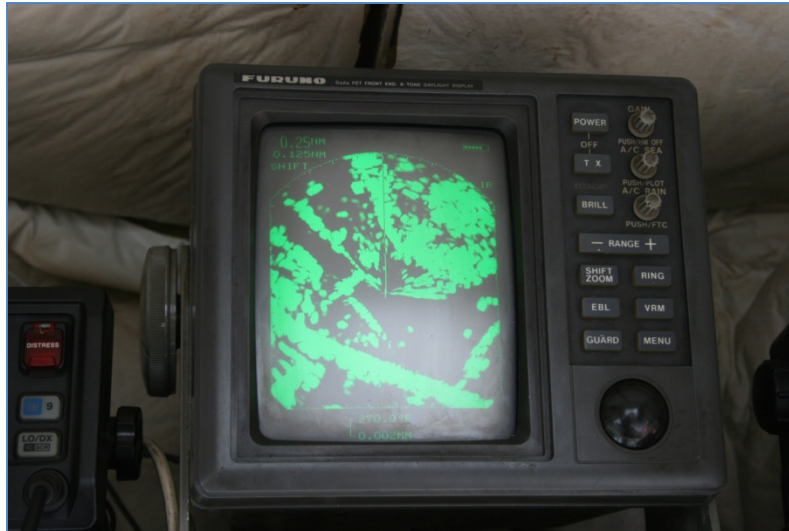
The day following the accident the navigation and communication equipment was tested by a third party contractor at the River Associates facility at the Philadelphia Navy Yard. Figure 9 shows a photograph of the radar screen during this testing.

Figure 9. Radar image during equipment testing.

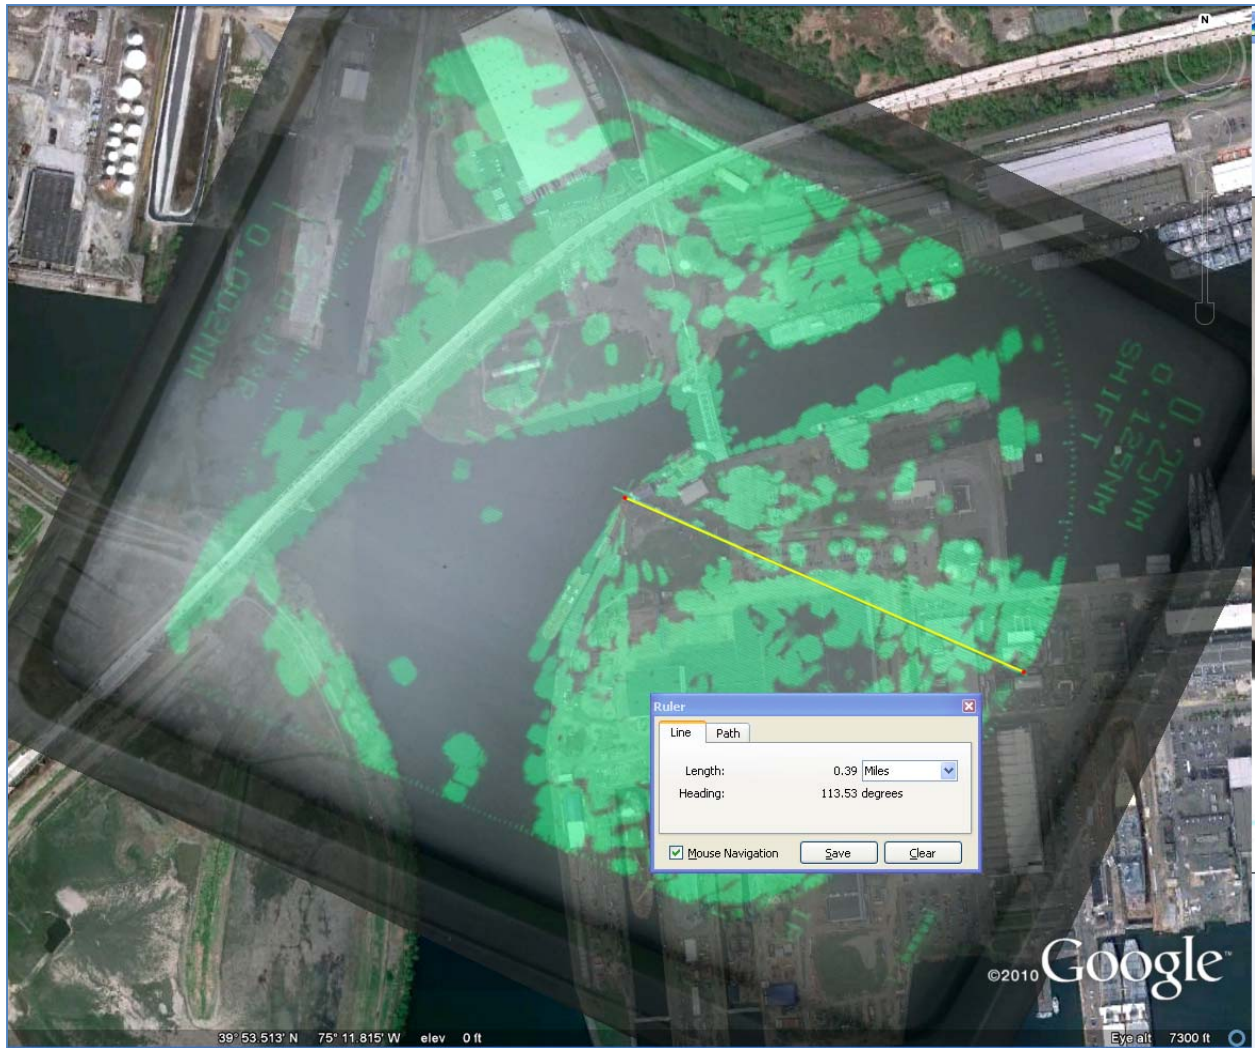
A cropped version of Figure 9 was overlaid on Google Earth using the bridges and shoreline and the radar heading reference line was again measured (Figure 10). The measurement tool indicated a true heading of 113.5° . Photos taken immediately prior to and following this test series show satellite compass readings of 123.8° and 123.5° true heading, respectively. Satellite compass displayed heading was biased approximately 10° to the right of the derived heading using the radar heading reference.

Figure 10. Transparent radar overlay showing true heading.

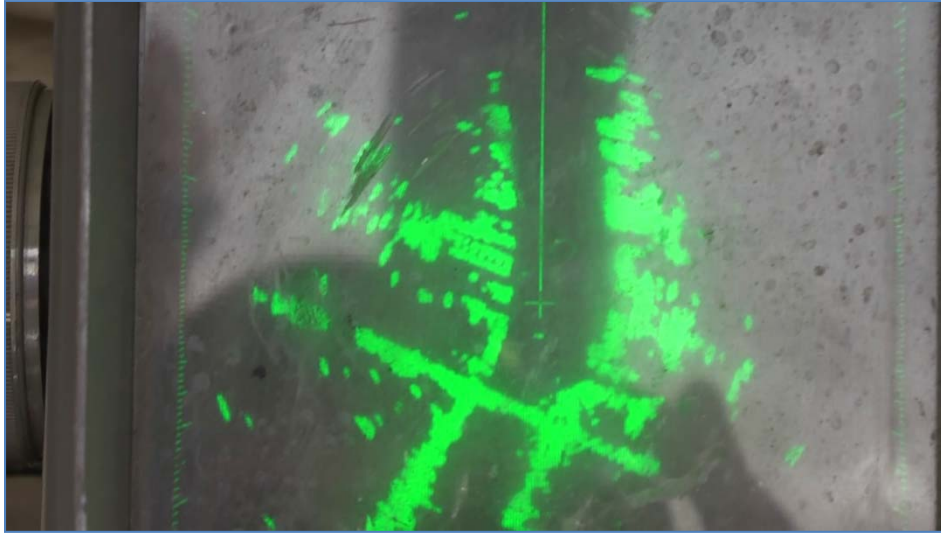
Figure 11 shows an image taken on the exemplar voyage. After overlaying the image in Google Earth, measurement of the true heading reference showed a true heading of 347.2° (Figure 12). Video footage caught an image of the satellite compass display right after the image in Figure 11 was captured and displayed 358° (Figure 13). The tenths of a degree digit was partially obscured, but it appears to show 358.1° . Satellite compass displayed heading was biased approximately 11° to the right of the derived heading using the radar heading reference.

Figure 11. Image from exemplar voyage showing radar display.

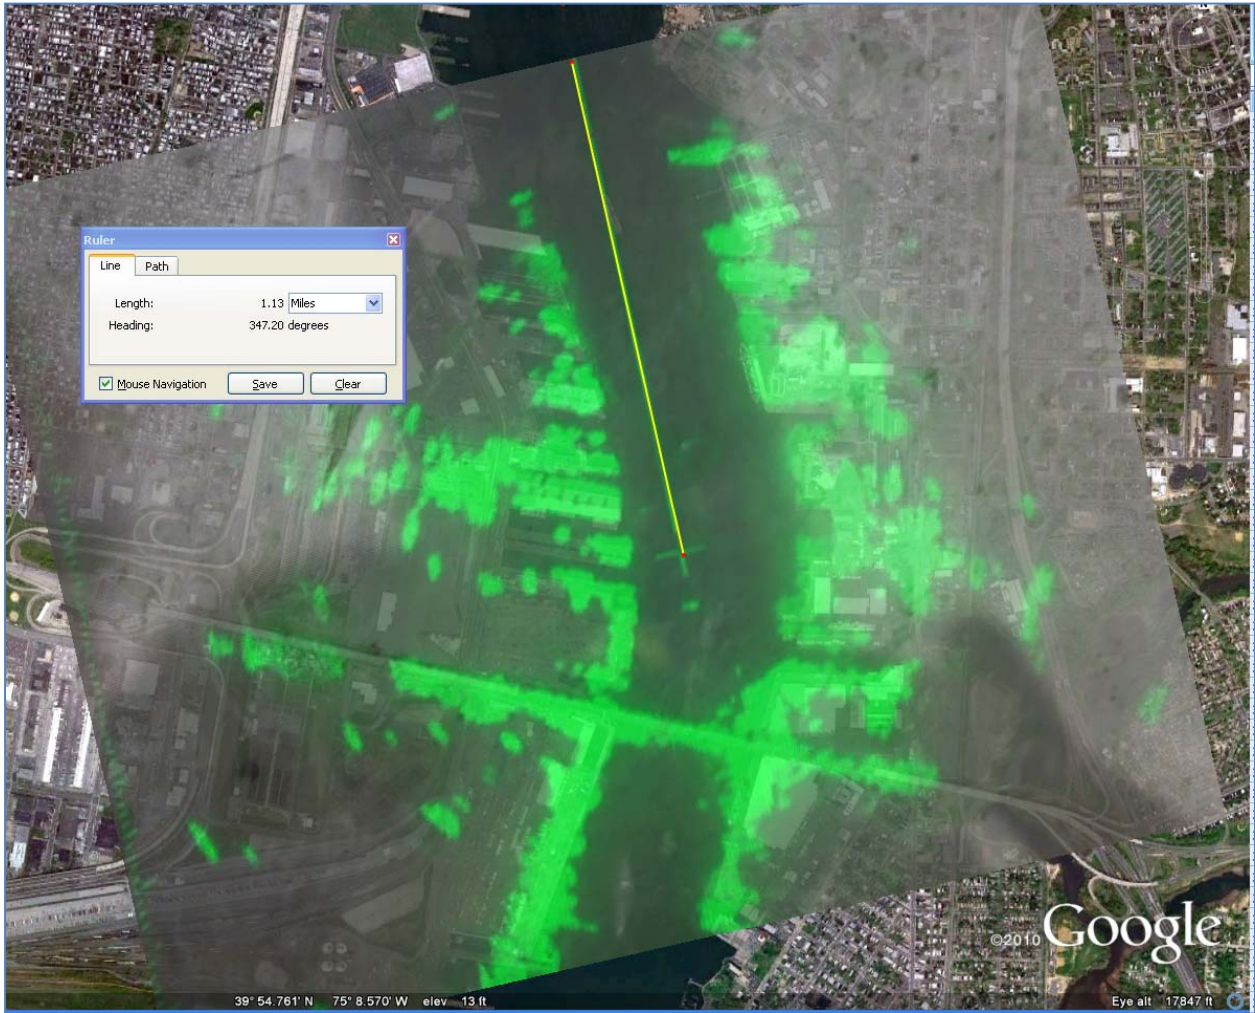
Figure 12. Transparent radar overlay showing true heading.

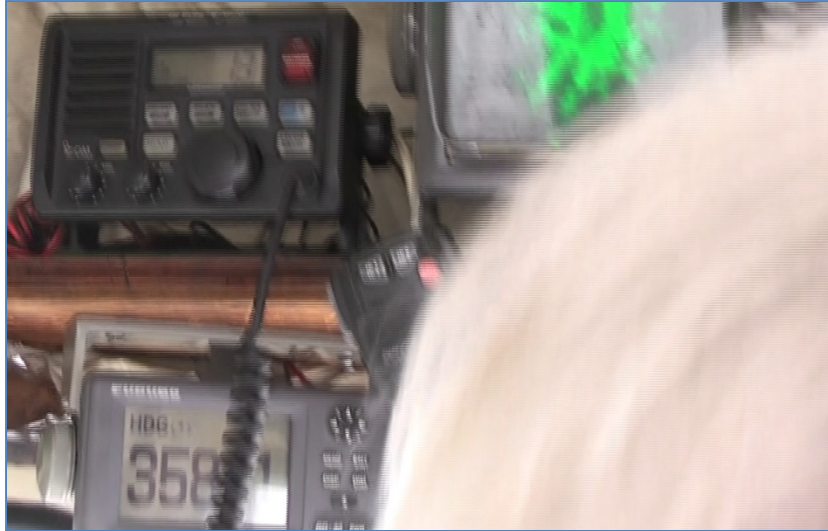
Figure 13. Satellite compass display.

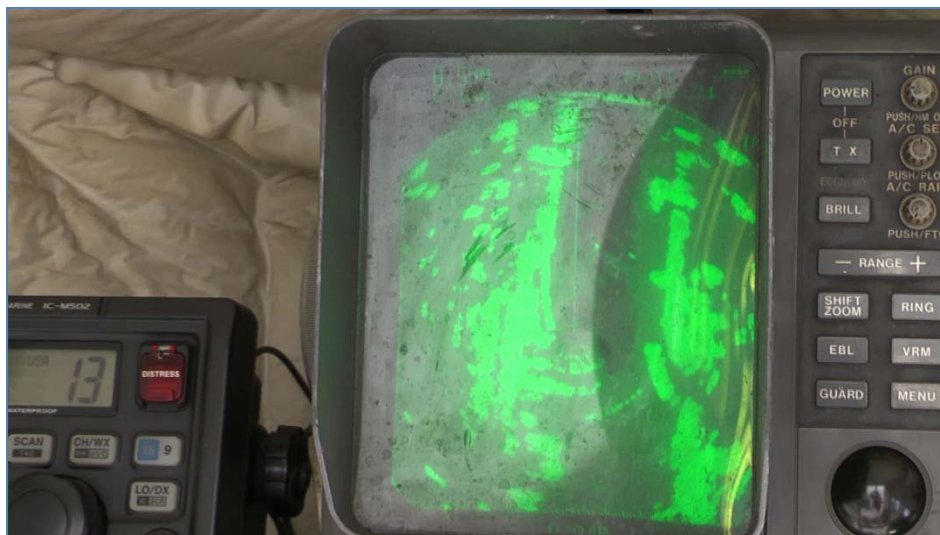
Figure 14 shows another image from later in the exemplar voyage. After overlaying the image in Google Earth, measurement of the true heading reference shows a true heading of 4.0° (Figure 15).

Figure 14. Image from exemplar voyage showing radar display.

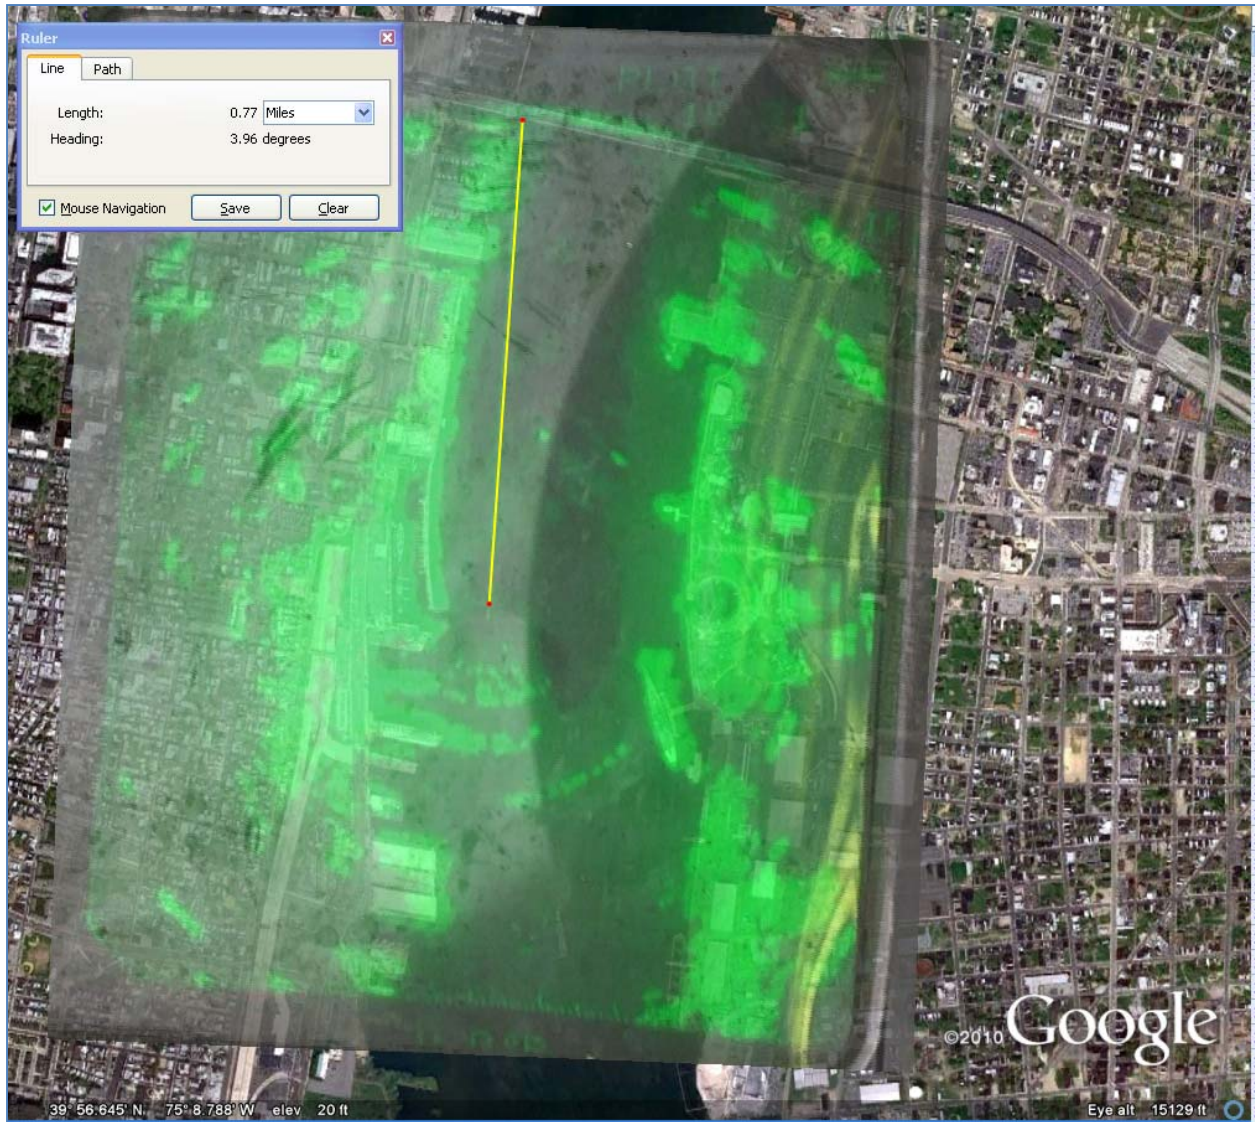
Figure 15. Transparent radar overlay showing true heading.

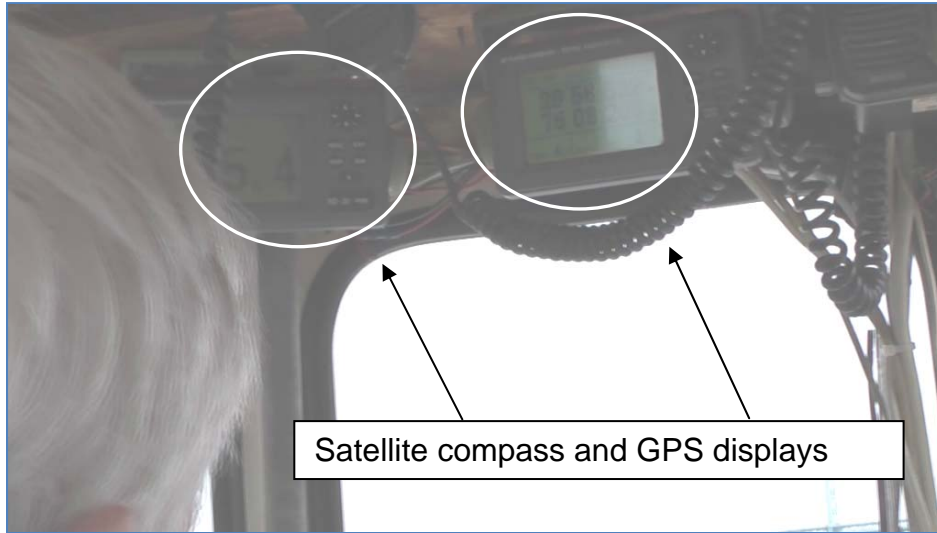
Figure 16 shows what is visible of the satellite compass and GPS display at this time. As the AIS heading data and satellite compass displayed data were shown to be consistent in Part 1, the AIS heading data can be compared to the radar heading reference using the AIS position report nearest to the position shown on the GPS display. Table 4 shows this comparison. The AIS reported heading was biased approximately 11° to the right of the derived heading using the radar heading reference.

Figure 16. Satellite compass and GPS display.
