S/S "NORWAY" - Main Boilers  
Cracks in Welds  
-----

Report Boiler 2A Prints from  
Ship file! Cracks

Examination of Linear Indications in Magnetic Particle Tests on  
Two Boilers of the SS "Norway"

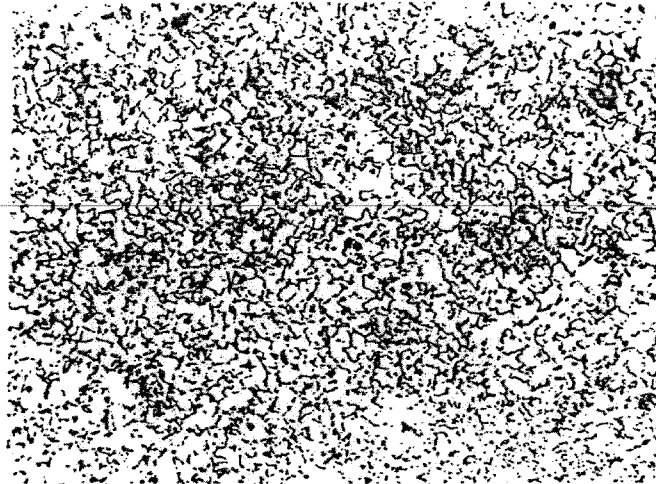
Replicas were made of the crack, crack surroundings, base material, heat-affected zone and the weld. The very fine-grained ferritic-pearlitic base material is shown in Fig. 2. Fig. 3 shows the structure in the middle of the weld. Both the base material structure and the weld structure with ferrite and portions of transition-stage structure are unobjectionable.

Fig. 2  
Base material structure replica  
Etched in  $HNO_3$   
180 - 182 DPH, 1-kg load  
Magnification: 200 : 1

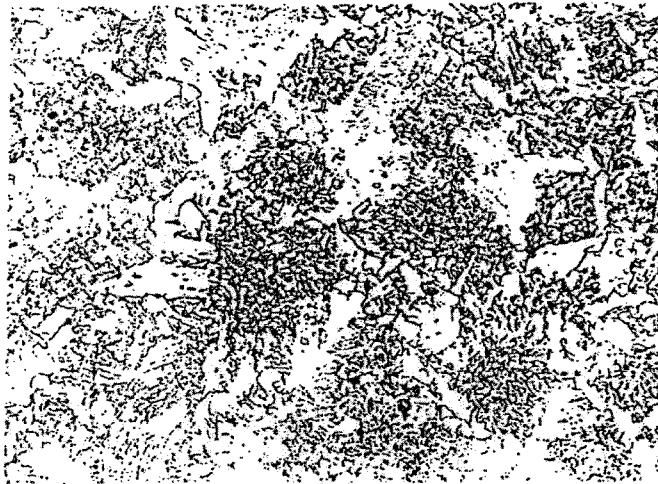
Fig. 3  
Weld structure replica  
Etched in  $HNO_3$   
224 - 232 DPH, 1-kg load  
Magnification: 200 : 1

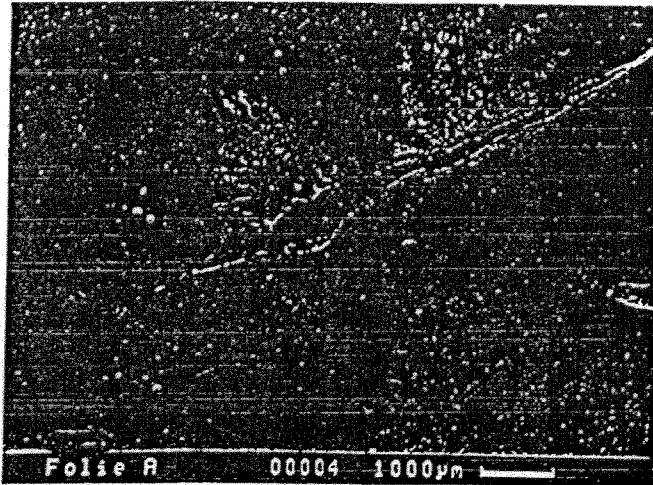
The scanning electron microscopic photograph of the crack is shown in Fig. 4. Figs. 5 and 6 show one photomicrograph of a crack tip each taken under a scanning electron microscope and a reflected light microscope. Pores arranged like pearls on a string are located immediately before the crack tip. Cracks result from the coalescence of these pores and the probability is that the 7 mm long crack will grow in this direction.

Fig. 4  
Crack  
SEM photograph

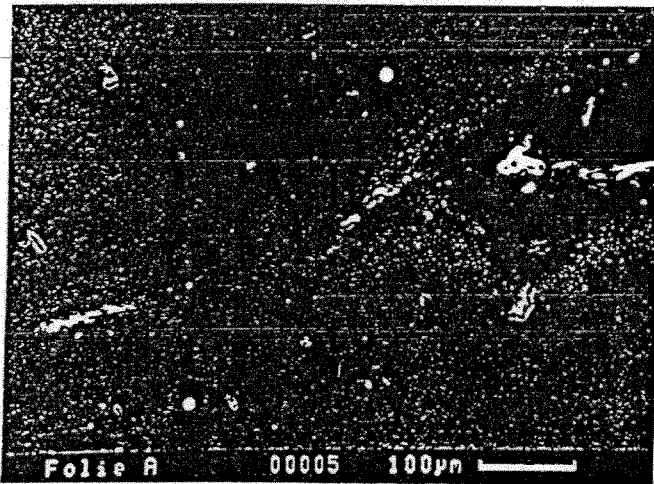
The 7 mm long crack is according to the examinations carried out a discontinuity essentially governed by the formation of micropores due to long-term thermal stressing. Such cracks are caused by the coalescence of pores forming at the grain boundaries. In Figs. 5 - 7, pores arranged like pearls on a string will be noted in the extension of the crack tips. Apart from the documented ones, no other pores were detected in the vicinity of the crack.

Fig. 5

1st crack tip with  
pore strings located  
directly in front

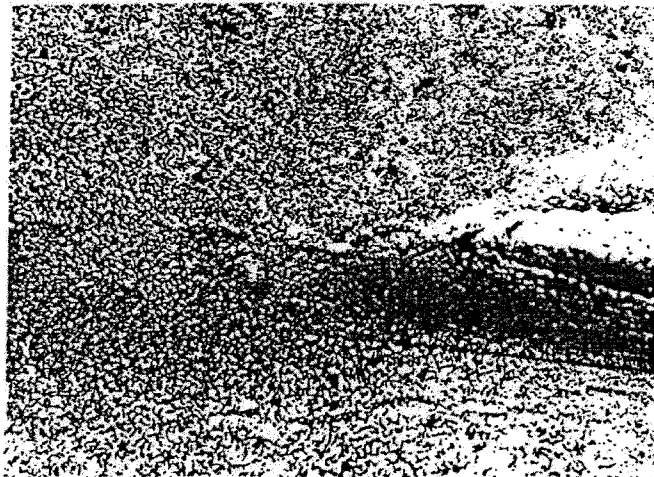
Fig. 6

as above

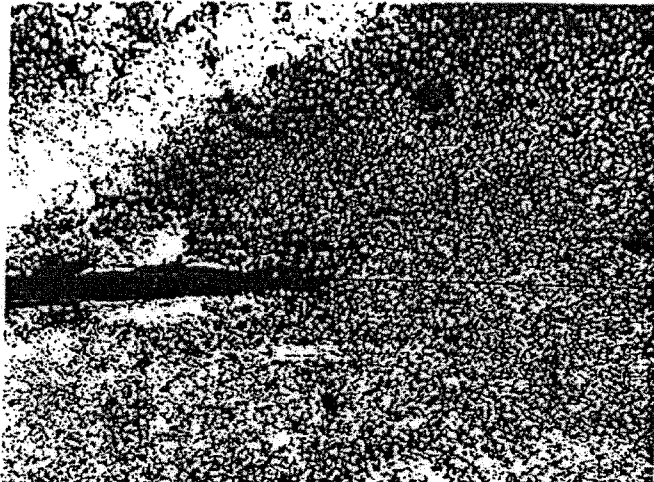
Fig. 7  
2nd crack tip  
Reflected light  
microscopic photograph

String of pores

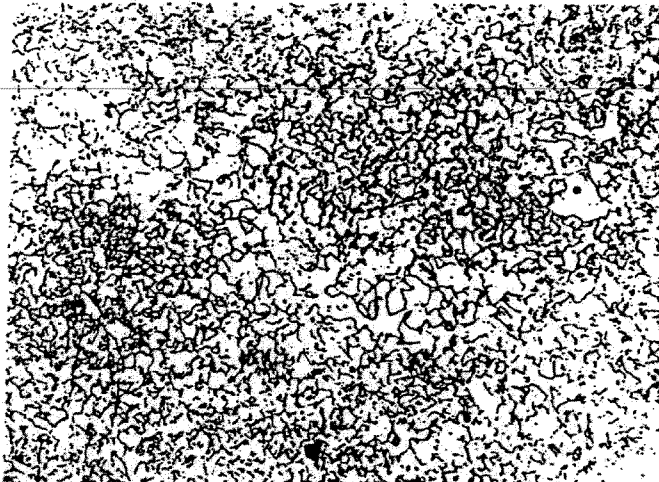
The structure of the crack face away from the weld is, like that of the base material, of the ferritic-pearlitic type (Fig. 8). In the area of the crack face near the weld the structure has rehardened and shows a high portion of transformation-stage structure.

Fig. 8  
Base material structure,  
about 1 mm beside the  
crack face, away from the  
weld

188 - 200 DPH, 1-kg load

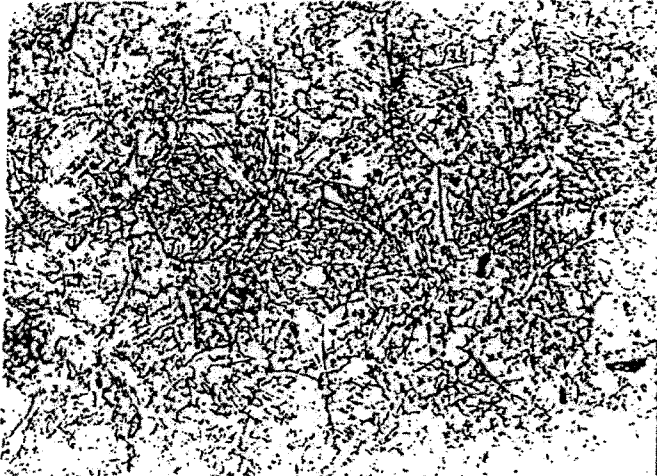
Obviously, micropores occur in the present case in the heat affected zone only. It seems to be a contradiction that in the hardness test lower hardness values were determined in the heat affected zone than in the zone of the crack face away from the weld. On the basis of the normal method of vessel manufacture it cannot be explained that areas away from the weld have a higher hardness than the area next to the fusion line.

Fig. 9  
Rehardened structure,  
opposite side of the  
crack face, near the  
weld

270 - 320 DPH, 1-kg load

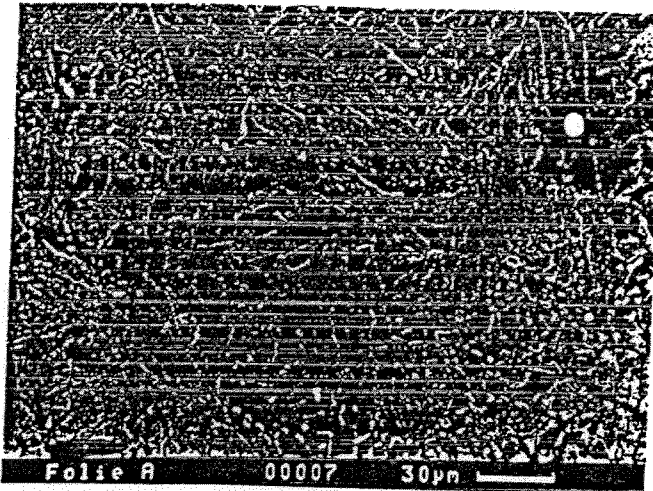
In the area of the heat affected zone small pores were found at the grain boundaries in some places. The pores are of such a size that they can only be detected at a magnification of 400X. At some few points the pores have grown to such an extent that they coalesced to form microcracks. Figs. 10 - 12 show reflected light microscopic photographs of these areas. To rule out any misinterpretation this area was examined under the scanning electron microscope. Due to the considerably greater depth of definition of the SEM the micropores appear more plastic as raised areas at the grain boundaries. Figs. 13 - 15 show areas in which the micropores have not yet coalesced. According to Figs. 10 - 13 the micropores seem to form at the primary grain boundaries.

Fig. 13

Micropores at grain boundaries in the heat-affected zone

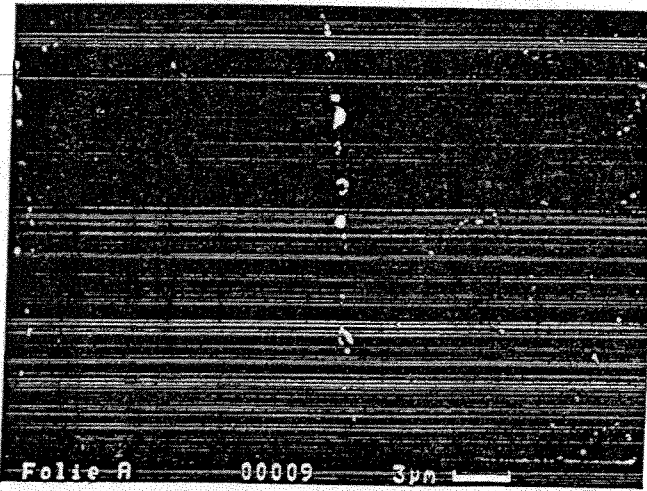
Fig. 14

as above

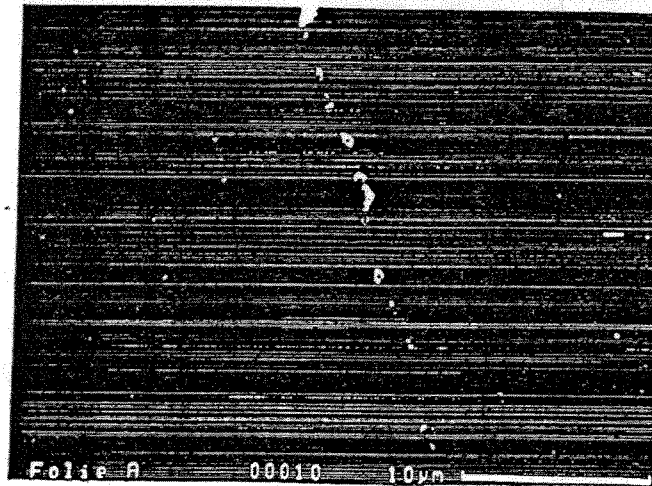
Fig. 15

as above
