NATIONAL TRANSPORTATION SAFETY BOARD

Materials Laboratory Factual Report 18-049

MATERIALS LABORATORY FACTUAL REPORT

Place : Philadelphia, Pennsylvania
Date : April 17, 2018
Vehicle : Boeing 737-700, N772SW
NTSB No. : DCA18MA142
Investigator : Pierre Scarfo, AS-40

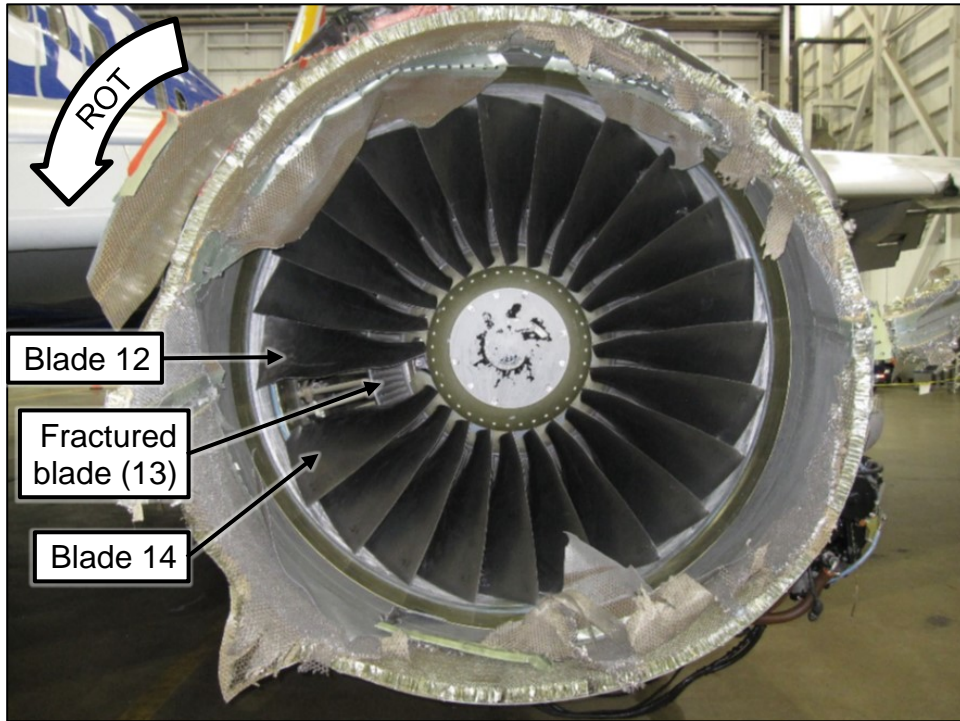
An overall view of the left (number 1) engine after the accident is shown in figure 1. The engine inlet was fractured, and the forward portion of the inlet was missing. One of the 24 fan blades was fractured at the root, and the remaining blades showed impact damage. During engine operation, the fan blades rotate clockwise as viewed looking forward. The fan blades were numbered sequentially also in the clockwise direction in accordance with blade numbering instructions provided in the Boeing Aircraft Maintenance Manual¹ where the number 1 blade is located immediately above an offset hole on the fan disk. The fractured blade was blade 13 as indicated in figure 1.

Figure 1. Overall view of the forward end of the number 1 engine after the accident.

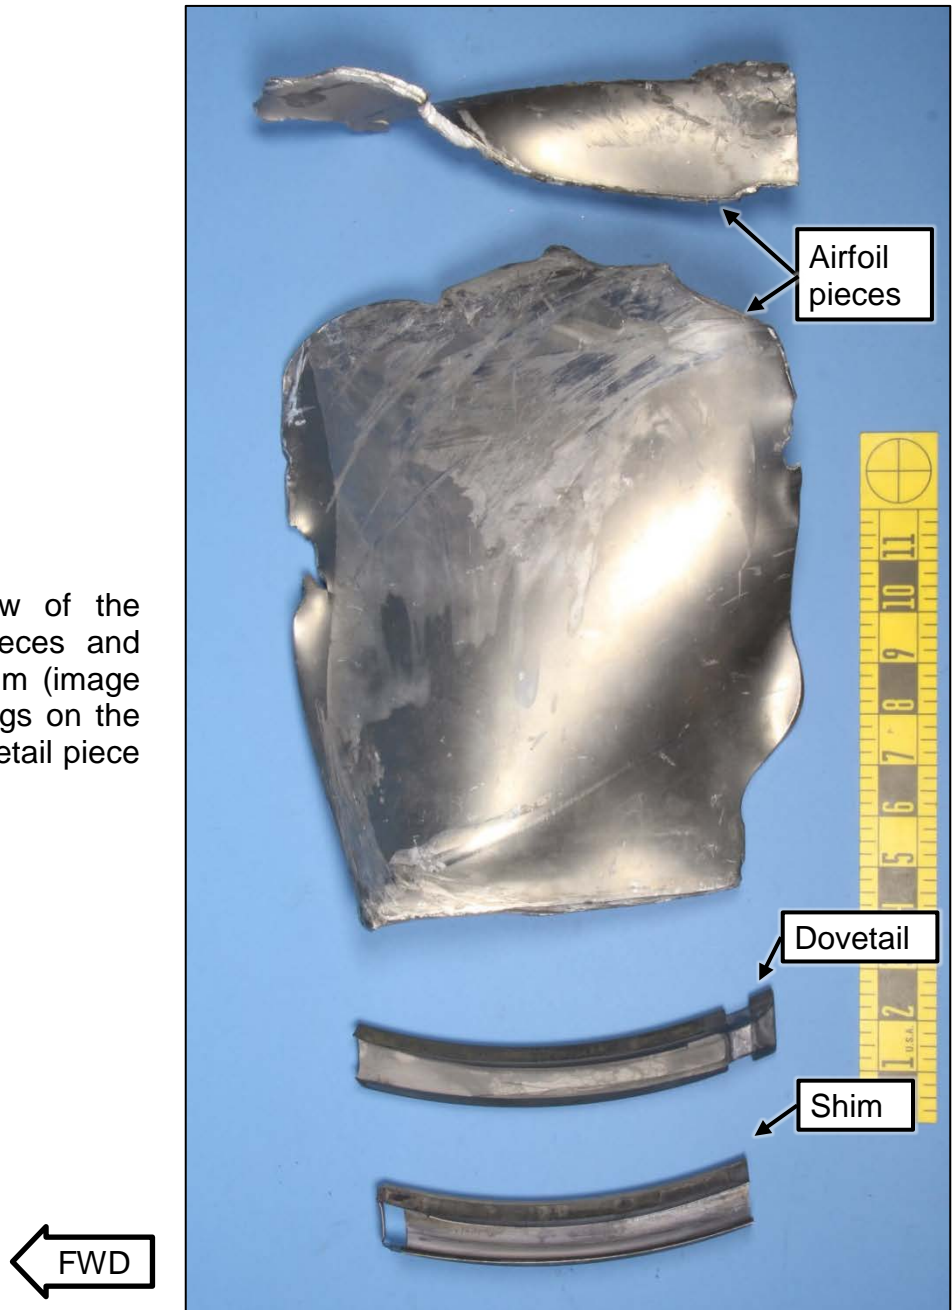
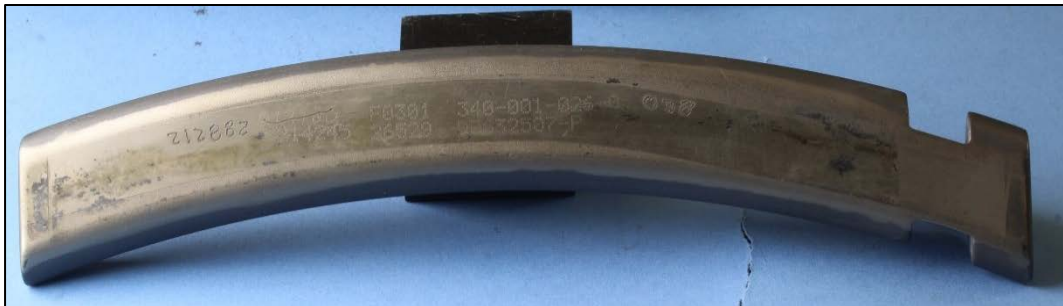
Blade 13 was fractured at the root and in the middle portion of the airfoil as shown in figure 5. The dovetail portion of the blade was retained within the fan disk, and the two airfoil pieces were recovered in the engine aft of the fan. The larger (inboard) airfoil piece had a fracture surface at the root end that mated to the fracture surface on the dovetail piece. To facilitate examination of the fracture surface, the shim was removed from the dovetail piece as shown in figure 5 by sliding it off the forward end of the dovetail piece. Each of the fan blade pieces were weighed, and the resulting measurements were 0.65 pound, 6.83 pounds, and 0.78 pound for the outboard airfoil piece, inboard airfoil piece, and dovetail piece, respectively. The total weight of the recovered blade pieces represented approximately 75% of the nominal weight (10.83 pounds) of a new fan blade.

Figure 5. Closer view of the recovered blade 13 pieces and corresponding blade shim (image to the right) and markings on the root end face of the dovetail piece (lower image).

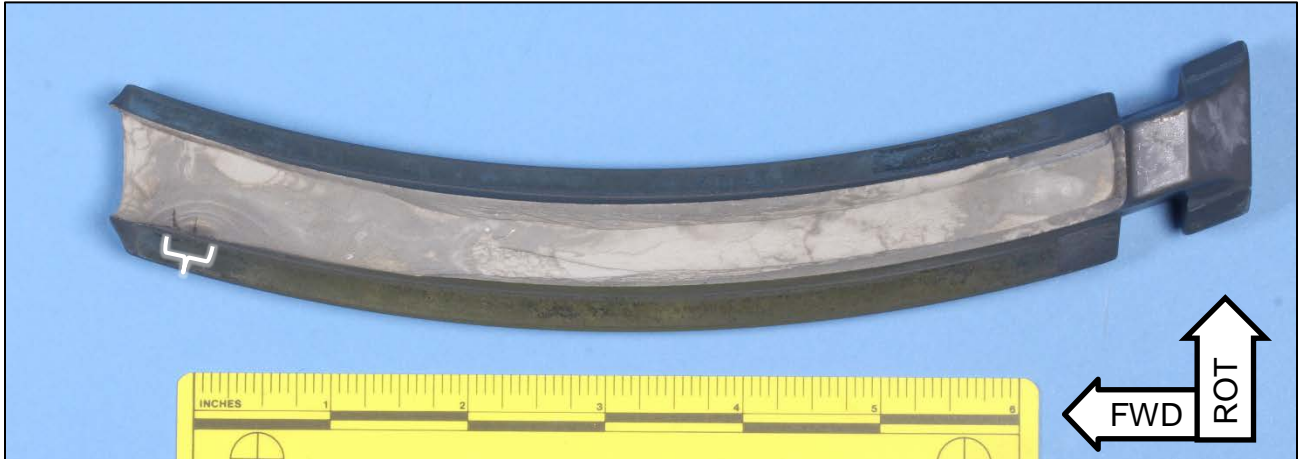
An overall view of the fracture surface on the dovetail piece of blade 13 after cleaning is shown in figure 6. A portion of the fracture surface was relatively smoother with curving crack arrest lines, features consistent with fatigue. Fracture features emanated from an origin area centered approximately 0.57 inch from the leading-edge

face on the convex side of the blade as indicated with a bracket in figure 6. Ratchet marks⁶ were observed in the origin area, consistent with multiple fatigue origins.

Figure 6. Overall view of the blade 13 fracture surface after cleaning. A bracket indicates the fatigue origin area located approximately 0.57 inches aft of the forward end on the convex side of the blade.

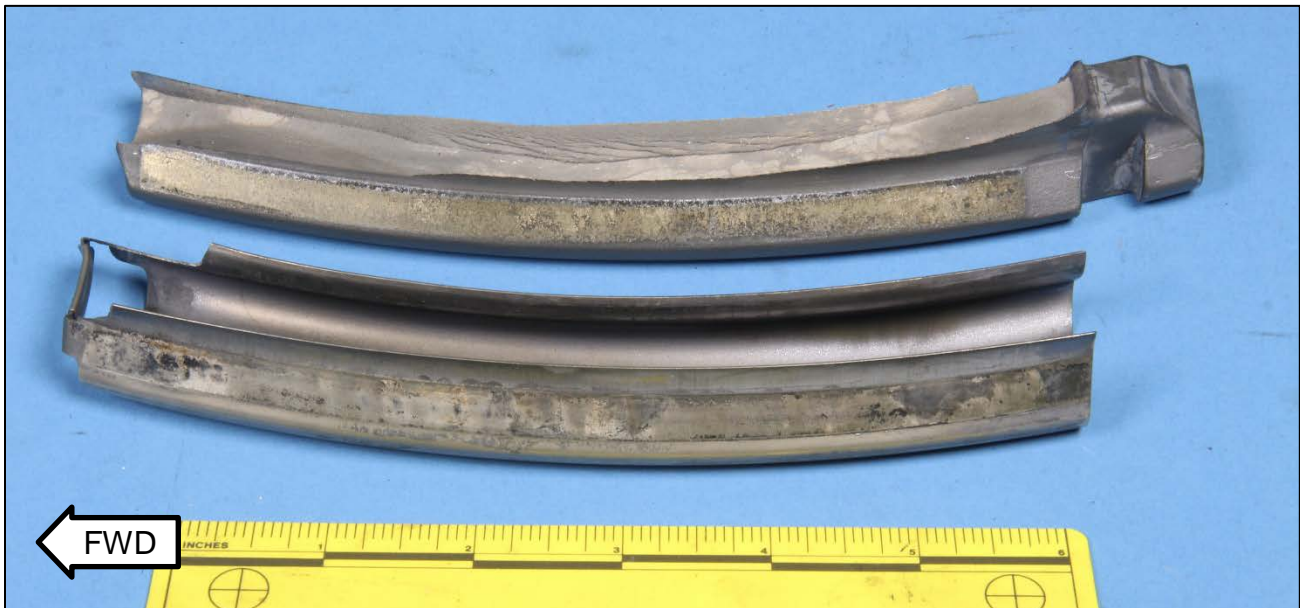
An overall view of the blade 13 dovetail piece and shim are shown in figure 7. The Cu-Ni-In coating was intact and appeared generally uniform in texture and color. The shim was largely intact with a small piece fractured and missing from the forward outboard corner. A closer view of the convex surface of the blade dovetail piece in the area of the fatigue origin is shown in figure 8. The fracture initiated approximately 0.036 inch outboard of the outboard edge⁷ of the Cu-Ni-In coating (see figure 7).

Figure 7. Overall view of the convex sides of the blade 13 dovetail piece and fan blade shim after the shim was disassembled from the dovetail.

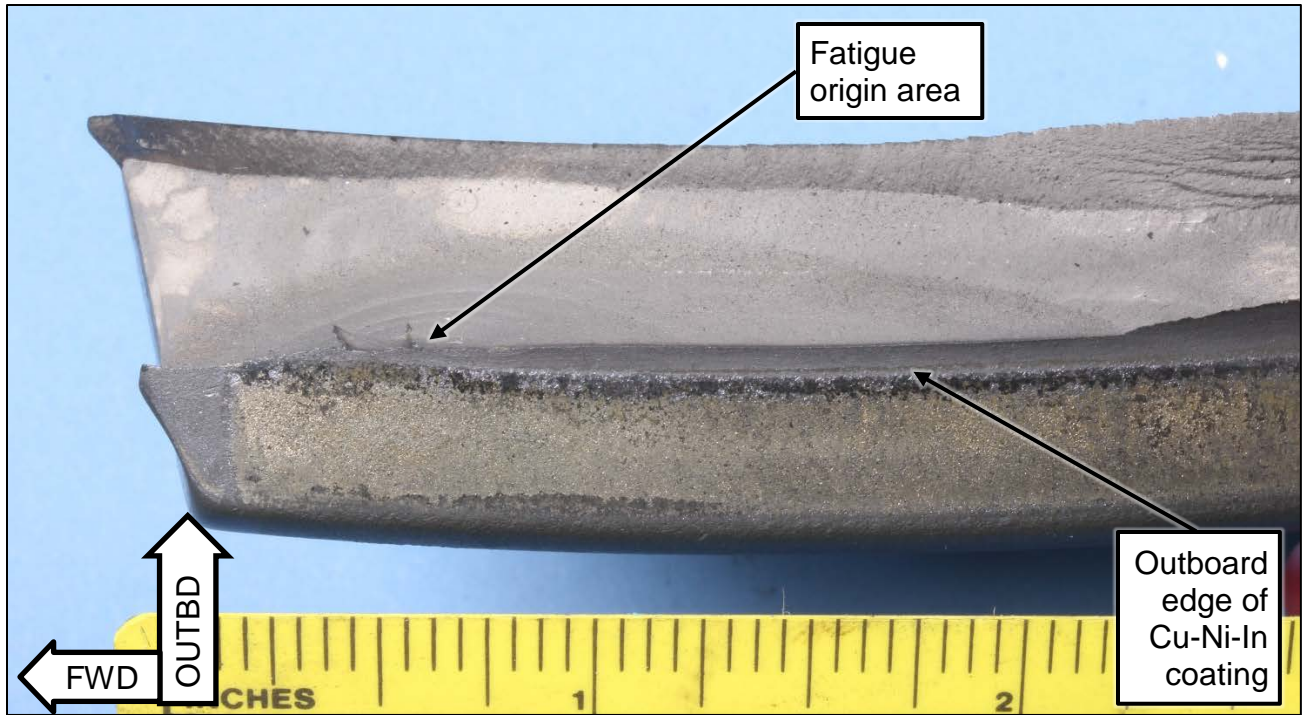
Figure 8. View of the convex face of the blade 13 dovetail at the fatigue origin area.

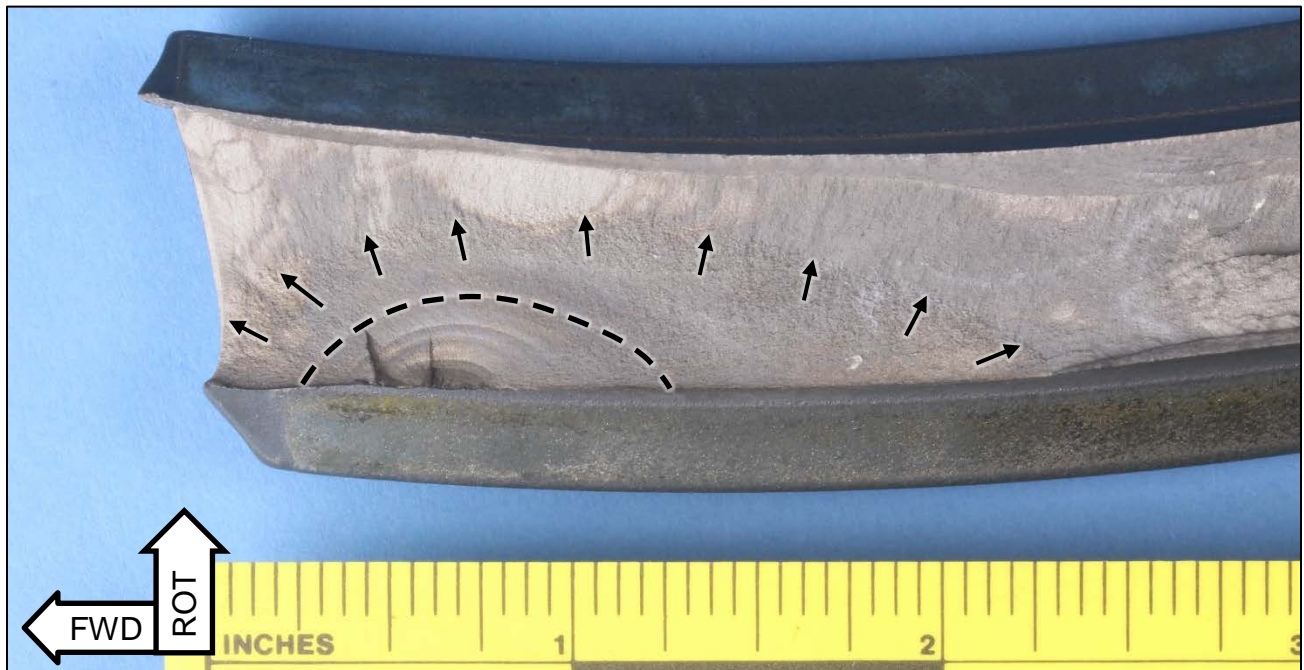
A closer view of the fatigue region on the blade 13 piece is shown in figure 9. A dashed line in figure 9 represents a boundary of the fatigue region where well-defined curving crack arrest marks were observed. This region was 0.976 inch long axially at the blade surface and extended up to 0.263 inch deep. Beyond that region, fracture features were in a relatively flat plane with a curving boundary indicated with unlabeled arrows in figure 9. The flat-plane region defined by unlabeled arrows intersected the forward face and extended up to 2.232 inches axially and up to 0.483 inch deep. Beyond the boundary defined by unlabeled arrows, the fracture surface had a slightly different texture with prominent shear lips, features consistent with ductile overstress fracture.

Figure 9. Close view of the fatigue region. A dashed line indicates the location of the last well-defined crack arrest mark.

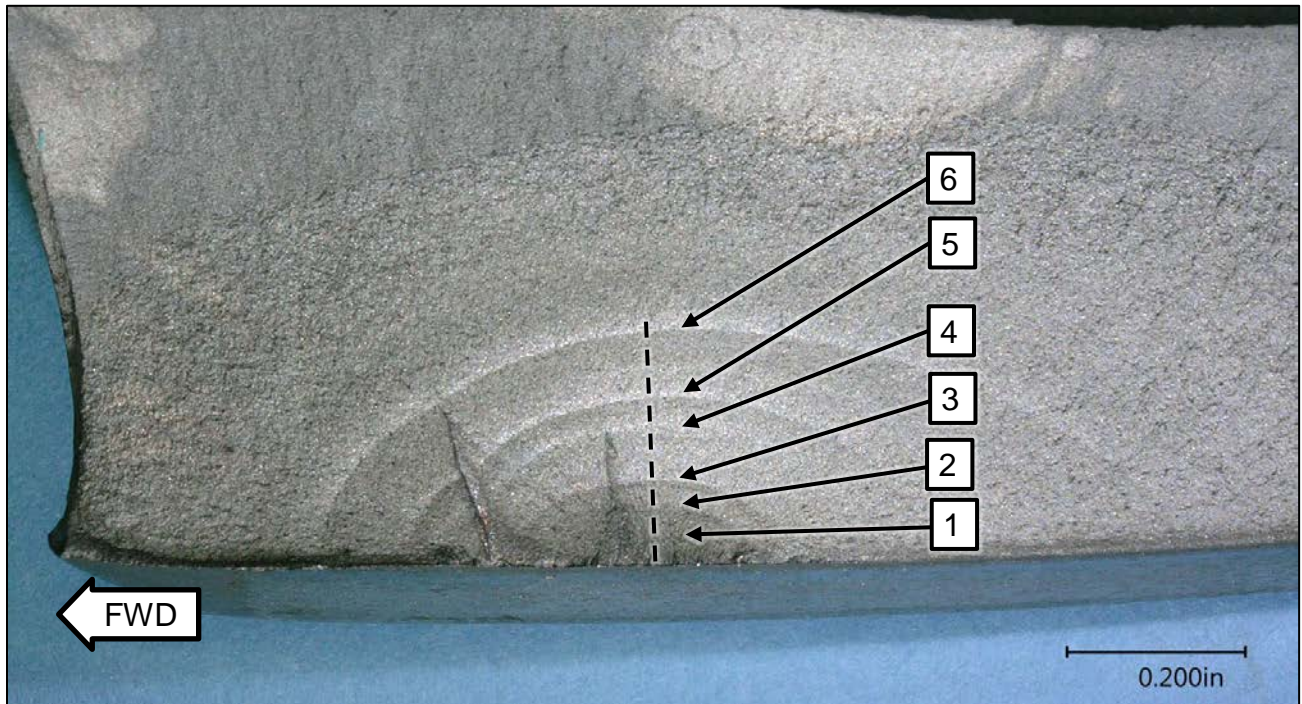
Six distinct crack arrest lines were visible on the fracture surface as indicated in figure 10. The arrest lines are shown numbered starting with the arrest line closest to the origin. The maximum depths of the crack arrest lines were 0.037 inch, 0.068 inch, 0.094 inch, 0.143 inch, 0.187 inch, and 0.263 inch for arrest lines 1 to 6, respectively. Following the optical examination of the fracture surface, a detailed SEM examination of the surface was conducted as described later in this report.

Figure 10. Close view of the cleaned origin area on blade 13. Distinct crack arrest lines are numbered, and a dashed line indicates the location where striation density was counted.

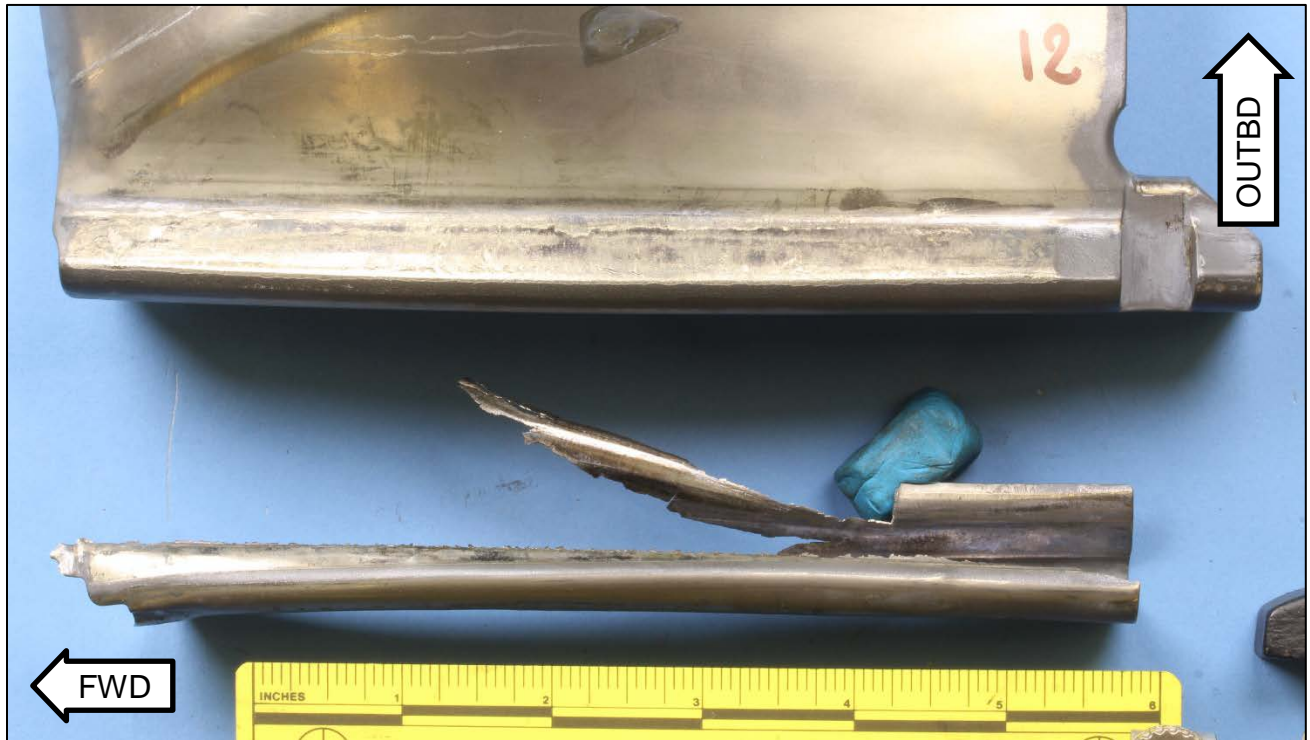
Closer views of the dovetails for blades 12 and 20 are shown in figures 11 and 12 and are representative of blades with more extensive damage to the dovetail contact faces. Later examination of the corresponding shims revealed coating material adhered to the interior surfaces of the shim in areas where these crater-like features were observed. No evidence of cracks in other blades were detected during the optical examination.

Figure 11. View of the dovetail and shim for the blade trailing the fractured blade. Pieces of the shim were fractured and missing.

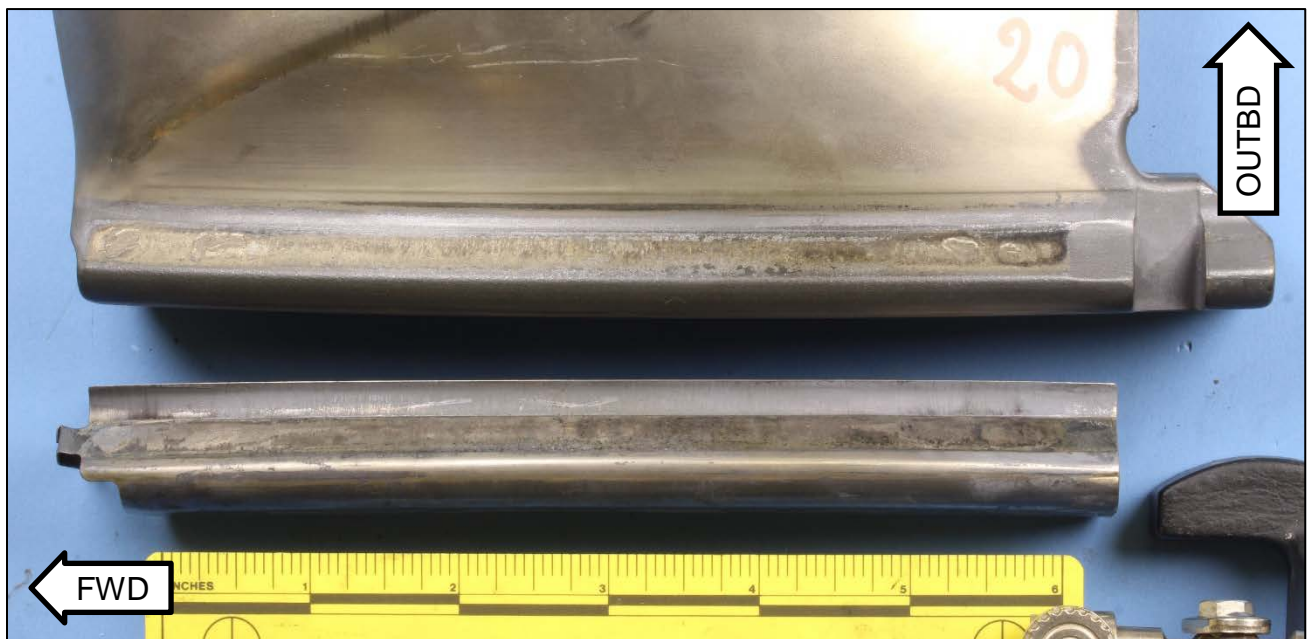
Figure 12. View of the blade 20 dovetail and shim. The Cu-Ni-In coating was disturbed near the forward and aft ends of the contact face.

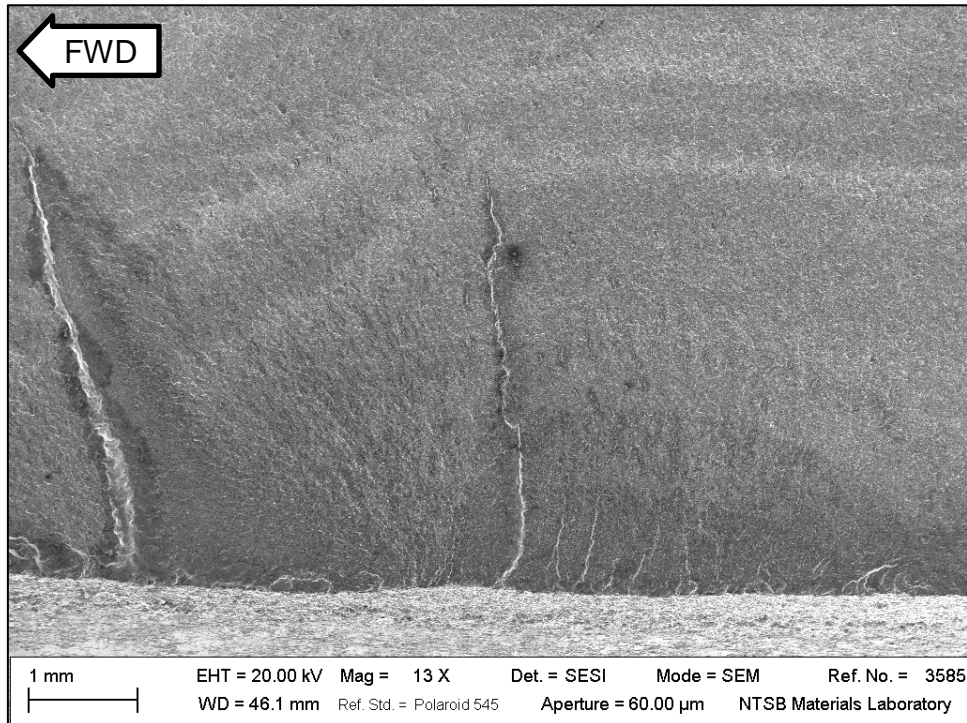
of the origin area is shown in figure 13. The crack arrest lines that were visible by optical microscopy were also generally visible in the SEM.

Figure 13. Overall view of the origin area after cleaning as viewed using an SEM.

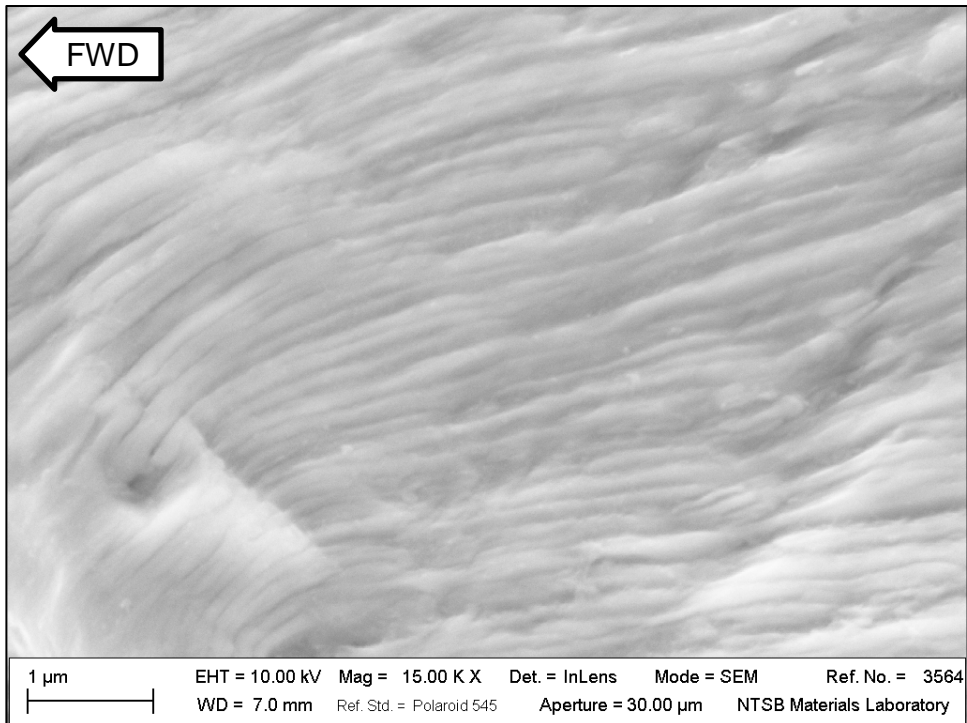
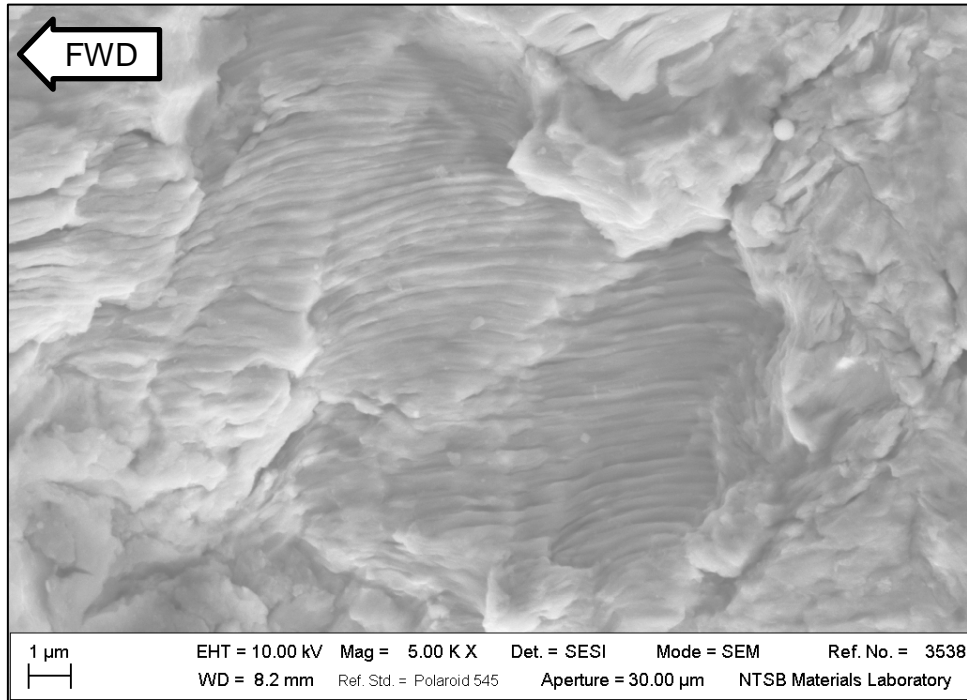
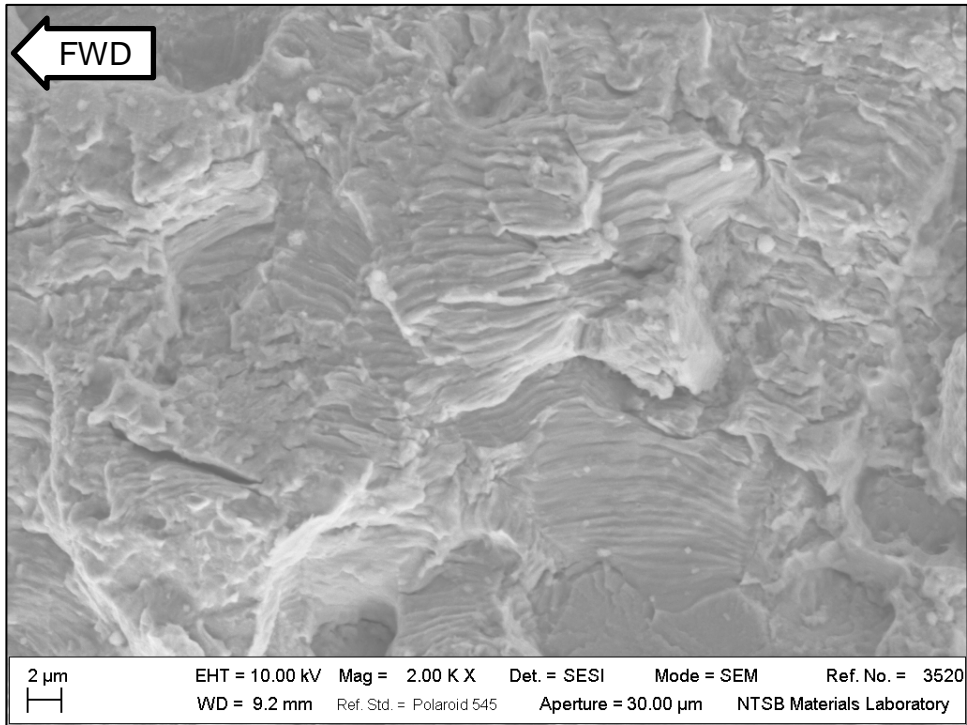
At higher magnifications, striations consistent with low-cycle fatigue crack growth were observed. Typical views of fracture features within the fatigue region at various distances from the convex surface of the blade are shown in figures 14 through 16. In general, striation spacing became larger as the depth of the crack increased. However, at the crack arrest lines shown in figure 10, the striation spacing showed an abrupt change where the distance between striations immediately past each arrest line was noticeably shorter than the spacing leading up to the arrest line, consistent with a temporary reduction in crack growth rate as the crack grew after each arrest line had been formed.

Figure 14. SEM image of the blade 13 fracture surface at 0.0124 inch from the convex surface.

Figure 15. SEM image of the blade 13 fracture surface at 0.123 inch from the convex surface.

Figure 16. SEM image of the blade 13 fracture surface at 0.256 inch from the convex surface.

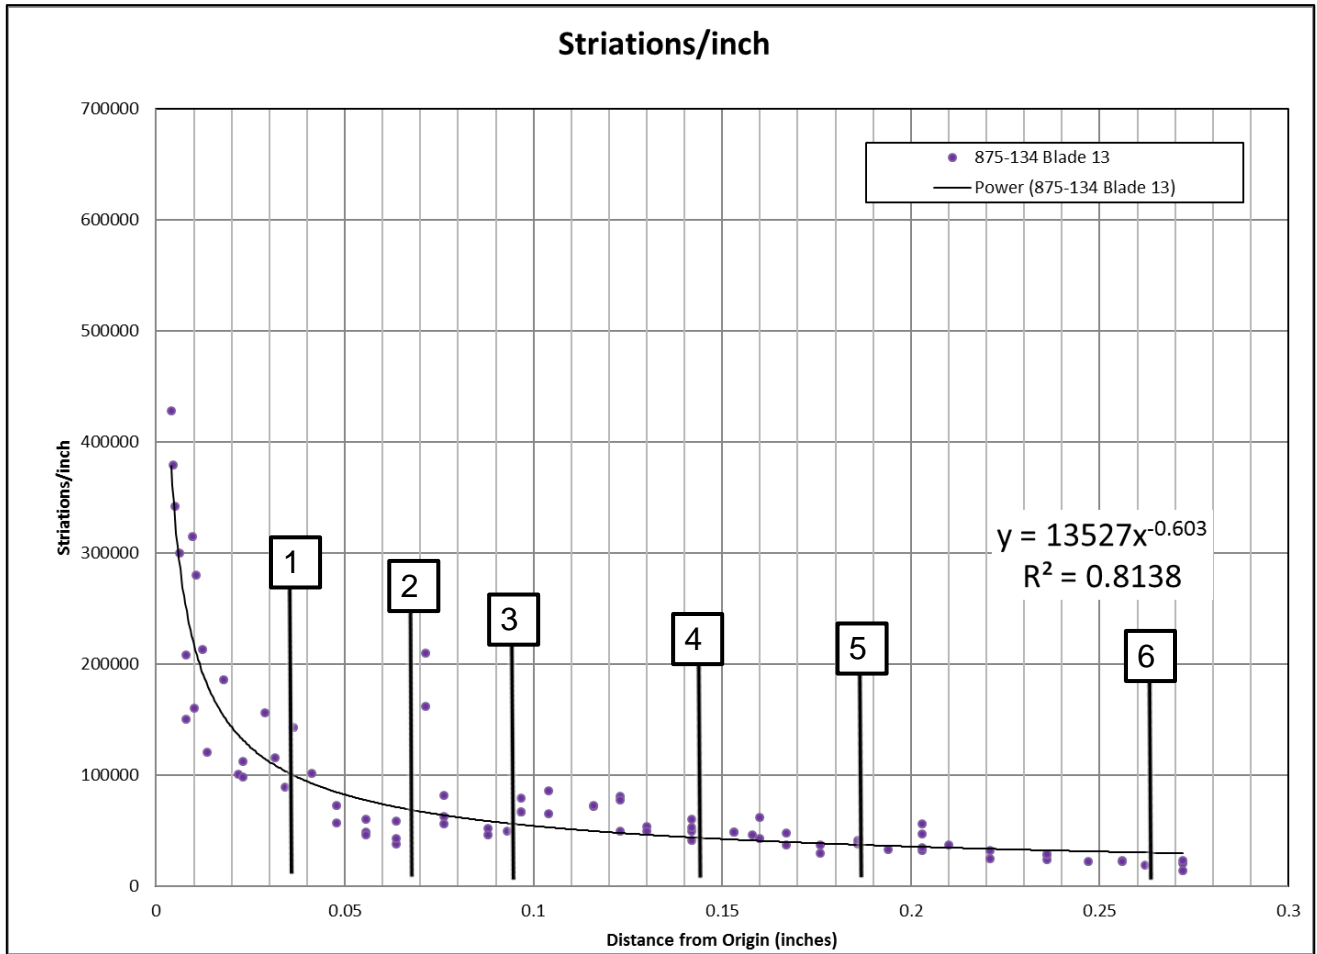
Striation density as a function of distance from the origin for the blade 13 fracture is shown plotted in figure 17, and a power-law curve represented by a solid line was fitted to the data. By integrating the area under the curve, a total number of striations could be estimated. The locations of the crack arrest lines are also noted in figure 17 as numbered 1 through 6. For crack growth from 0.0005 inch to crack arrest line 6 at 0.263 inch, the estimated number of striations was approximately 18,400. Since one striation is usually associated with one engine flight cycle, the total number of engine flight cycles associated with crack growth is approximately equal to the estimated number of striations. Beyond, crack arrest line 4, an accurate estimate of the number of striations was not possible due to the extent of ductile tearing intermixed with the striations.

Assuming that crack arrest line 6 was associated with the last blade lubrication, it was estimated that crack growth beyond crack arrest line 6 on blade 13 represented the 1,709 engine flight cycles accumulated since the last relubrication. Combining this number with the estimated 18,400 cycles associated with crack growth from 0.0005 inch to crack arrest line 6, the total number of cycles associated with crack growth from 0.0005 inch deep to failure was estimated to be approximately 20,000 cycles.

Figure 17. Striation density as a function of distance from the origin for blade 13. Locations of crack arrest lines 1 through 6 are noted on the graph.

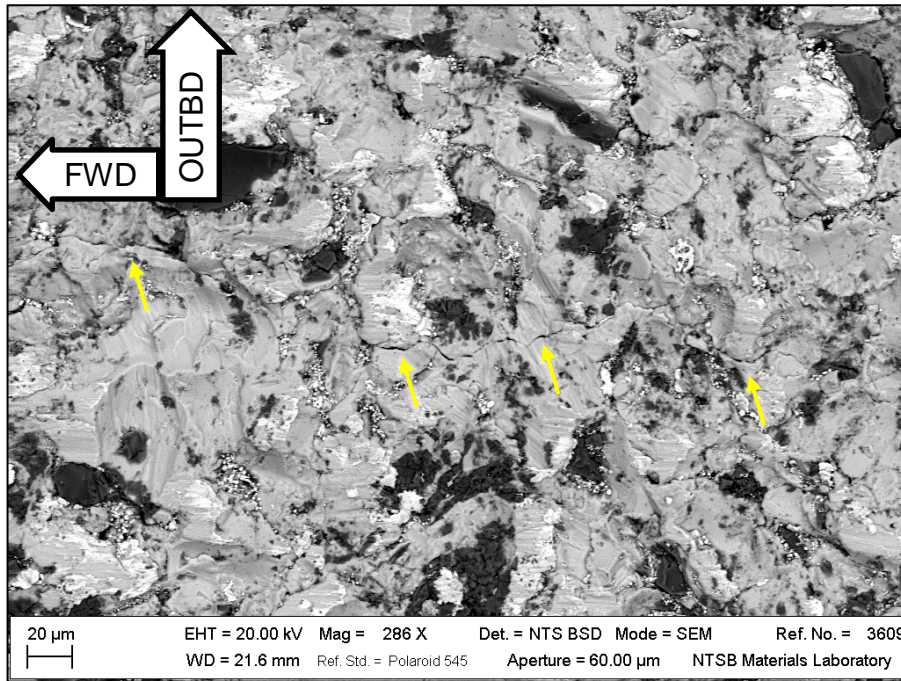
The dovetail piece from blade 13 was repositioned in the SEM to examine the blade surface adjacent to the origin area. The surface had an irregular rough texture consistent with a grit-blast surface. When viewed using the backscattered electron detector in composition mode,⁸ lighter areas consistent with deposits of Cu-Ni-In and darker areas consistent with lubricant or grit remnants were present scattered on the surface (see figure 18). In the area shown in figure 18, secondary crack features were observed as indicated with arrows.

Figure 18. SEM images of a secondary crack feature observed on the surface of blade 13 adjacent to the origin area as viewed using backscattered electron detector.

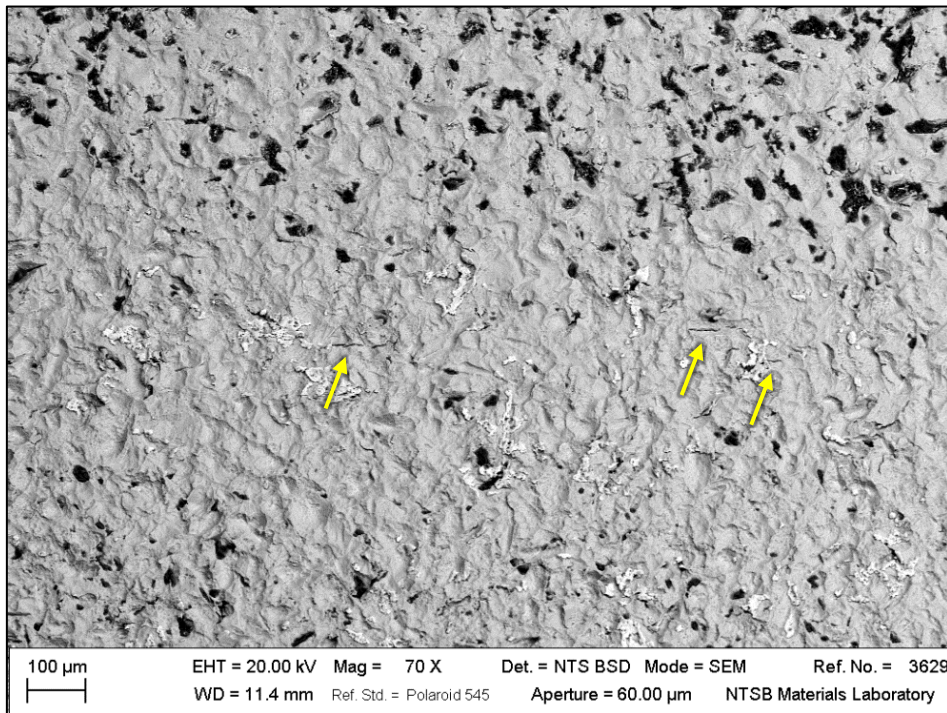
The forward portion of the blade root including the dovetail was sectioned from the remainder of the blade to facilitate the SEM examination. First, the coating was stripped from the dovetail to expose the underlying surface by soaking in concentrated nitric acid. Next, the surface on the convex side of the blade was etched using a solution of 15% concentrated nitric acid and 15% concentrated hydrofluoric acid added to water (15/15 reagent). Isolated microcrack features,⁹ generally <100 microns long, were observed at locations ranging from 0.47 inch to 1.11 inches aft of the leading edge and 0.61 inch outboard of the root end face. Typical microcrack features are shown in the SEM image in figure 19.

Figure 19. SEM image using the backscattered electron detector showing the etched surface of blade 20. Unlabeled arrows indicate isolated microcracks.

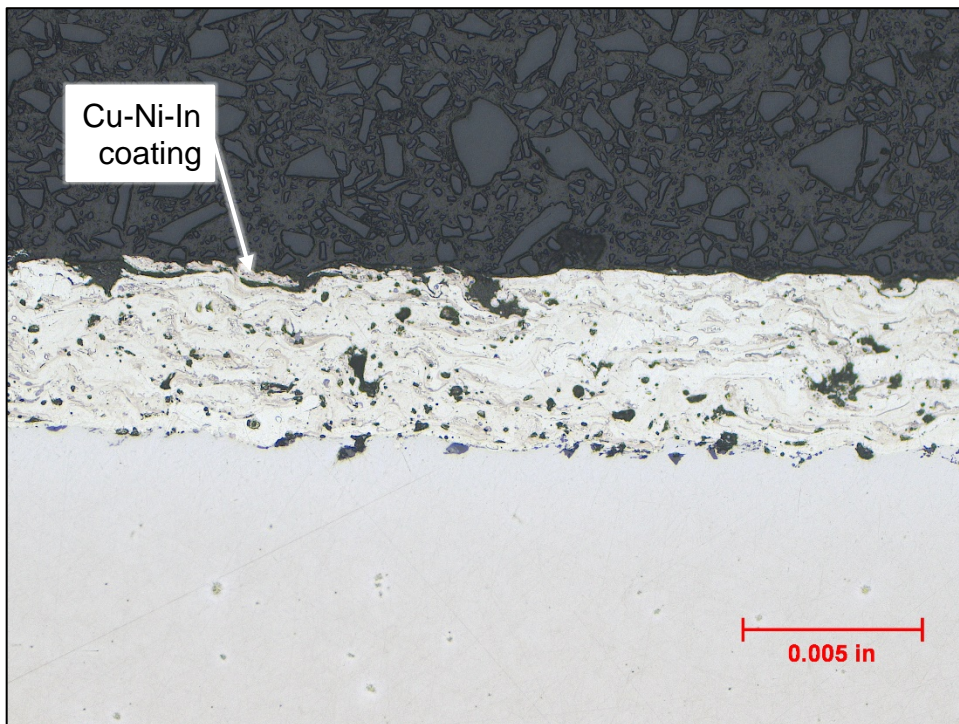
The metallographic samples from the blade 13 dovetail were repolished to obtain a better polish condition on the Cu-Ni-In coating, and the coating was examined in the as-polished condition. The Cu-Ni-In surface coating was intact and present on the contact faces at both the convex and concave sides of the dovetail. A typical view of the coating is shown in figure 23 showing the coating near the middle of the convex contact face on the middle metallographic sample. Relatively large grit-blast particles such as the particle shown in figure 24 were observed at the interface between the coating and the substrate in a few areas. The grit-blast media used on the dovetail surface before coating during the last blade repair was 70-grit aluminum oxide.

Figure 23. Micrograph of the Cu-Ni-In coating near the middle of the contact face on the convex side of the cross-section shown in the previous figure.

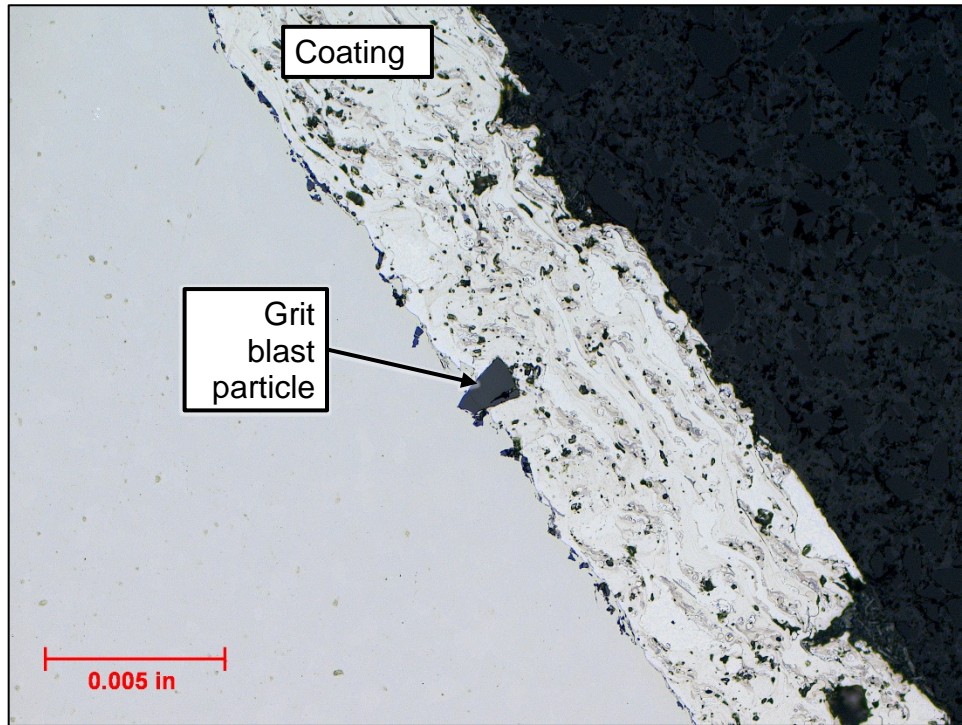
Figure 24. Concave side of the coating showing a relatively large grit-blast particle embedded in the surface.

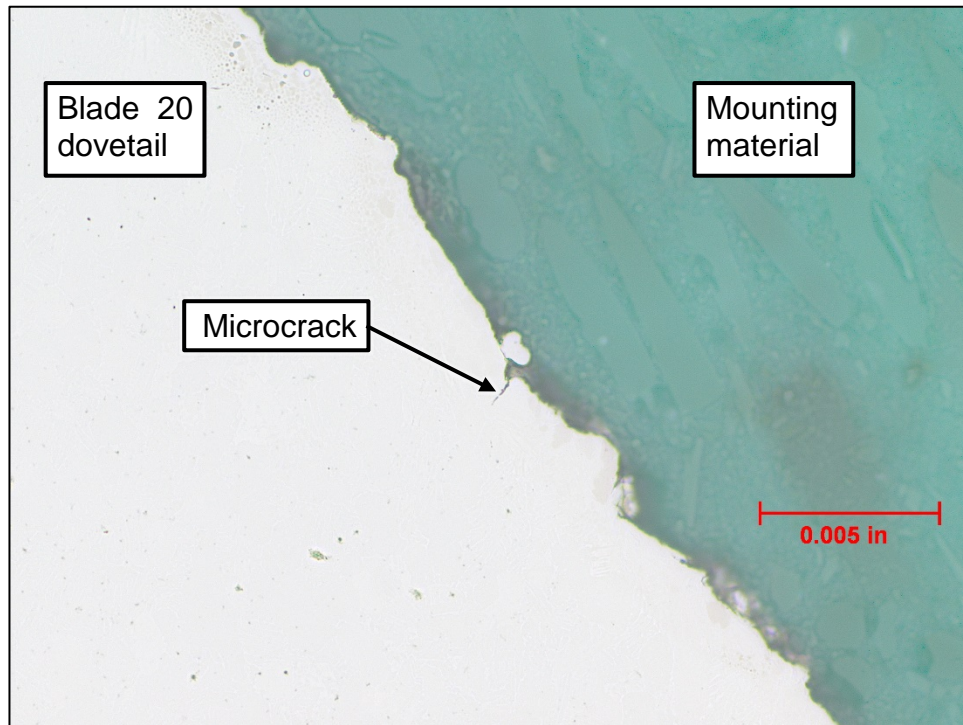
The root end of blade 20 that had been examined using the SEM was sectioned to prepare a metallographic examination of the cross-section approximately 0.5 inch aft of the leading edge. A view of the blade 20 piece after sectioning is shown in figure 25. The specimen was mounted in a polymer material and was polished to facilitate an examination of the cross-section at the convex surface for evidence of microcracks. No crack features were observed after the first polish, but the sample was repolished from the grinding step (120 grit) and reexamined. In the repolished sample, one microcrack was observed as shown in figure 26. The microcrack had a depth of 0.001 inch in the plane of the polish and was located 0.61 inch from the root end face.

Figure 26. Microcrack in the grit-blast region of the convex face in the as-polished cross-section of blade 20 in the transverse plane shown in the previous figure.

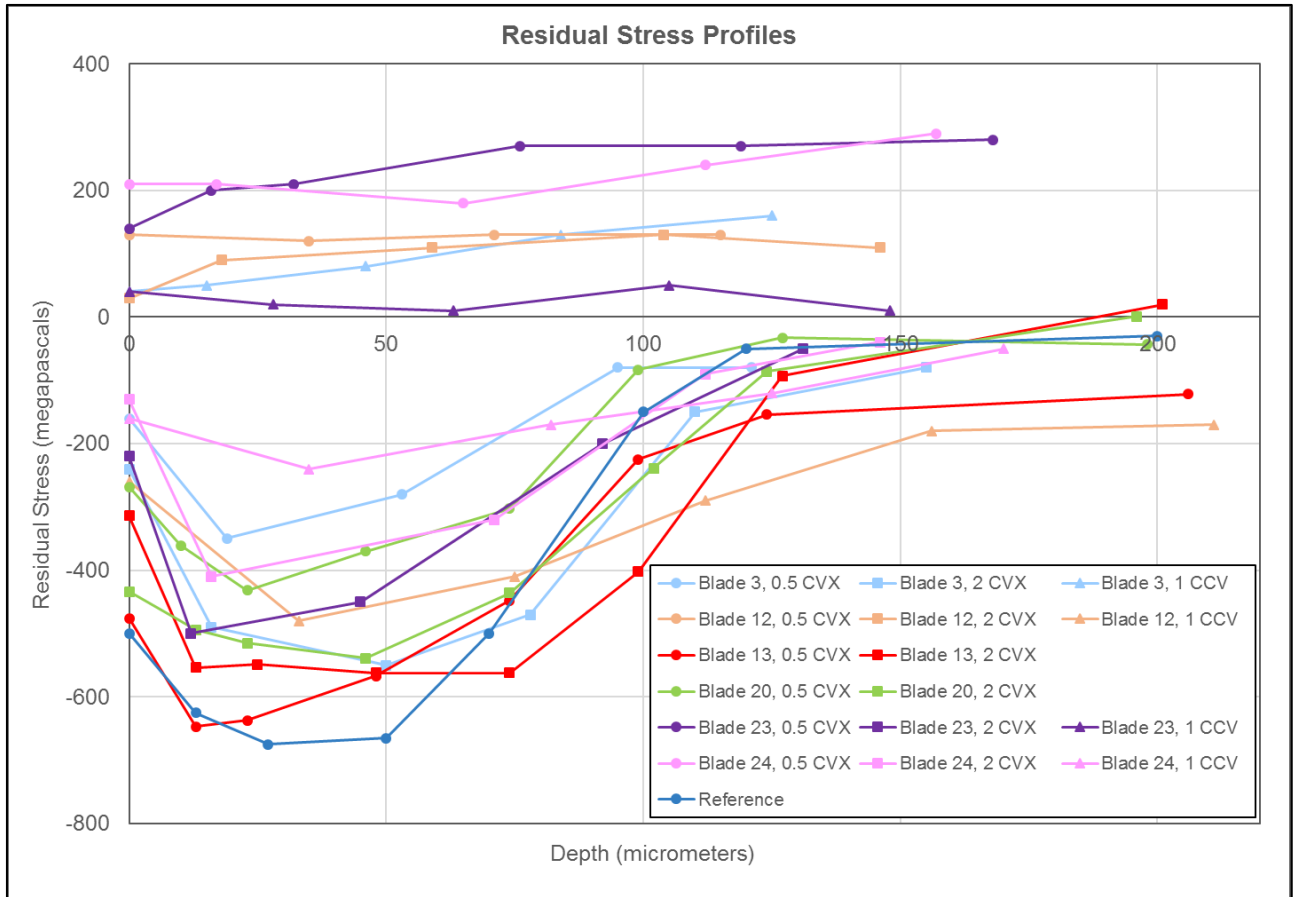
Results of the residual stress measurements are shown plotted in figure 27. Abnormal residual stress profiles including residual tension near the surface were observed in one or more locations on each of the intact blades tested from the accident engine when compared to the reference profile. Minimum residual stress values (most compressive) from the residual stress profile measurements are listed in table 4. In many cases, the minimum residual stress value was higher (less compressive) than the expected minimum value, which is expected to be no greater than -500 megapascals. In table 4, the residual stress profiles with a minimum residual stress value that was above -500 megapascals (abnormal profile) are highlighted in yellow, and the profiles with a minimum residual stress value below -500 megapascals (expected profile) are

Figure 27. Residual stress profiles for fractured blade 13 and intact blades 3, 12, 20, 23, and 24. In the legend, identifiers 0.5 CVX, 2 CVX, and 1 CCV after the blade number indicate measurement locations with distance in inches from the leading edge on the convex (CVX) side or from the trailing edge slot on the concave (CCV) side. The reference residual stress profile is also shown for comparison.

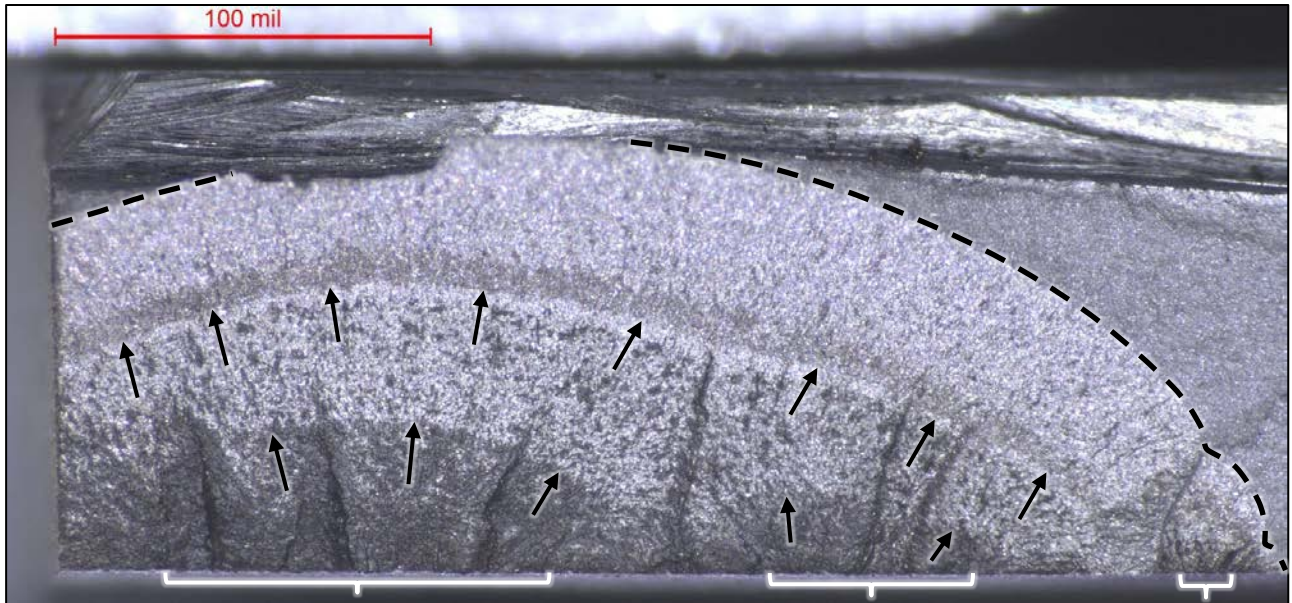
unlabeled arrows in figure 28. The first and second crack arrest lines extended up to approximately 0.040 inch deep and 0.073 inch deep, respectively.

Figure 28. Overall view of the crack fracture surface of blade M after opening by lab fracture. Dashed lines indicate the crack boundary. Unlabeled brackets and arrows indicate the location of fatigue origins and crack arrest lines, respectively. Photo courtesy of GE Aviation.

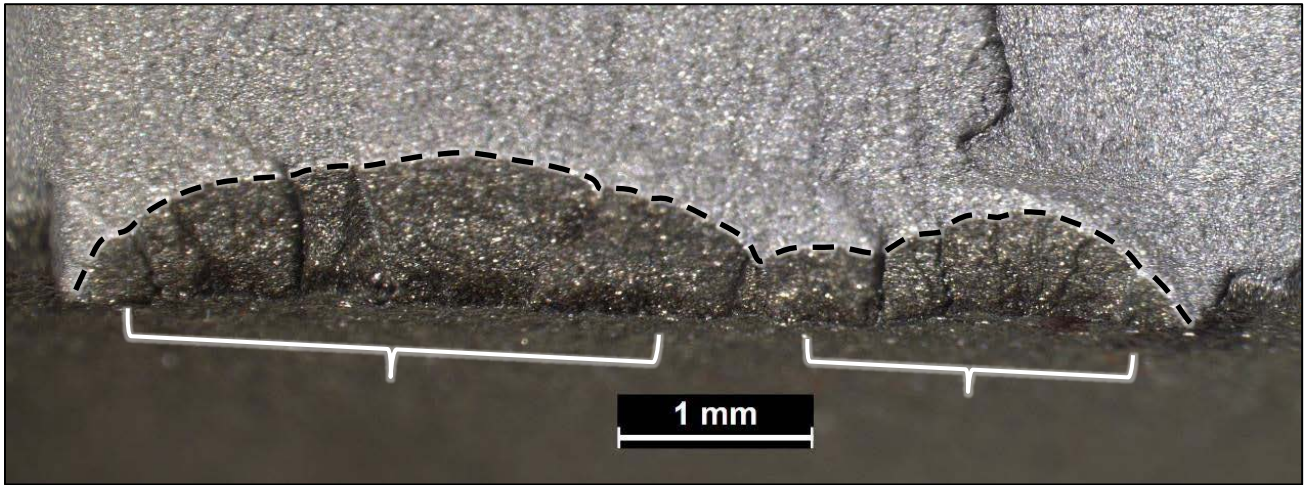
Figure 30. Overall view of the crack fracture surface of blade N after opening by lab fracture. Dashed lines indicate the crack boundary. Unlabeled brackets indicate the location of fatigue origins. Photo courtesy of Safran Aircraft Engines.

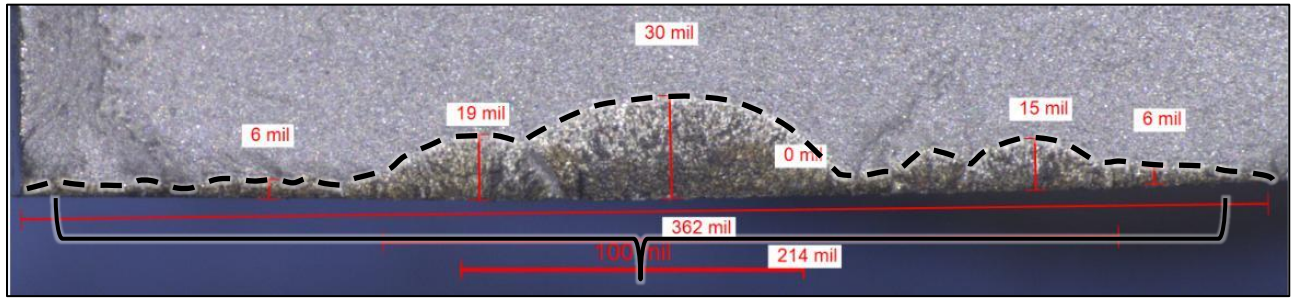
Figure 32. Overall view of the crack fracture surface of blade O after opening by lab fracture. A dashed line indicates the crack boundary, and an unlabeled bracket indicates the location of fatigue origins. Photo courtesy of GE Aviation.
