NATIONAL TRANSPORTATION SAFETY BOARD

Materials Laboratory Factual Report 18-049

MATERIALS LABORATORY FACTUAL REPORT

Place : Philadelphia, Pennsylvania
Date : April 17, 2018
Vehicle : Boeing 737-700, N772SW
NTSB No. : DCA18MA142
Investigator : Pierre Scarfo, AS-40

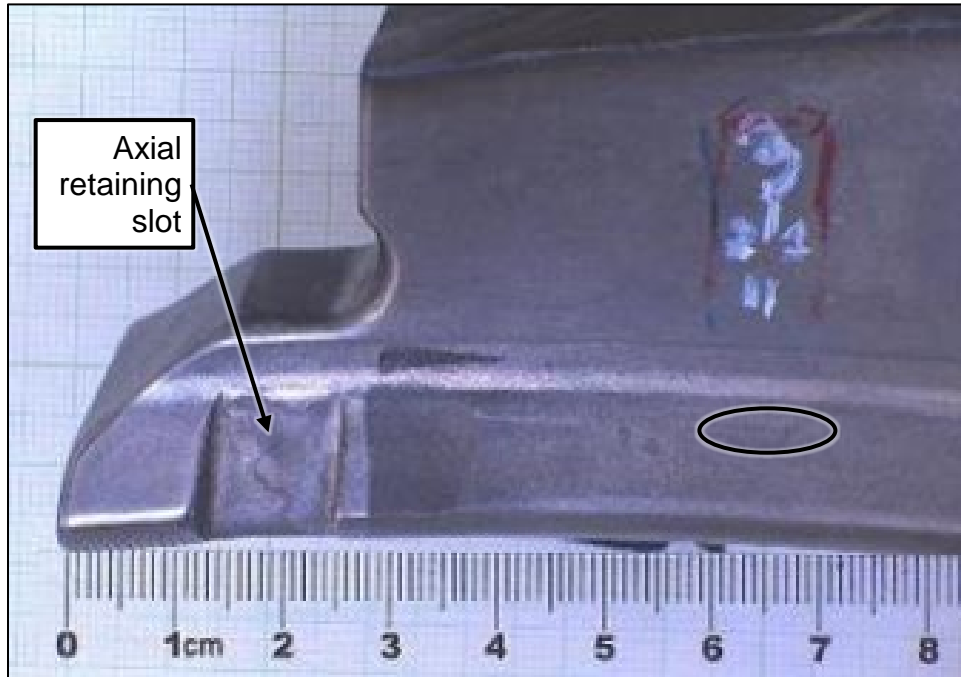
Figure 34. Crack location (circled area) near the aft end of blade P on the concave side contact face. Photo courtesy of Safran Aircraft Engines.

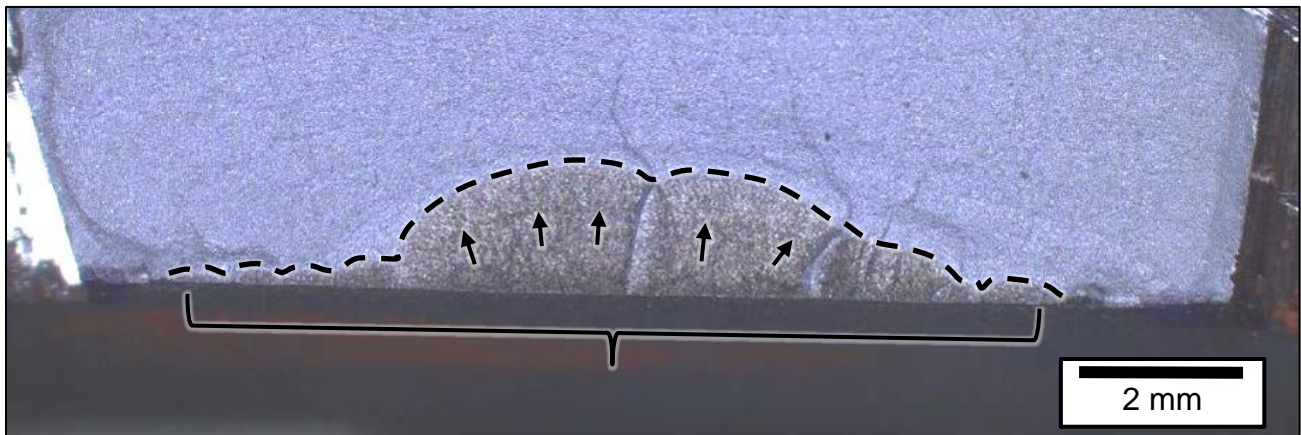
Figure 35. Overall view of the crack fracture surface of blade P after opening by lab fracture. Dashed lines indicate the crack boundary. Unlabeled brackets and arrows indicate the location of fatigue origins and crack arrest lines, respectively. Photo courtesy of Safran Aircraft Engines.
