NATIONAL TRANSPORTATION SAFETY BOARD

MATERIALS LABORATORY FACTUAL REPORT

Report No. 15-013

Place : Clayton, AL
Date : April 3, 2014
Vehicle : Cessna T210L, N1631X
NTSB No. : ERA14LA179
Investigator : Heidi Moats, AS-ERA

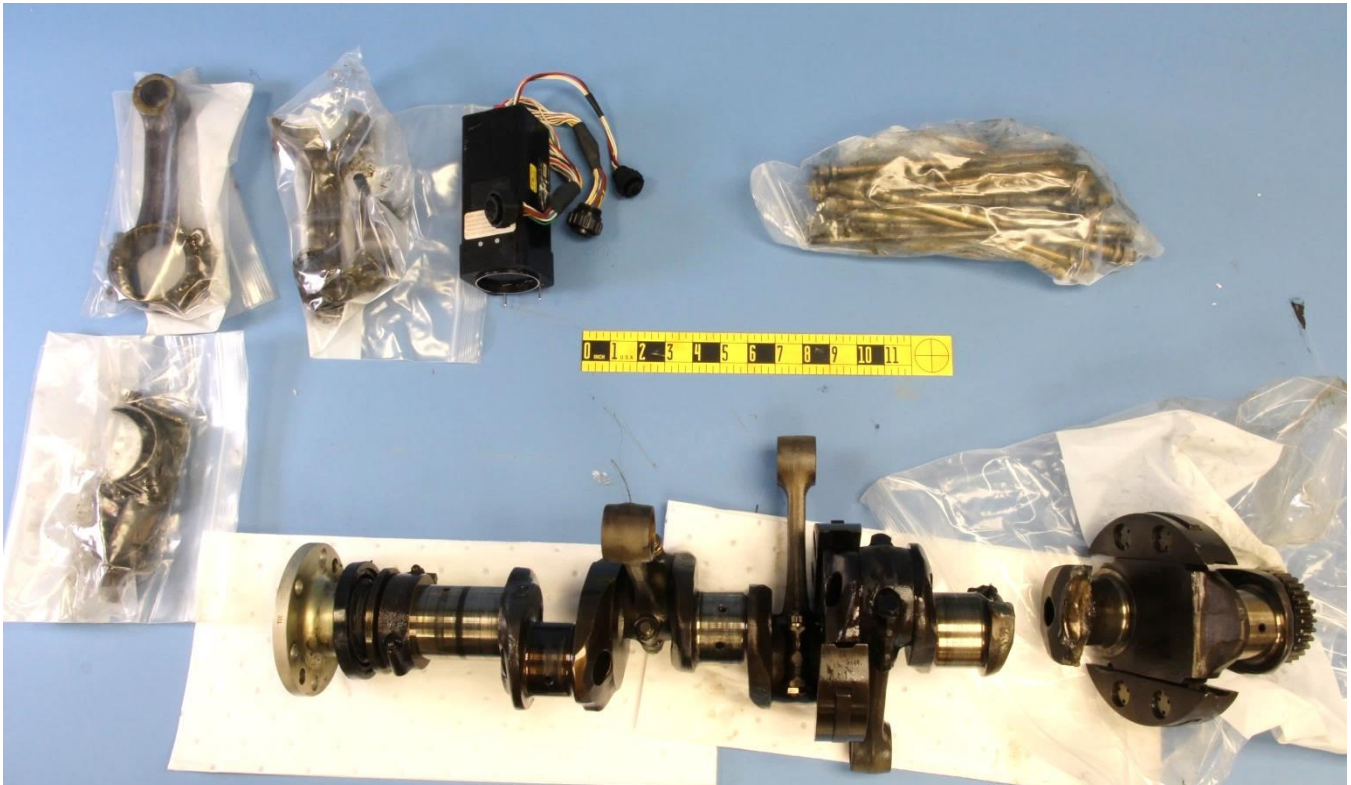
Figure 1 illustrates the fractured crankshaft, piston rods, and bearing pieces, as received. The engine analyzer module in Figure 1 was submitted to the NTSB Vehicle Recorder Division for further investigation.² The crankshaft had fractured at a web just forward of the #2 connecting rod journal and aft of the #2 main rod journal, as shown in Figure 2.³ The mating fracture surfaces of the web are illustrated in Figure 3. The aft fracture surface was battered such that most fracture features were obliterated, consistent with post-fracture damage (see Figure 4). The mating forward face was relatively unsullied, and exhibited crack arrest marks along the surface, as illustrated in Figure 5. These

Figure 1 – The engine components, excluding the engine case halves, as received.

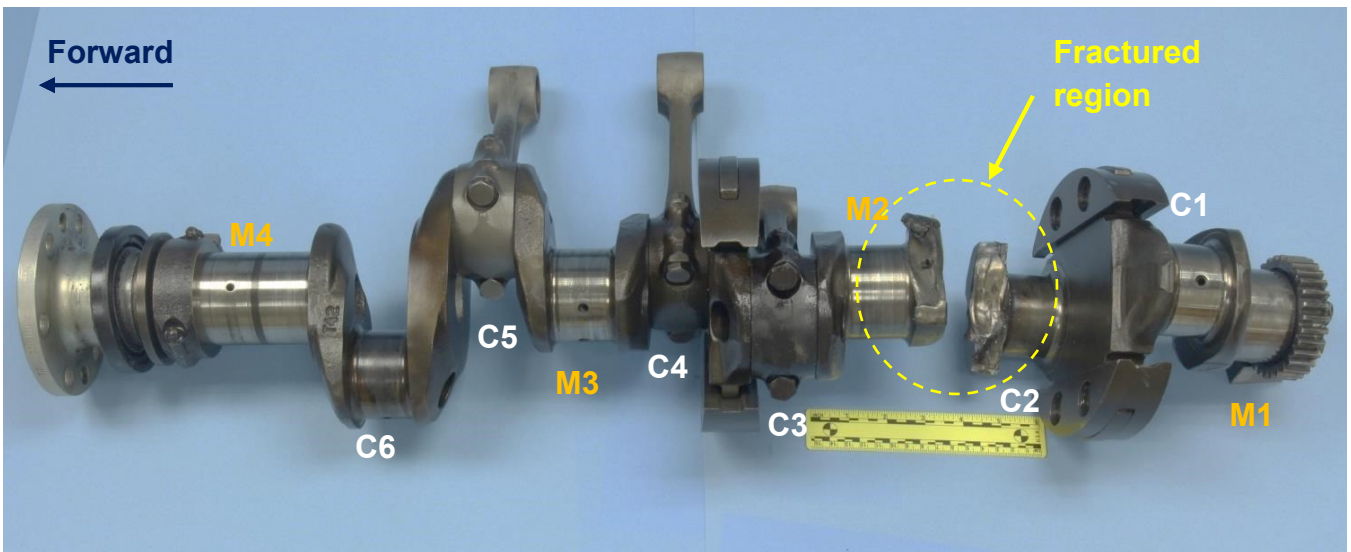
Figure 2 – Both halves of the crankshaft as received. The main journals are labeled “M1” through “M4” in orange text. The connecting rod journals are labeled “C1” through “C6” in white text, right to left.

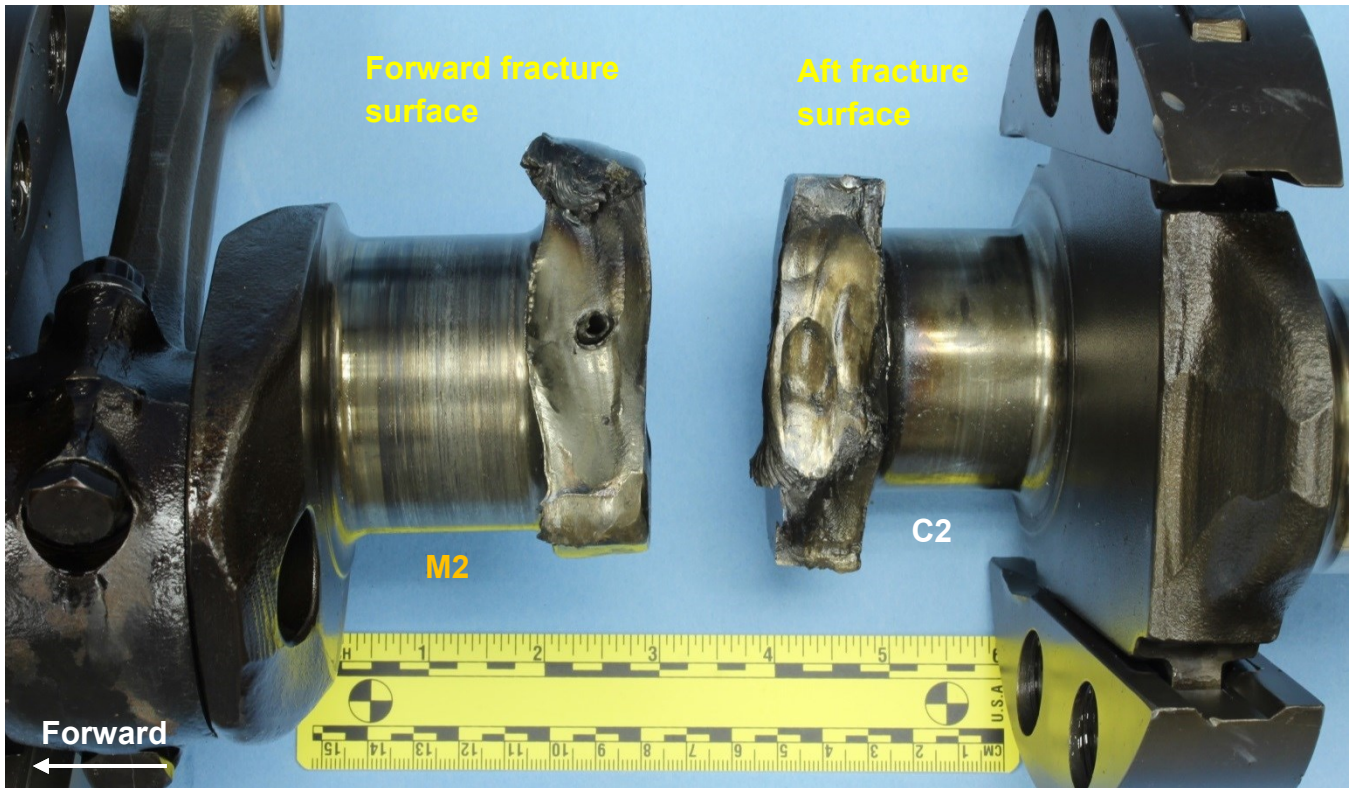
The adjacent crankshaft journal exhibited circumferential wear scars (see Figure 3). The journal surface closest to the aft fracture surface exhibited color changes that ranged from yellow and orange to purple and dark blue, moving aft to forward along the journal surface toward the fracture surface (see Figure 3 and Figure 4).

Figure 3 – The mating fracture surfaces of the crankshaft, as received.

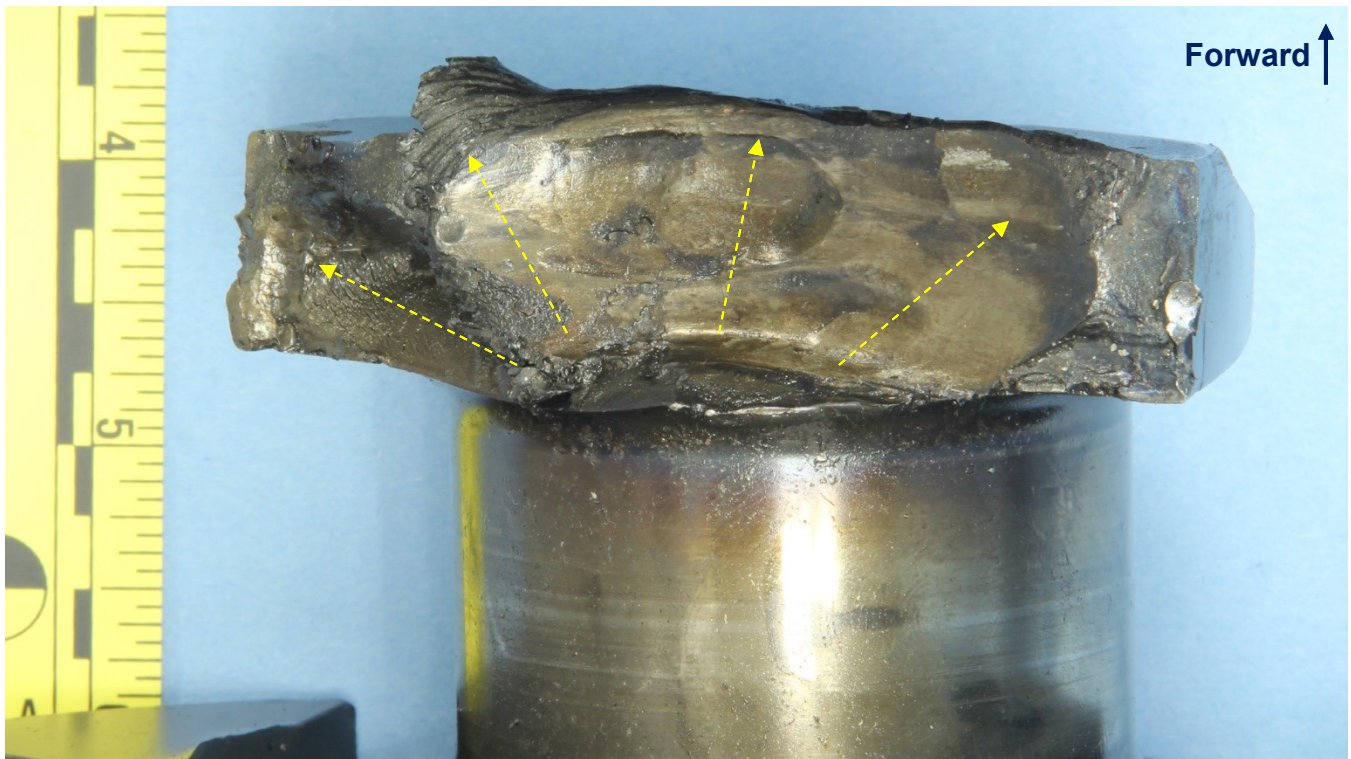
Figure 4 – The aft fracture surface of the web, as received. The surface exhibited batter consistent with post-fracture damage. The dashed lines represent the crack propagation direction.

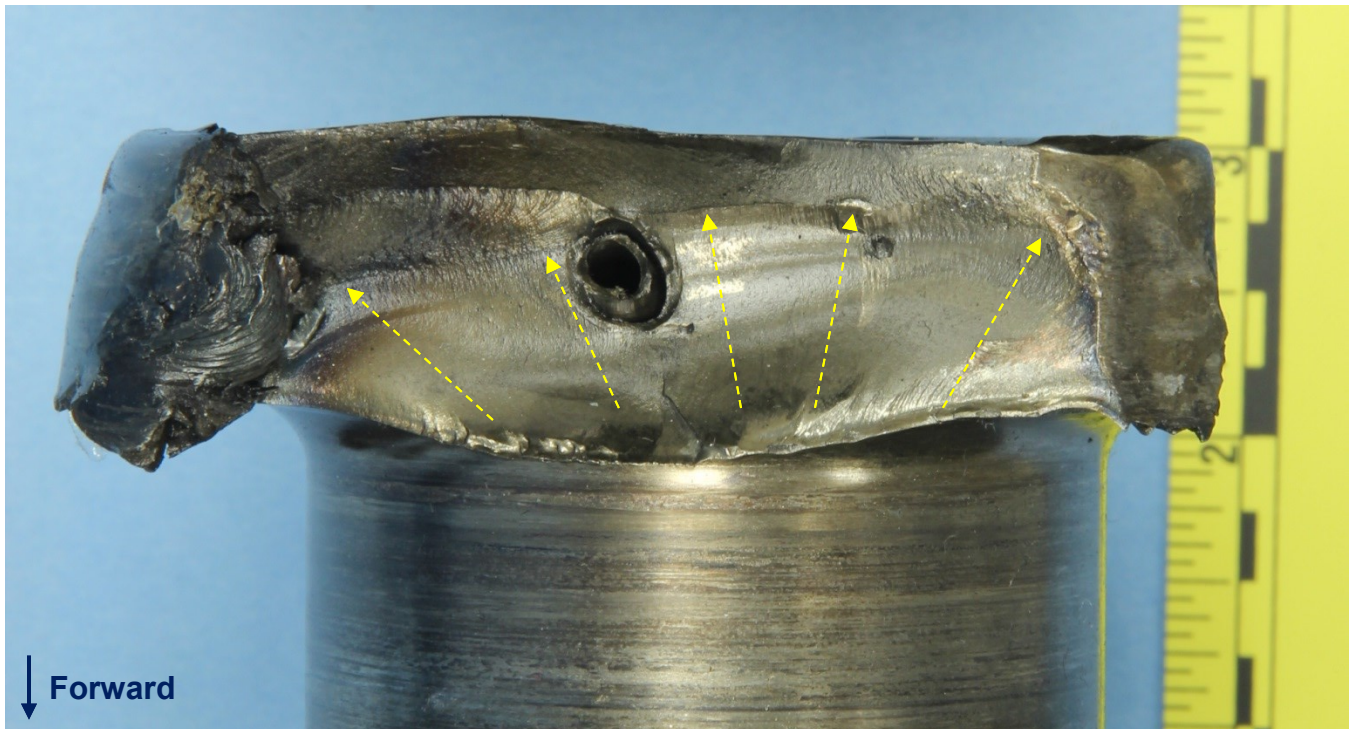
features were consistent with progressive cracking. The forwardmost portion of the fracture (the initial stages of the crack propagation) exhibited small ratchet marks indicative of multiple crack initiation sites.

Figure 5 – The forward fracture surface of the web, as received. The fracture surface exhibited crack arrest marks and ratchet marks. The dashed lines represent the crack propagation direction.

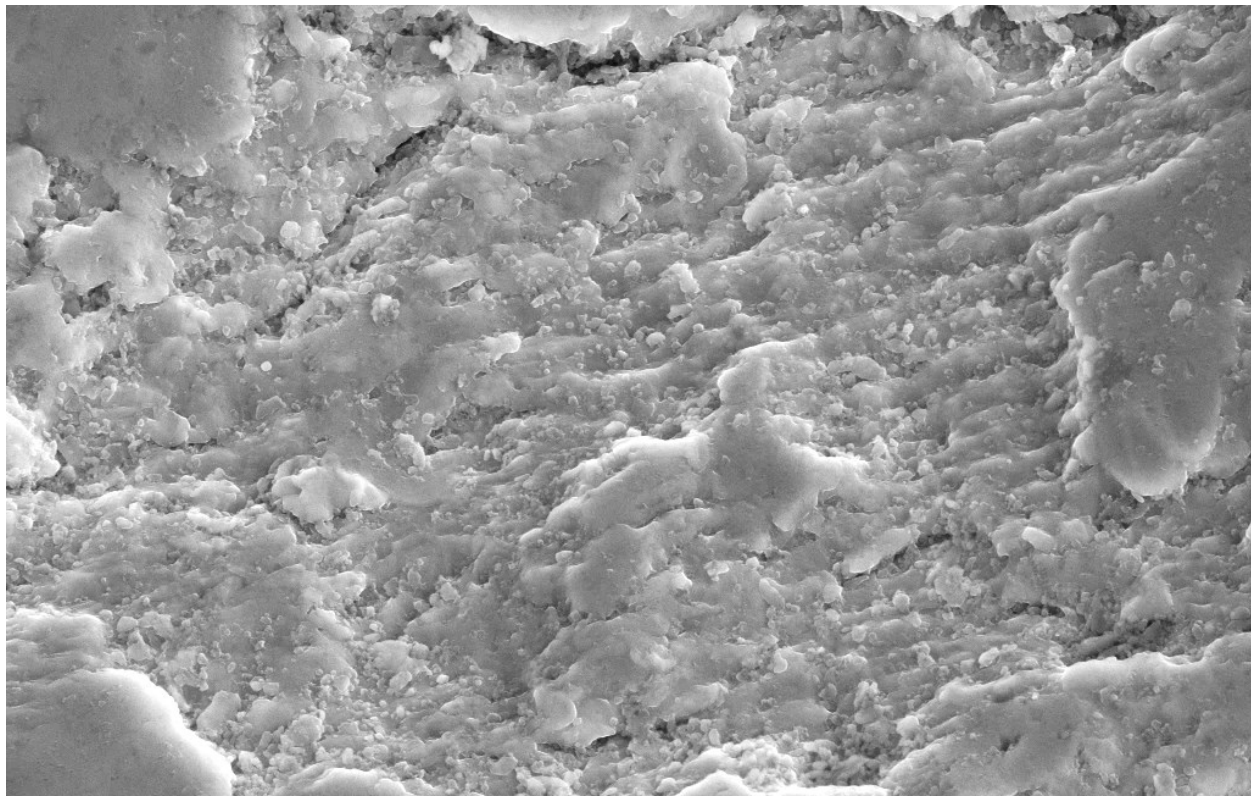
The web fracture was examined using a scanning electron microscope. As shown in Figure 6, the fracture surface exhibited fatigue striations consistent with fatigue crack propagation. The crack initiation sites are displayed in Figure 7. The initiation sites were smooth, with no indications of material defects such as inclusions, pits, or voids. There were no machine marks in these areas or along the journal fillet shown to have initiated cracks.

Figure 6 – Secondary electron (SE) micrograph of fatigue striations on the web forward fracture surface.

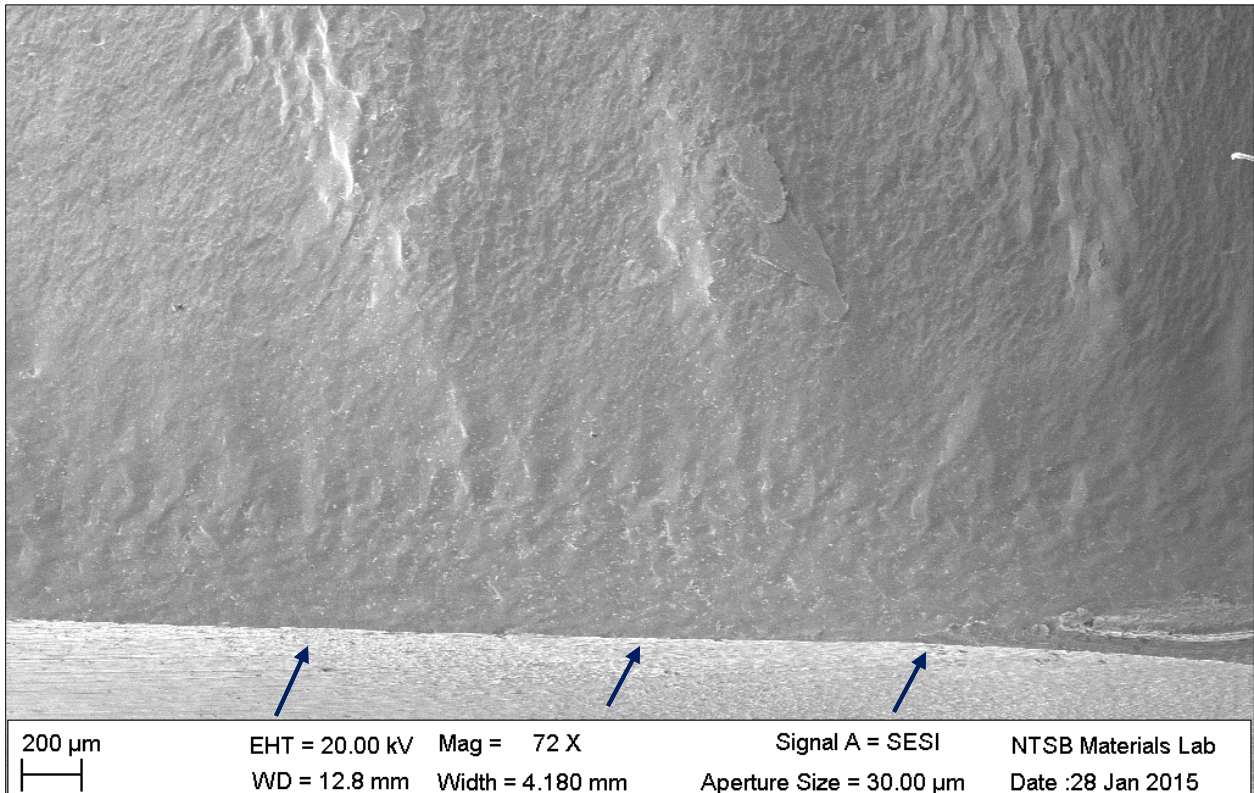
Figure 7 – SE micrograph of the fatigue crack initiation site on the web forward fracture surface (arrow).

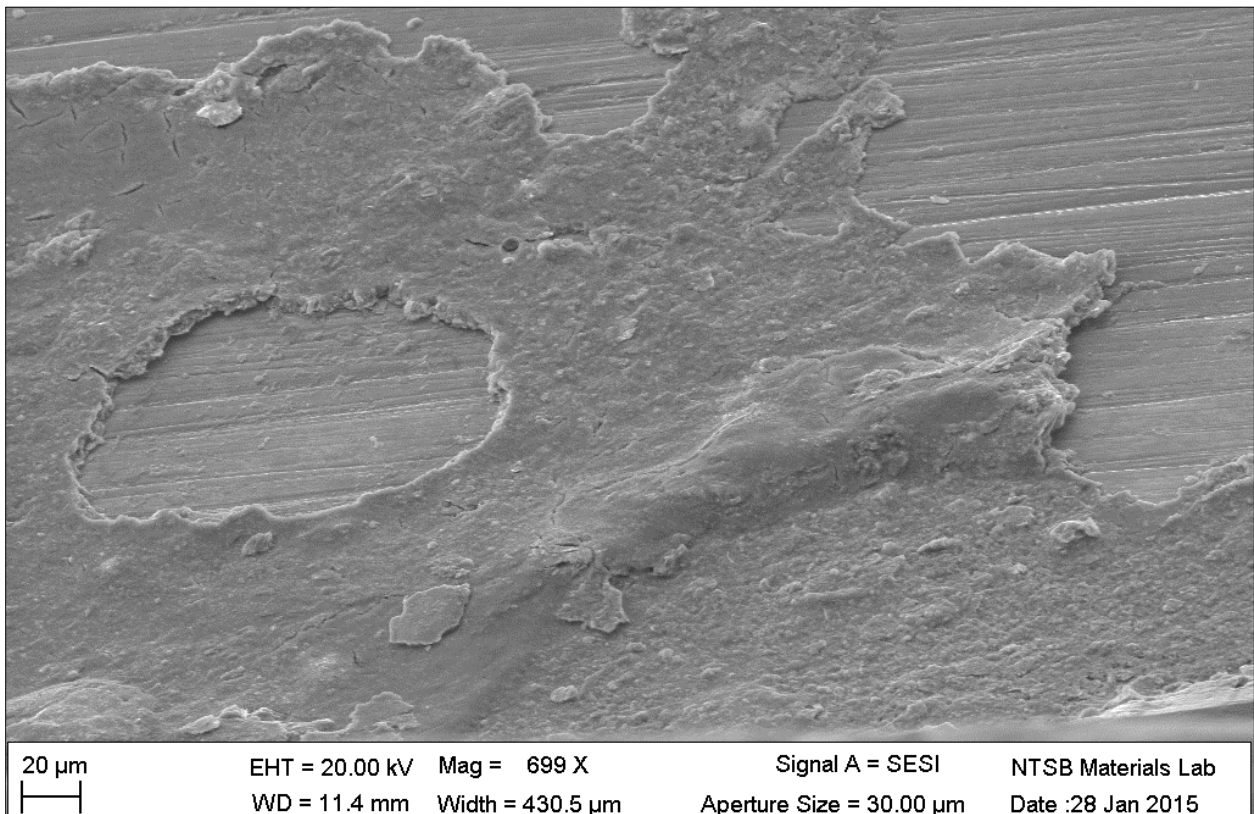
Along the bearing journal surface just forward of the fatigue crack initiation sites, there were material deposits associated with galling wear (Figure 8). The chemical composition of this material was inspected using energy dispersive x-ray spectroscopy (EDS). This galled material was consistent with babbitt material typical of bearing materials using in airplane piston engines. In contrast, the material of the bearing journal and crankshaft were consistent with alloy steel.

Figure 8 – SE micrograph of galled material deposits on the bearing journal aft of the web forward fracture initiation point.

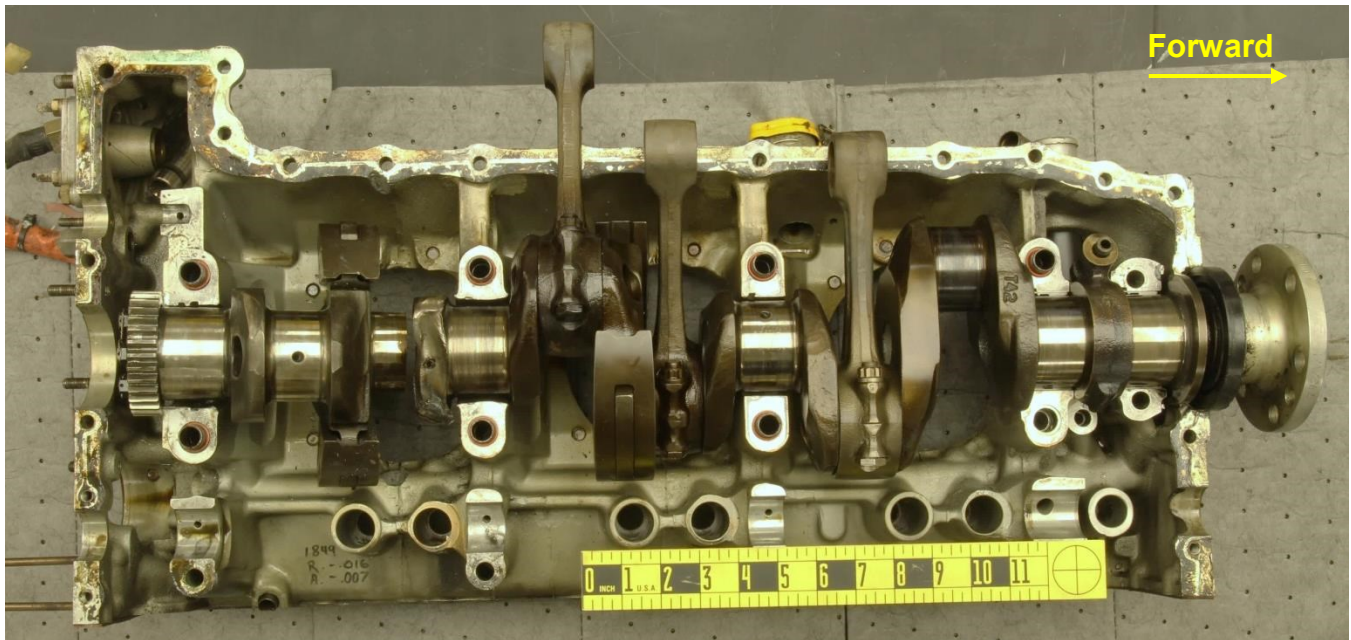
Figure 9 shows the left half (aft looking forward) of the engine case with the fractured crankshaft placed in its working position. The fracture in the crankshaft web corresponded with the location of the #1 cylinder. The interior surfaces of both case halves exhibited smearing and impact damage consistent with the location of the crankshaft fracture (see Figure 10). The aftmost main bearing journal of the case exhibited outward plastic deformation along the edges. In addition, the bearing surface exhibited circumferential material spalling (see Figure 10a).

Figure 9 – The left half of the engine case, with the crankshaft placed in its previous location.

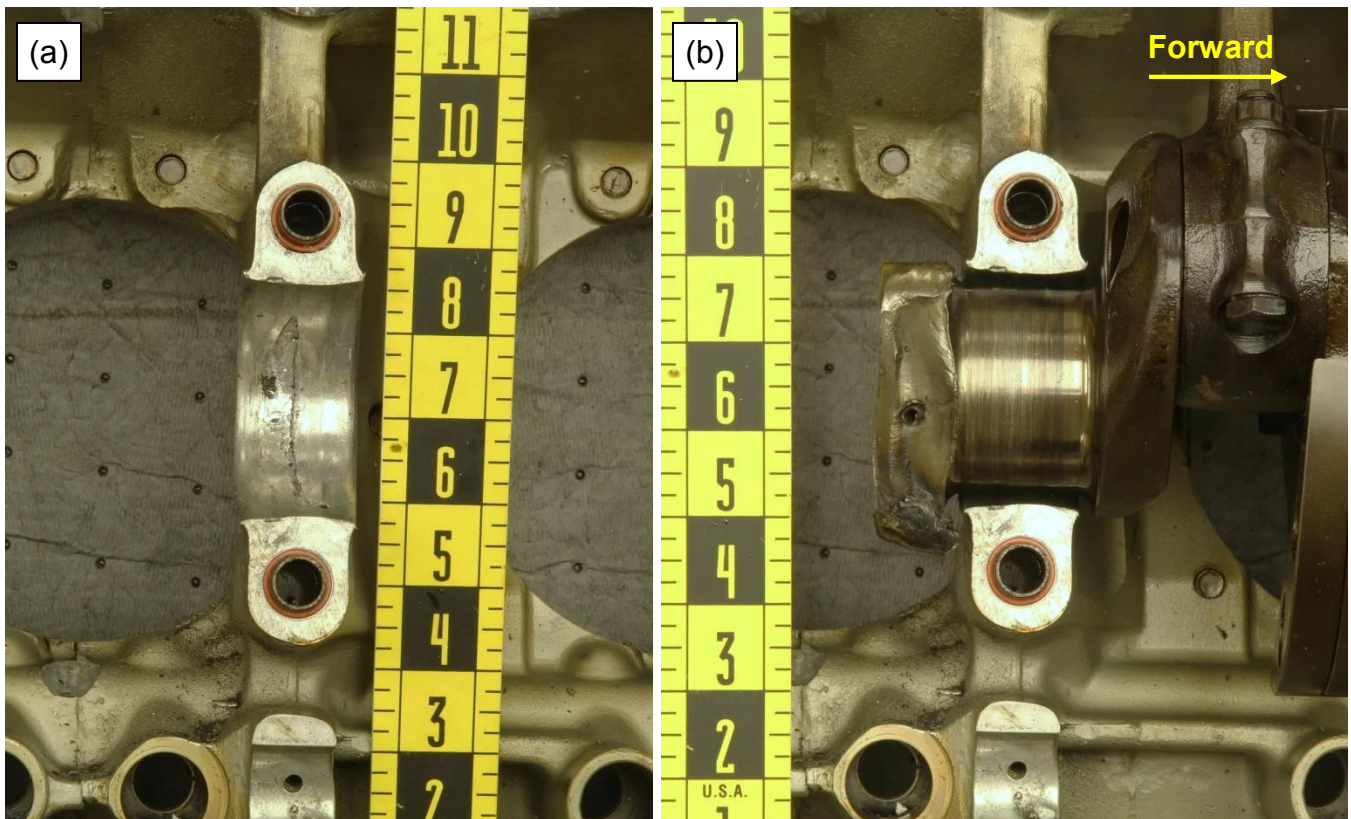
Figure 10 – The second main bearing journal of the left case (a) without the crankcase and (b) with the crankcase in position.

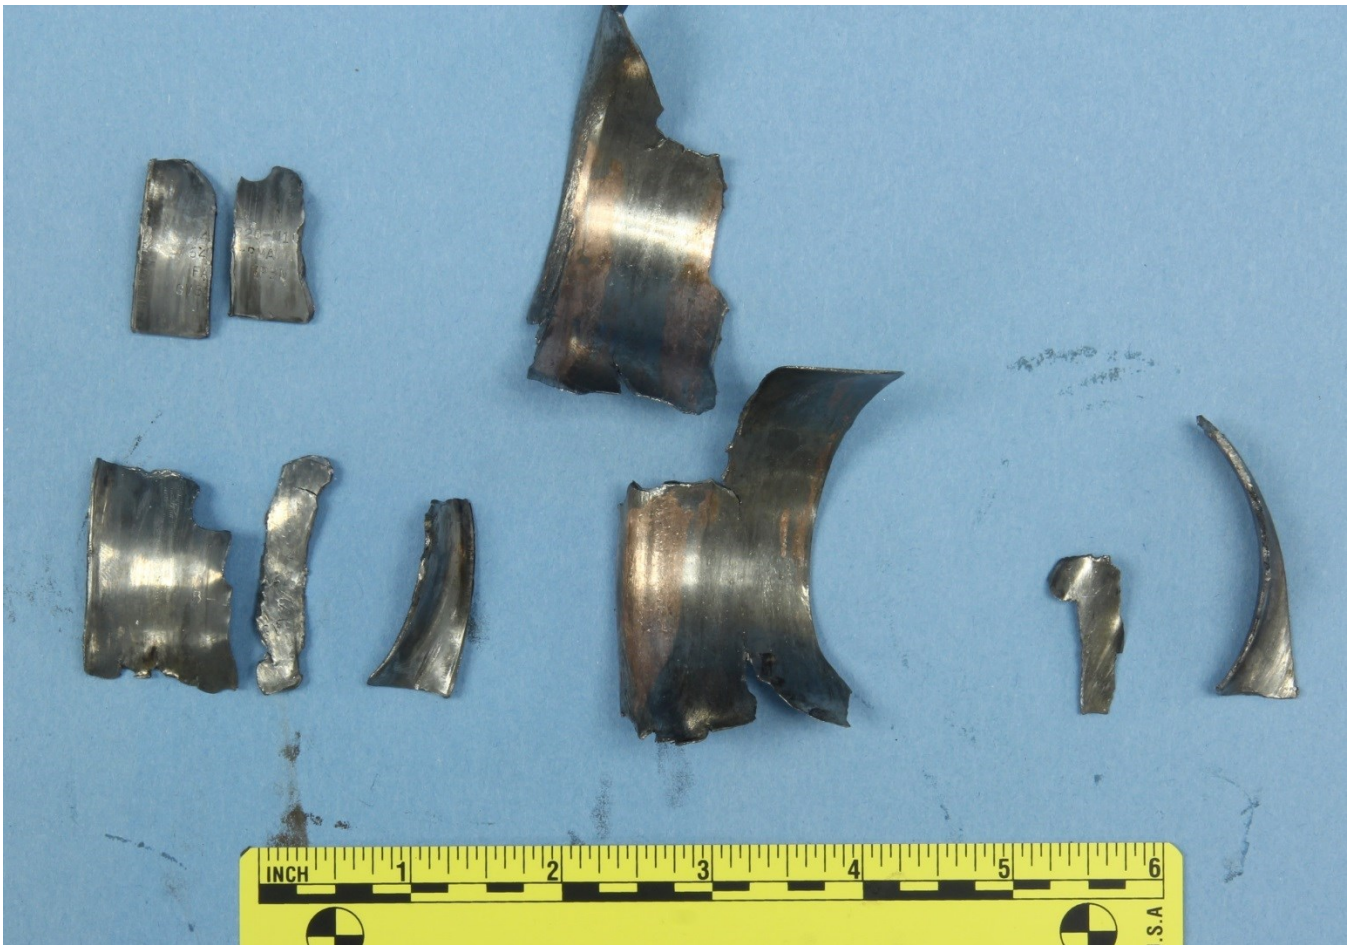
The remnants of the babbitt material are illustrated in Figure 11. These components, which were comprised of layers of multiple materials, had been crushed and mixed together. Two of these crushed components exhibited a rounded lip, consistent with the aft bearing edge smeared on the second main bearing in Figure 10a.

Figure 11 – Bearing pieces from the main bearing position in Figure 10, after cleaning.

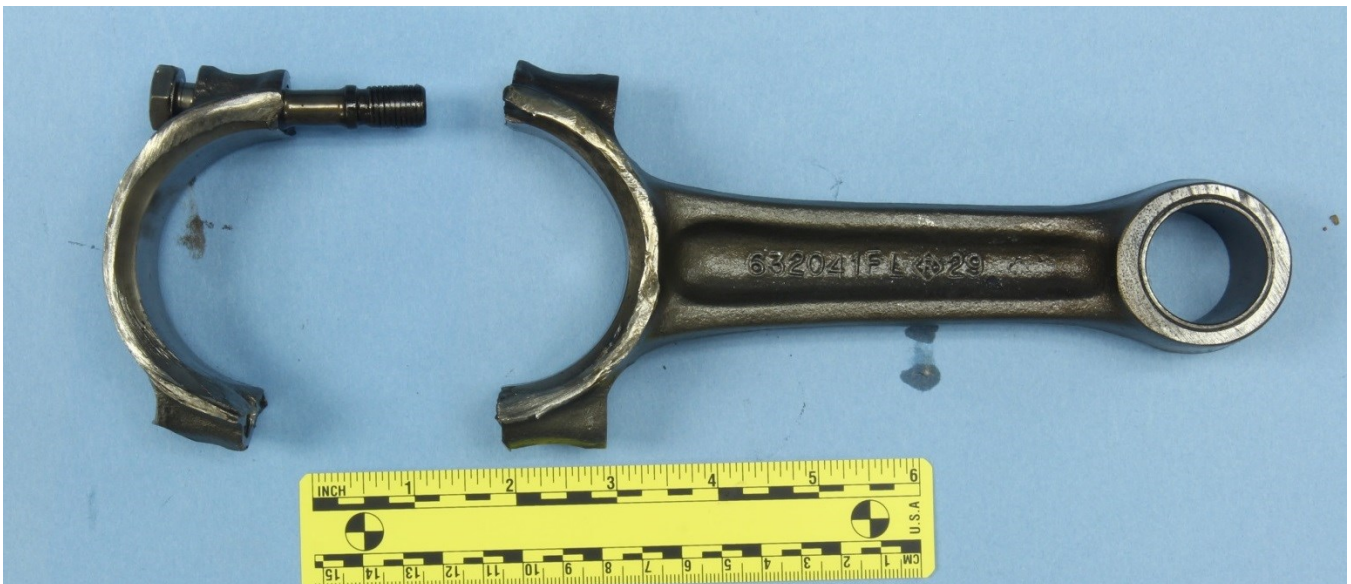
Figure 12 shows the #2 connecting rod, as received. This connecting rod exhibited the most damage of the two submitted—the aft side faces of the cap and rod yoke exhibited smearing and impact damage. The bearing surfaces of the rod and cap exhibited circumferential wear scars and indications of material spalling. The bearing material near the bolt holes exhibited smearing.

Figure 12 – Portions of the #2 connecting rod and rod cap assembly, as received.

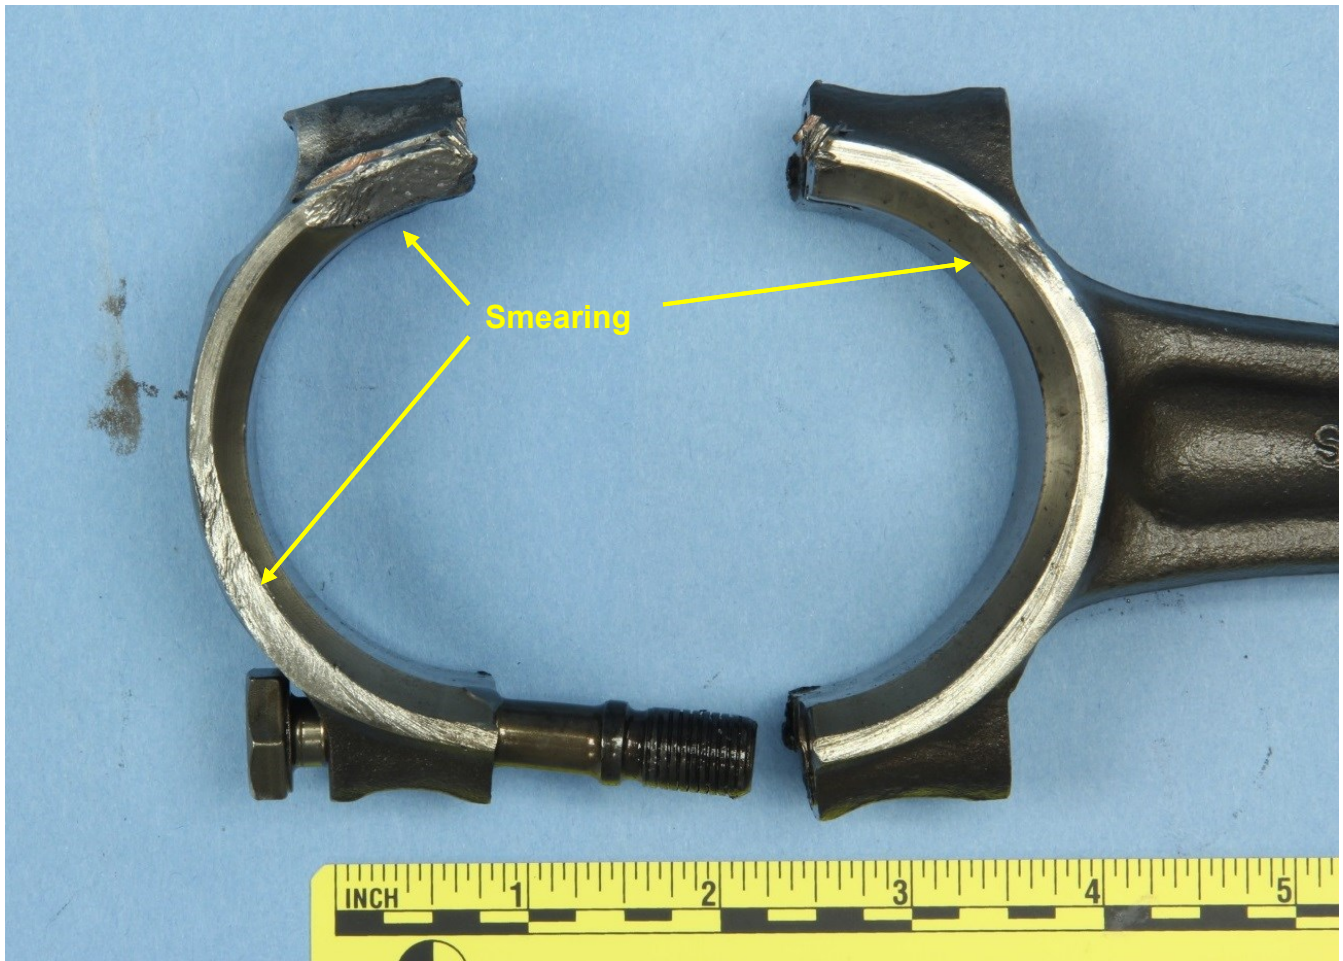
One of the bolts for the #2 connecting rod cap was intact, but bent outboard; the other bolt had fractured (see Figure 13 and Figure 15, respectively). The fractured bolts exhibited a fracture surface with a 45° slant and local plastic deformation. Figure 16 illustrates the fracture surface of the bolt. The fracture exhibited a dull gray luster, with a rough surface and radial patterns consistent with a fracture direction from left to right in the

Figure 13 – The connecting rod and cap, viewed opposite of Figure 12. Smearing damage was present on the aft side flat surfaces. The rod bolt (bottom of figure) was bent outward.

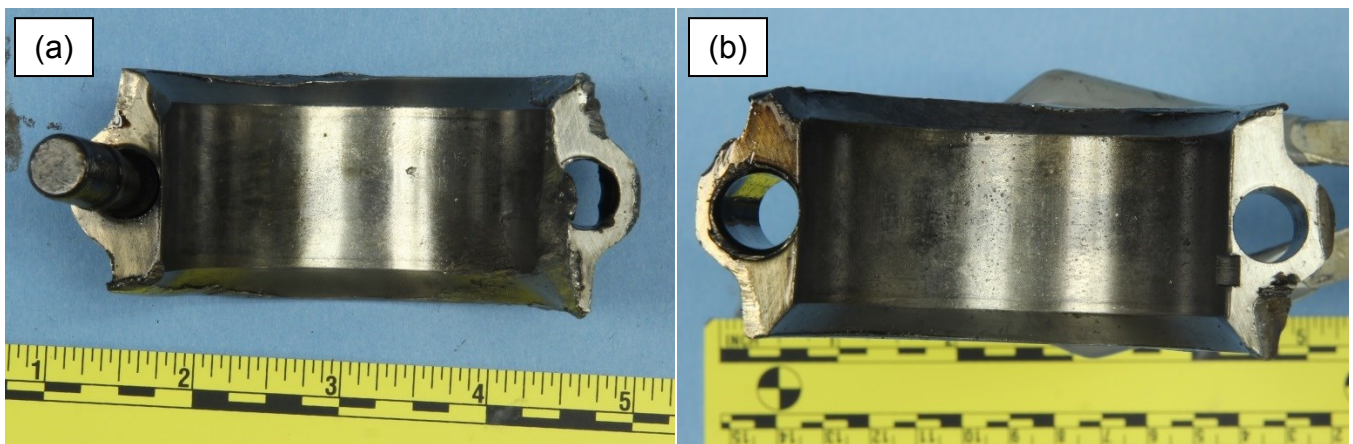
Figure 14 – The bearing surfaces of the #2 (a) connecting rod cap and (b) the connecting rod.

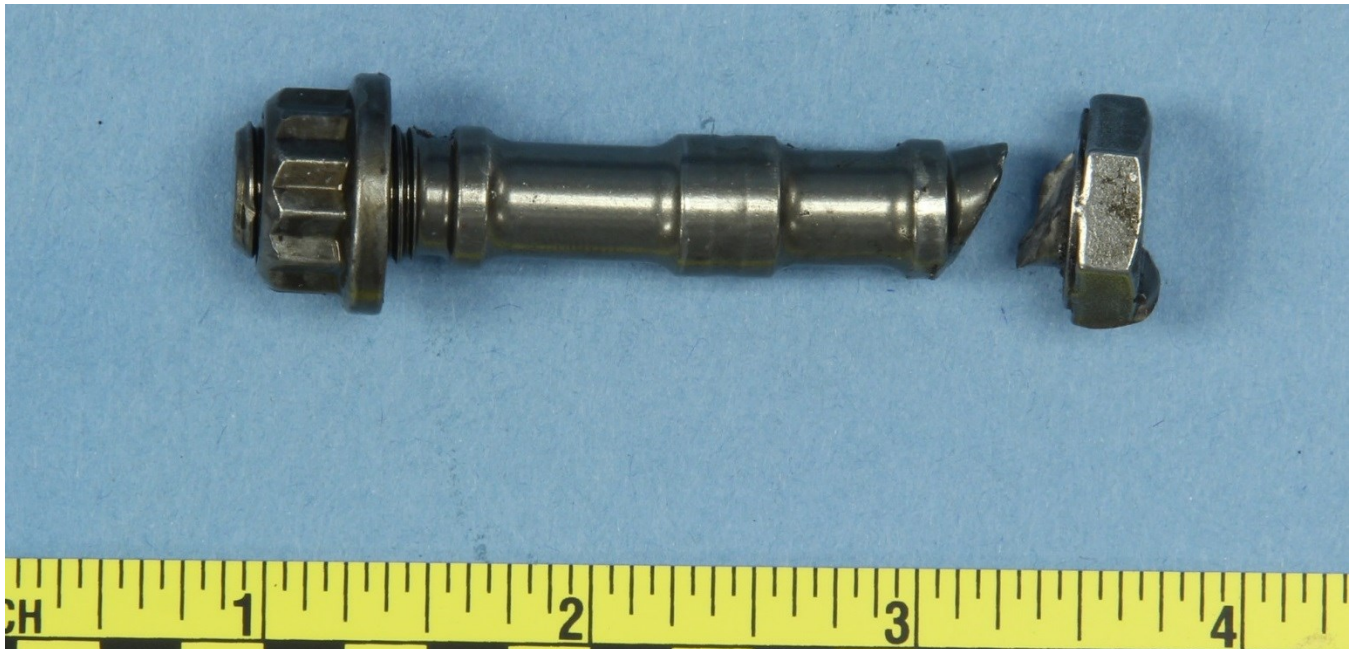
Figure 15 – The fractured rod bolt pieces from the #2 connecting rod. The bolt had fractured on the right.

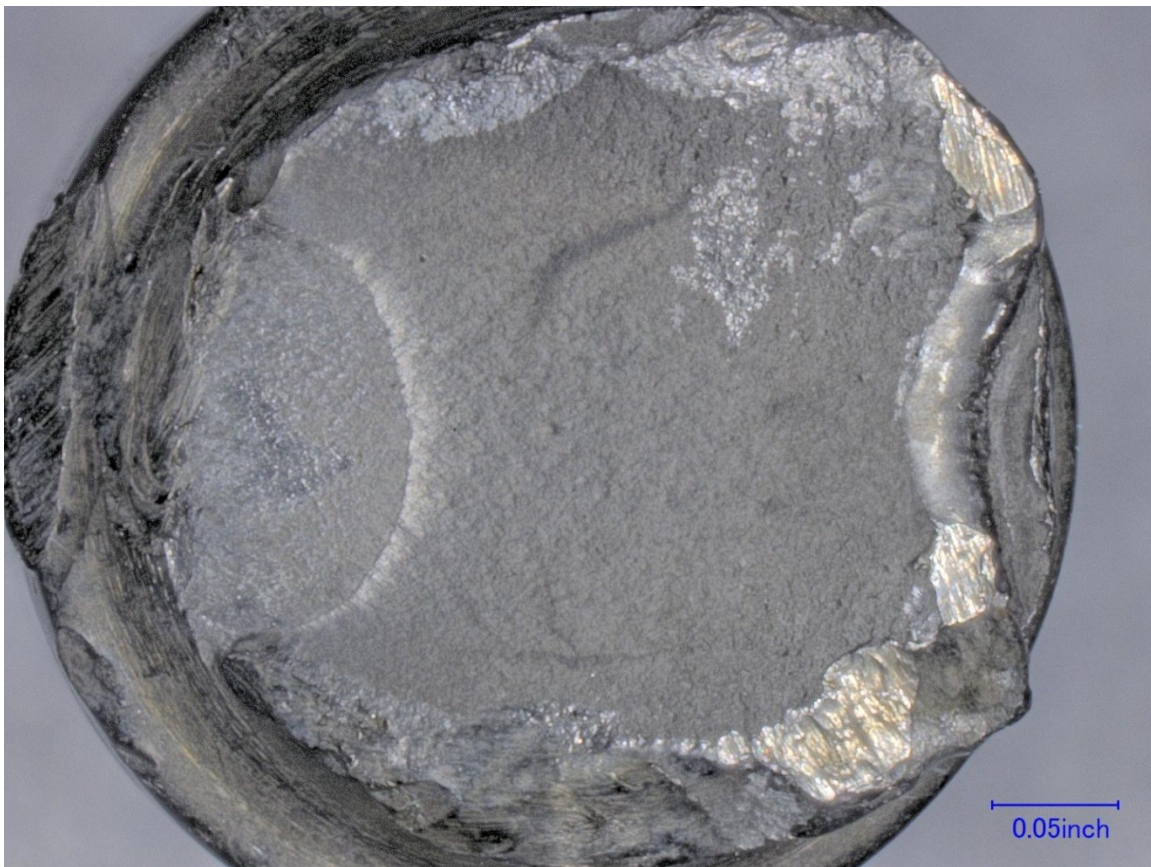
Figure 16 – The fracture surface of the broken rod bolt from the #2 connecting rod.

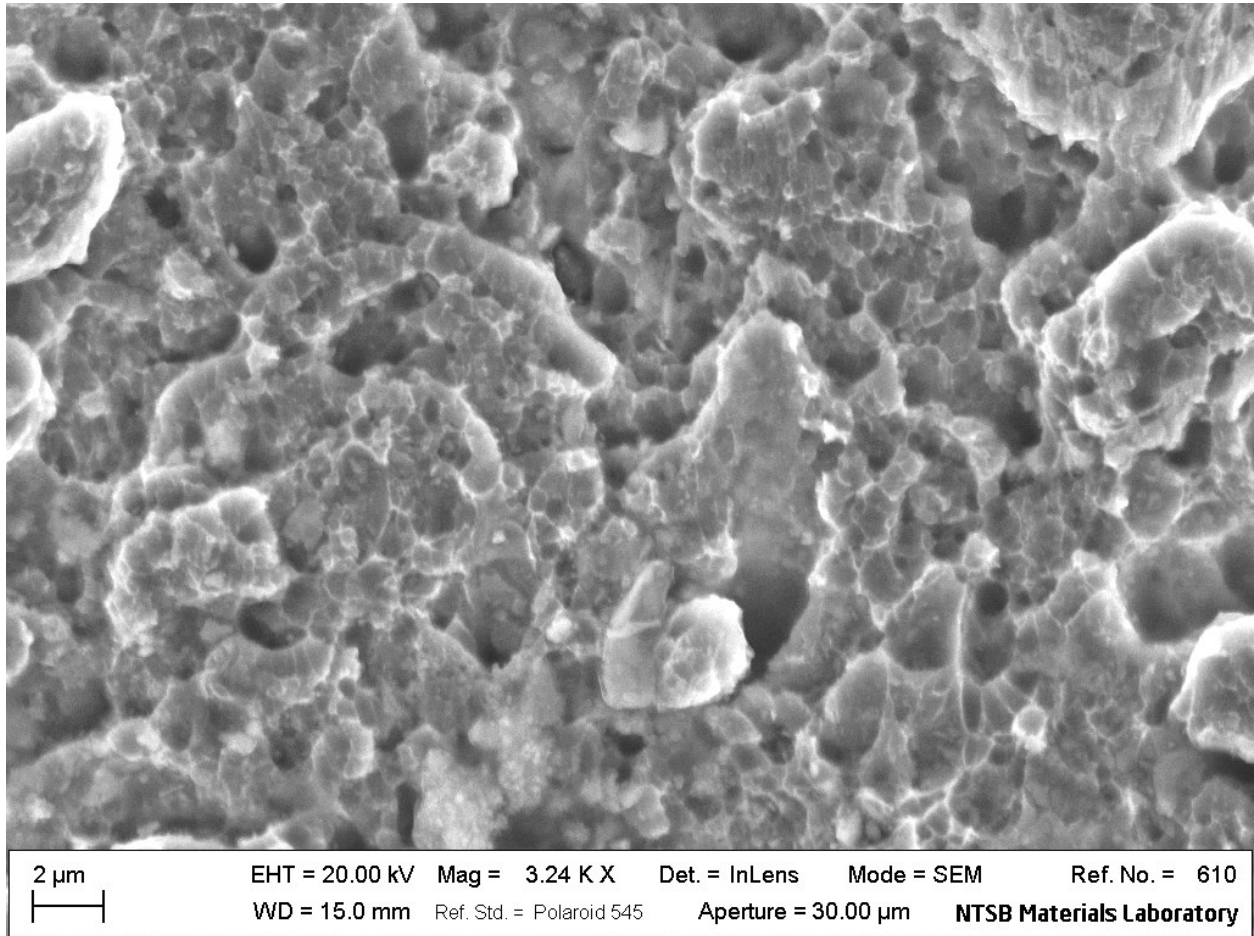
figure. Examination using a scanning electron microscope found the fracture surface to exhibit dimple rupture (Figure 17). These fracture features were consistent with failure by tensile overstress.

Figure 17 – SE micrograph of the fracture surface of the bolt in Figure 16, showing dimple rupture.

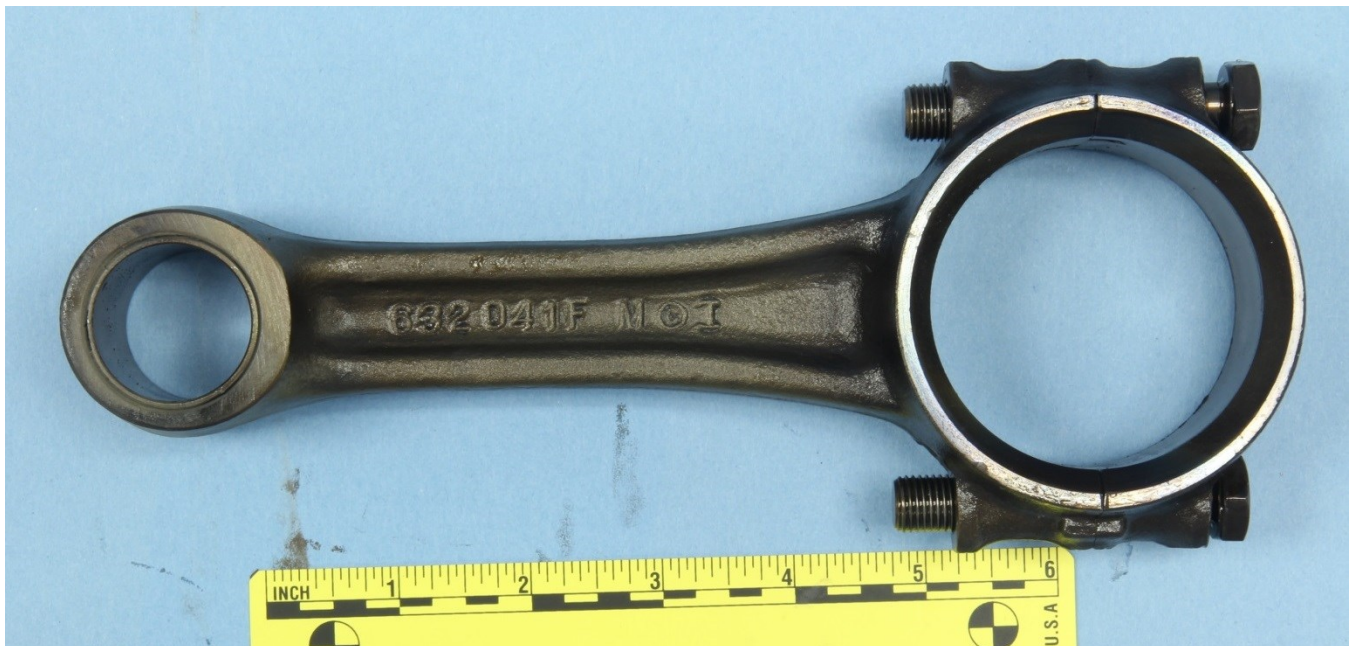
Figure 18 illustrates the #6 connecting rod and cap, as received. These components were in relatively good condition, and they exhibited no indications of macroscopic damage or deformation. Both bolts for the rod cap were intact with no indications of deformation or thread wear.

Figure 18 – The #6 connecting rod and cap, as received.

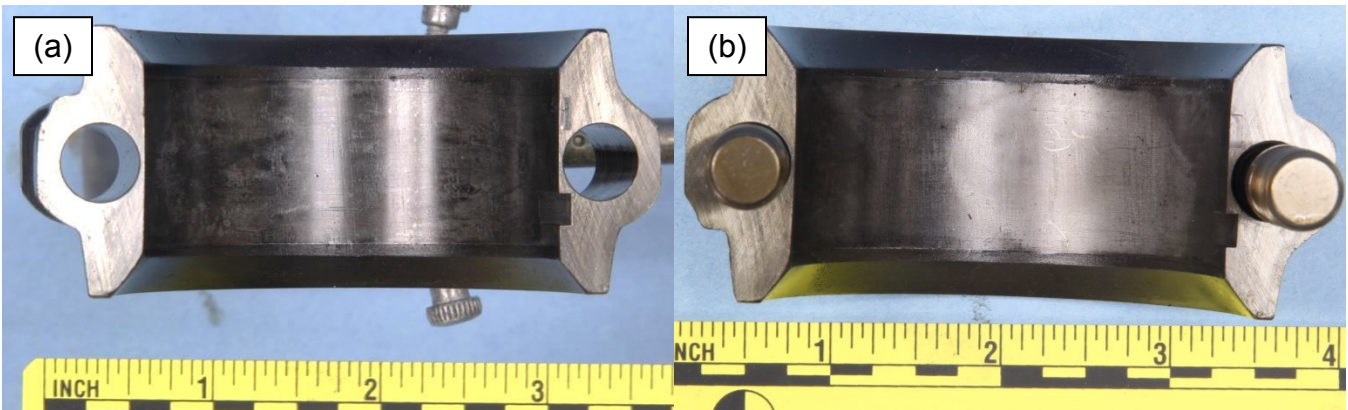
The bearing surfaces of the rod and cap exhibited circumferential wear marks consistent with wear from the adjacent crankshaft bearing surfaces. Approximately half of the rod bearing surfaces exhibited dark discoloration that was generally uneven (see Figure 19).

Figure 19 - The bearing surfaces of the #6 (a) connecting rod and (b) the connecting rod cap.

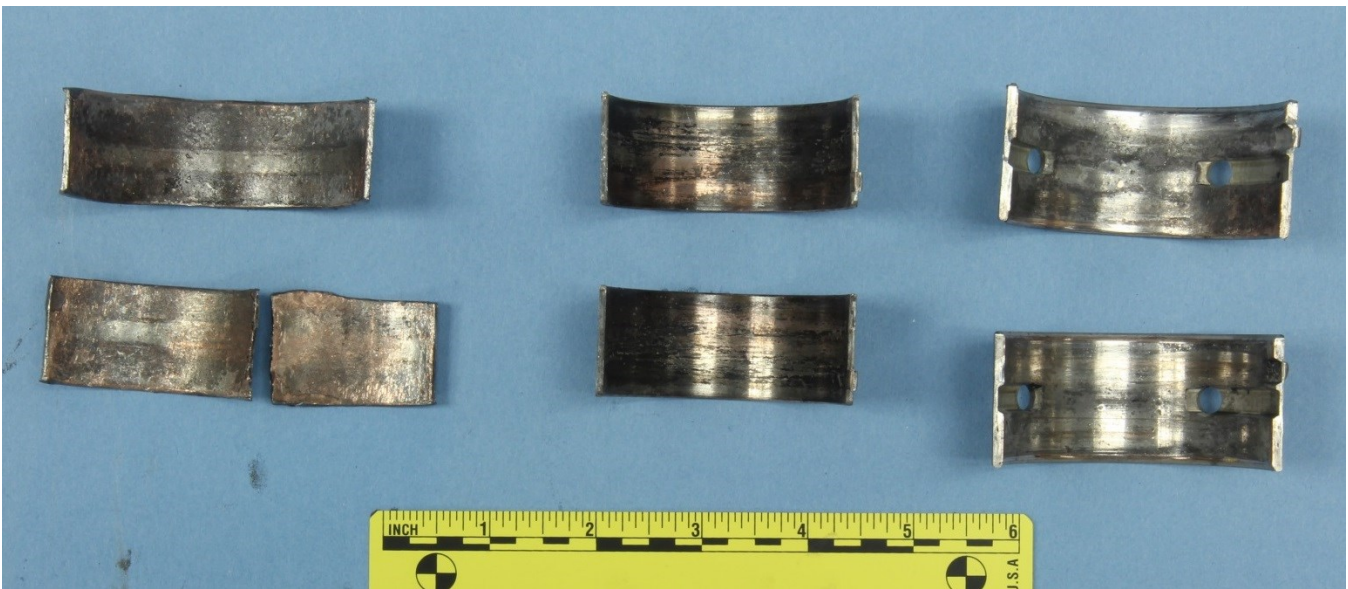
The babbitt bearing material corresponding with this rod position is shown in Figure 20. Most of these components were generally intact, as opposed to the #2 components. However, these bearings exhibited heavy circumferential wear scars, spalling, galling, and radial deformation. The corresponding crankshaft journal exhibited circumferential wear scars, with surface darkening and heat tinting. These features were consistent with elevated temperature exposure and oil degradation.

Figure 20 – The journal bearings from the #6 position after cleaning. The bearing surfaces exhibited circumferential wear scars, plastic deformation, and spalling.

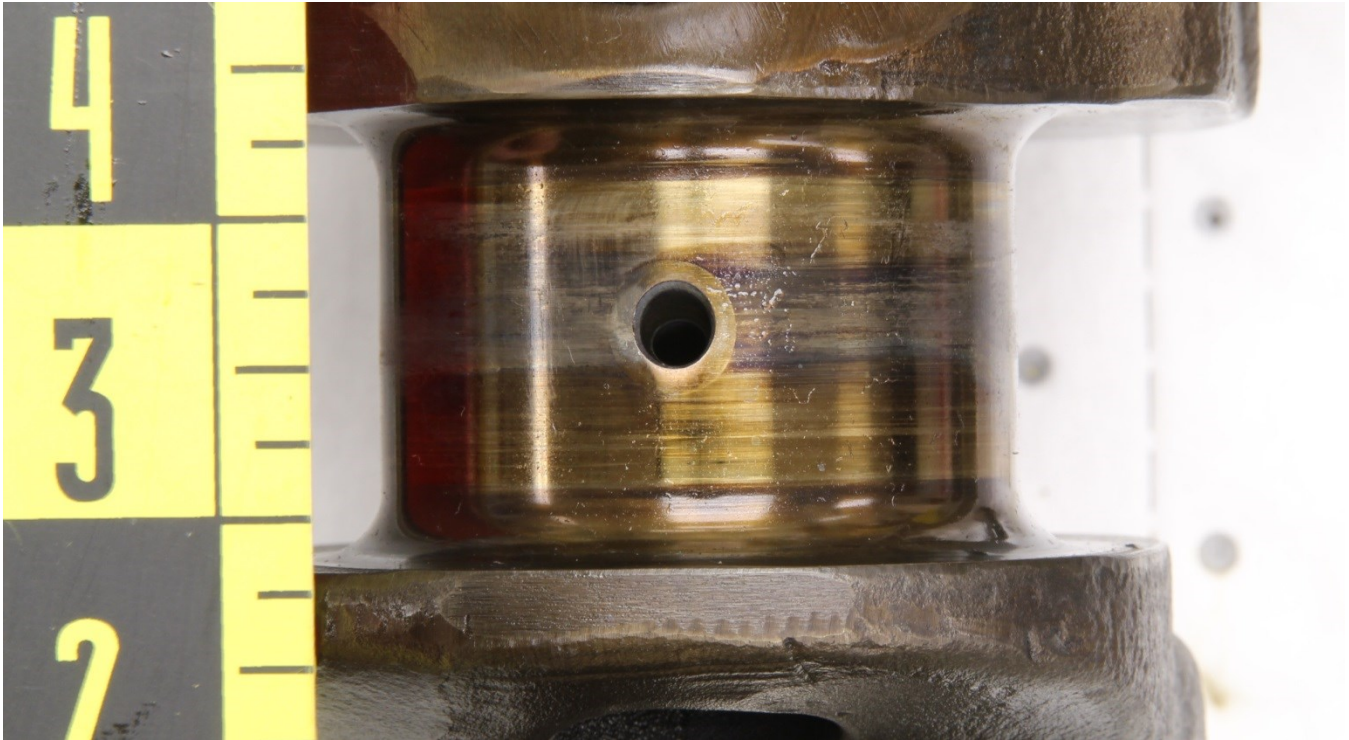
Figure 21 – The #6 bearing journal of the crankshaft, as received.
