Norwegian Caribbean Lines

QCM Job No. 1EM-1292

FAILURE ANALYSIS OF BOILER TUBES

Determine cause of failure of several boiler tubes received by Norwegian Caribbean Lines reportedly removed from the S/S Norway.

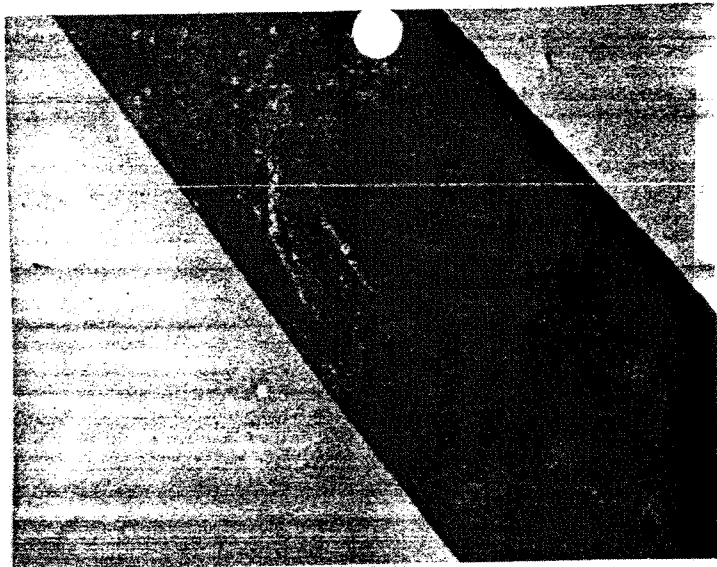
A photograph showing one of the main failures is in Figure 1. Noted is this sample failed in what would be called a typical thick wall rupture failure. Also submitted were several samples with lesser degrees of failure. As one of these samples was previously examined, it will be discussed first.

Photograph Figure 1
Showing main failure of tubing.

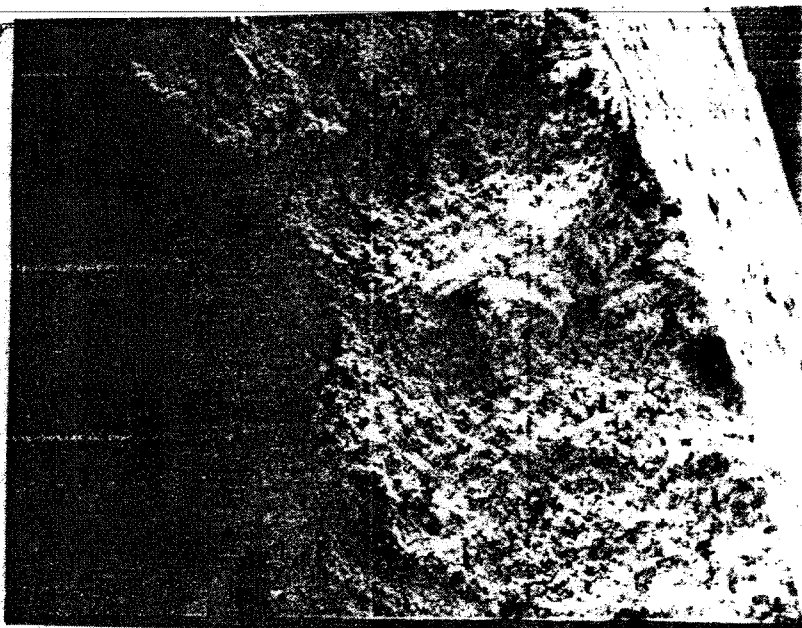
A SEM photograph showing the failed surface of the smaller fracture is in Figure 2. Noted is corrosion products on the surface. A photograph showing secondary cracking on the outside diameter surface is in Figure 3. Noted again is oxidation and multiple secondary cracking. EDAX analysis of this surface is in Table I as No. 3. A similar photograph showing the inside diameter is in Figure 4. Noted in this area is a pit with a crack initiating from it and several smaller cracks. A higher magnification view is in Figure 5. This shows the depth of the secondary crack in the pit. EDAX analysis of this area is in Table I as No. 5.

Photograph Figure 2
Magnification - 12X
Prior to cleaning. Showing
fracture surface of smaller
failed parts.

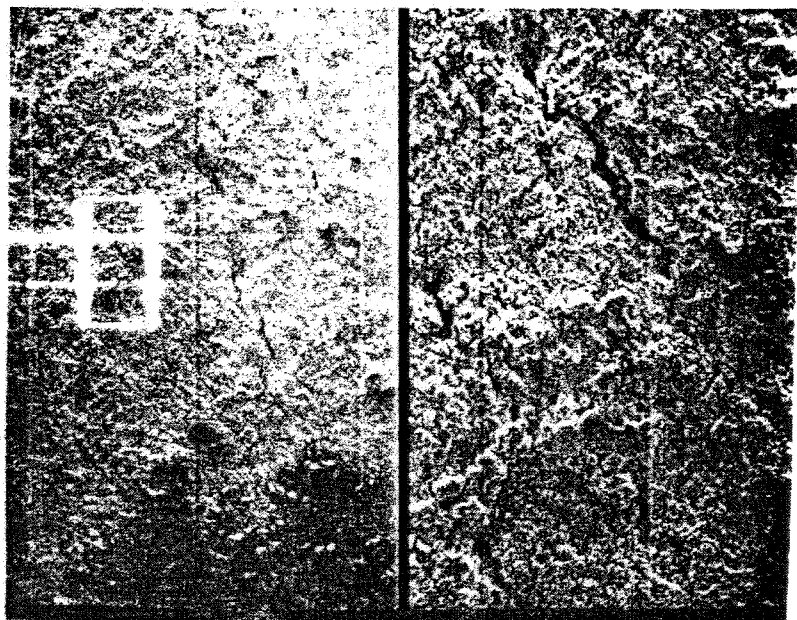
Photograph Figure 3
Magnification 15-75X
Showing secondary crack in the
outside diameter surface.
EDAX analysis results in Table
I.

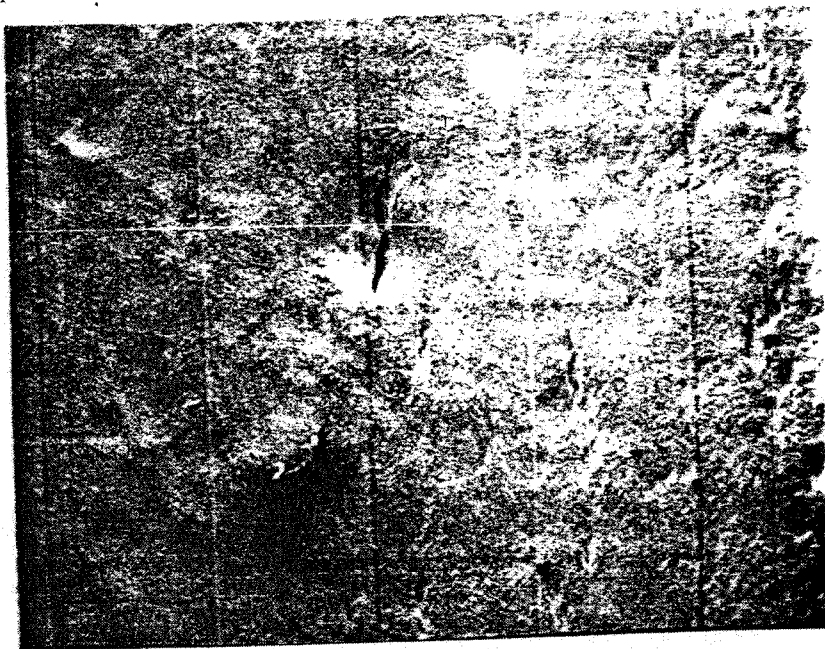
Photograph Figure 4
Magnification - 15X
Showing inside diameter surface
Note pitting and multiple
cracking.

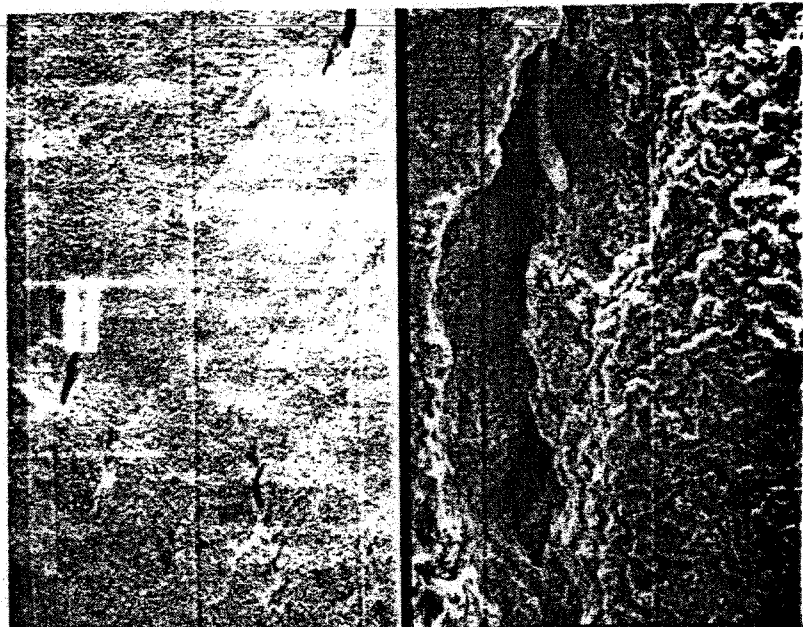
Photograph Figure 5
Magnification 15-75X
Showing pitting of inside tubing.
Noted is depth of secondary
crack. EDAX analysis in Table
I.

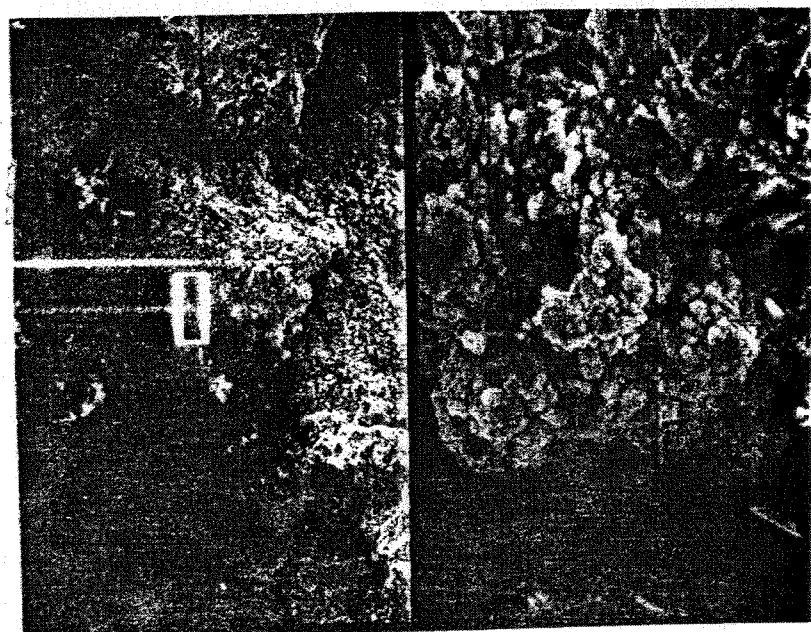
A photograph showing the fracture surface, near the OD, prior to cleaning is in Figure 6. This photograph suggests a high temperature failure similar to stress rupture. EDAX analysis of this region is in Table I as No. 6. It shows an extremely high Vanadium content with Copper also present. A photograph showing the fracture surface at the inside diameter region is in Figure 7. This

Photograph Figure 6
Magnification 50-500X
Showing fracture surface of
outer diameter prior to cleaning
Suggests an intergranular
fracture mechanism. EDAX
analysis in Table I.

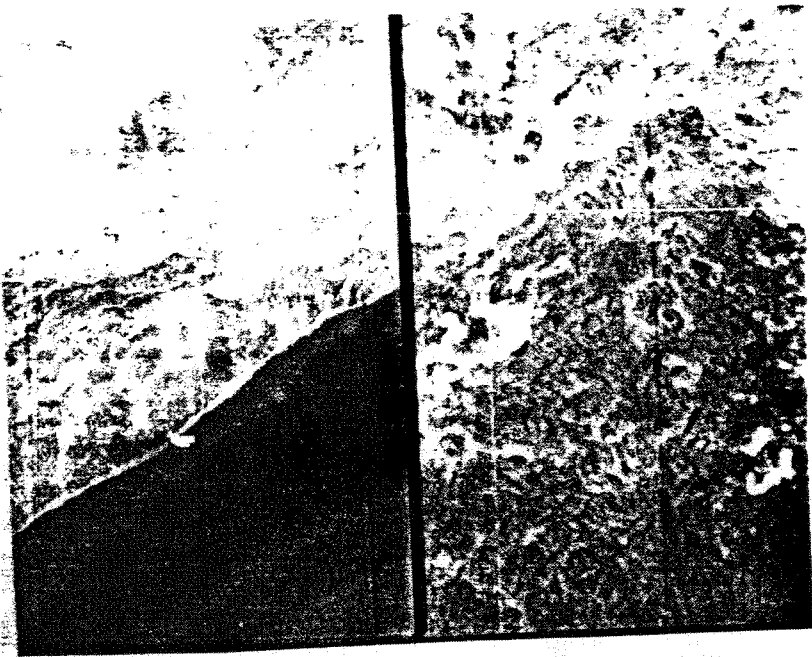
also suggests corrosion or high temperature failure, but also indicates a very low cycle type fatigue propagation. The rate of which is 2×10^{-4} in/cycle which is in the low cycle (high stress) region. This is much like high temperature corrosion fatigue, meaning part of the mechanism is thermal in nature. EDAX analysis of this sample is in Table I as No. 7. A photograph showing the failed surface just slightly removed from that shown in Figure 7 is in Figure 8. This shows an intermediate type failure, suggesting corrosion or rupture propagation. EDAX analysis of that region is in Table I as No. 8. This particular area shows an elevated Copper and Nickel content.

Photograph Figure 7
Magnification 35-350X
Showing inside diameter surface
prior to cleaning. This fracture
shows some fatigue which is
most probably thermal in nature.
EDAX analysis in Table I.

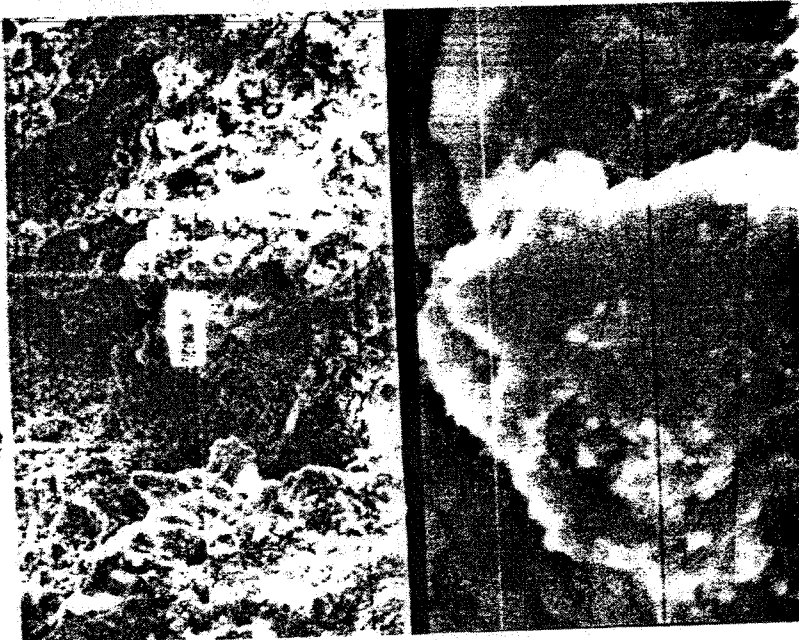
Photograph Figure 8
Magnification 150-1500X
Showing intergranular type
failure of area near that shown
in Figure 7. EDAX analysis in
Table I.

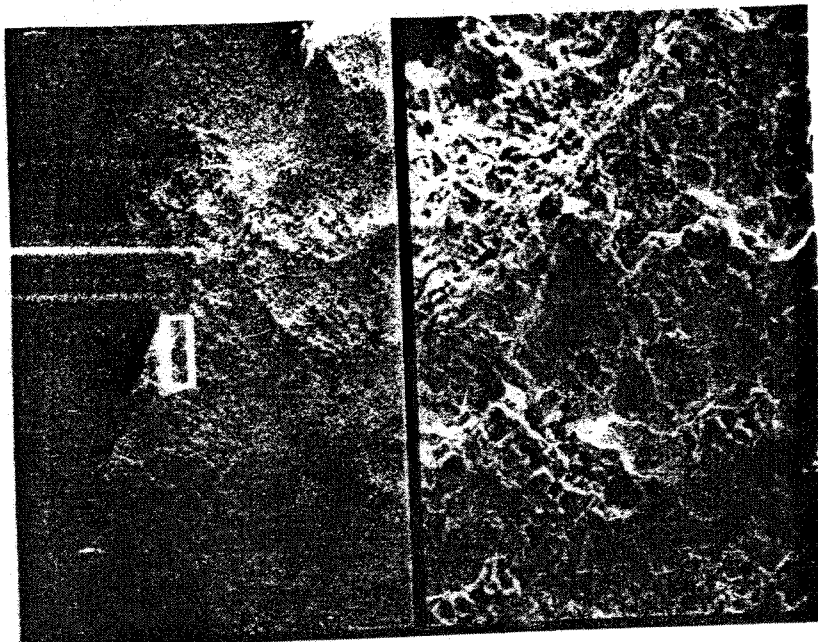
A photograph showing the inside diameter of failed part after cleaning is in Figure 9. Noted is definite intergranular cracking mechanism. This failure is undoubtedly a combination of corrosion and rupture at the inner diameter. A photograph taken in a slightly different area is in Figure 10. This photograph again shows fatigue propagation. These striations are at a rate of approximately 6×10^{-5} in/cycle indicating vibrating and thermal fatigue stresses. A photomicrograph showing the fracture surface at the outer diameter is in Figure 11. This area is definitely all intergranular cracking and the direct result of stress rupture type failure. The sample was then examined using microstructural and EDAX techniques.

Photograph Figure 9
Magnification 35-350X
Showing intergranular cracking
of inside diameter area after
cleaning.

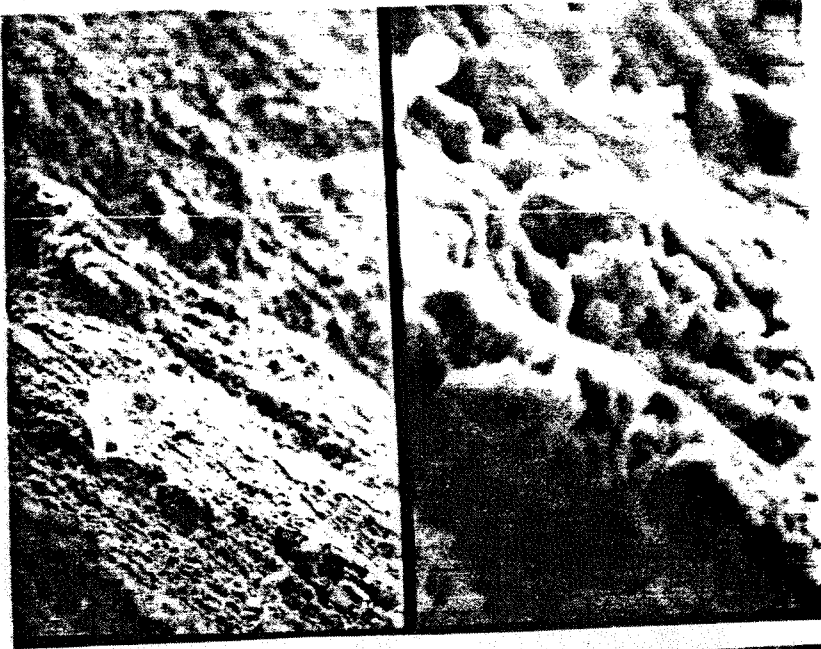
Photograph Figure 10
Magnification 150-1500X
Showing some fatigue striations
occurring at the inside diameter
surface. These are most likely
the result of thermal and
fatigue striations.

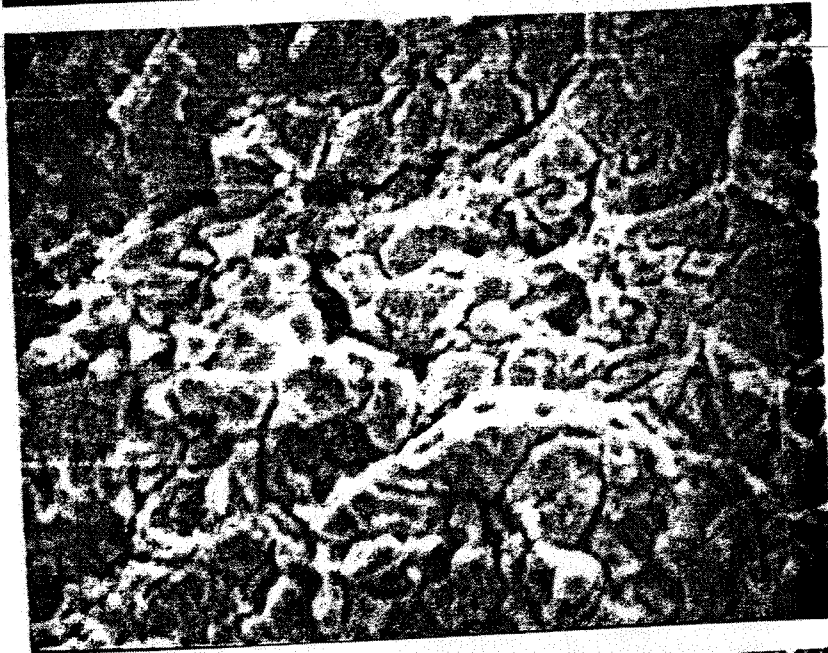
Photograph Figure 11
Magnification - 1000X
Showing intergranular cracking
at outside diameter surface.
This is definitely the result of
stress rupture failure.

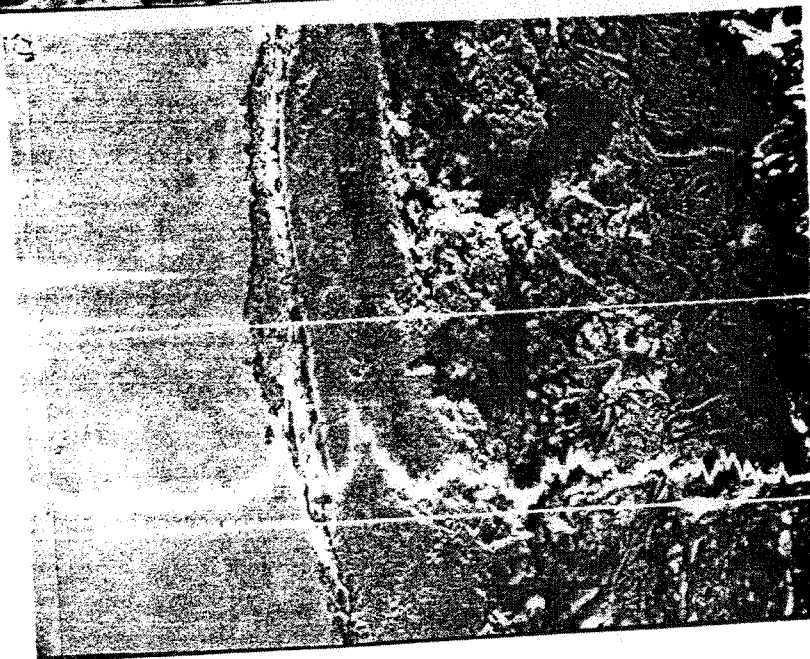
A SEM photograph showing a line profile analysis for Sulfur is in Figure 12. Noted is very high Sulfur content in secondary cracks. This definitely indicates that a sulfide bearing gas was involved in the corrosion aspect at the inner diameter. A photograph taken outside the area is in Figure 13. This again shows the secondary cracking. The photograph in Figure 14 reveals a line profile analysis for Sulfur across this crack. Again it is noted that a high Sulfur content occurs in the crack and adjacent surface at the inner diameter. Tensile and rupture specimens were also removed from this sample. The data for thicker and thinner areas is in Table II. Also to be determined is the stress rupture properties. This data will be supplied in a separate report. The remaining portion of this report was performed on the main failure samples.

Photograph Figure 12
Magnification - 120X
Line profile for Sulfur. Shows
high Sulfur content in secondary
cracking.

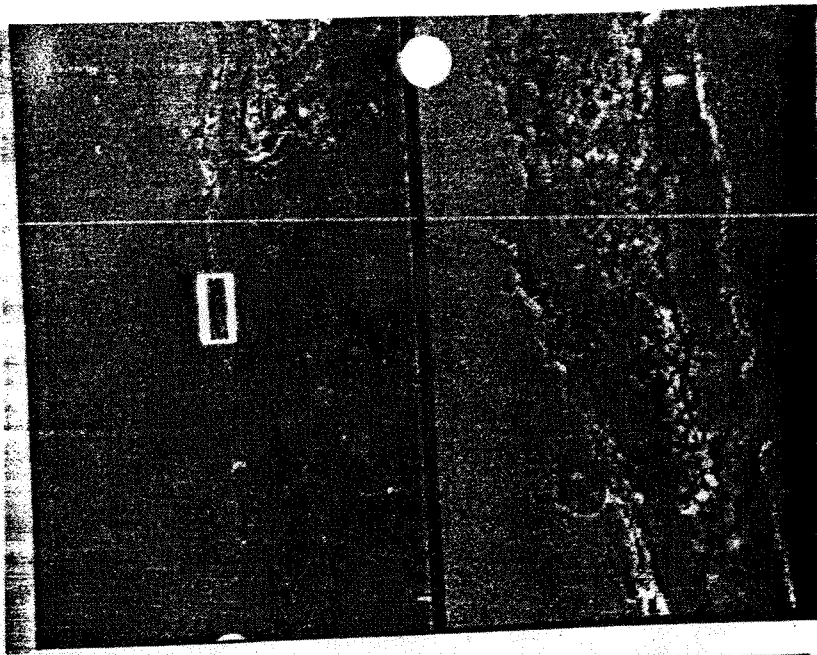
Photograph Figure 13
Magnification 40-400X
Showing separate area and a
secondary crack at inner diam-
eter.

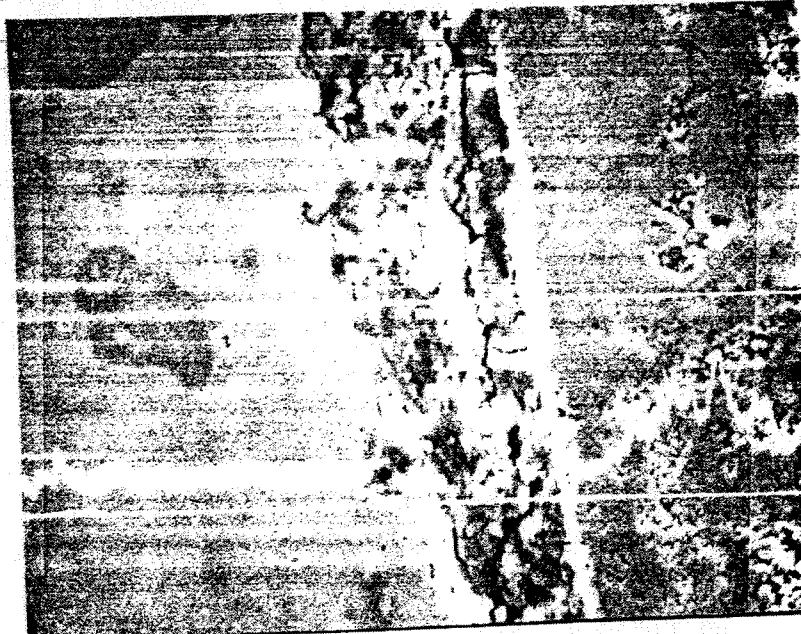
Photograph Figure 14
Magnification - 400X
Showing line profile analysis fo
Sulfur. Noted is high Sulfur
content in crack area.

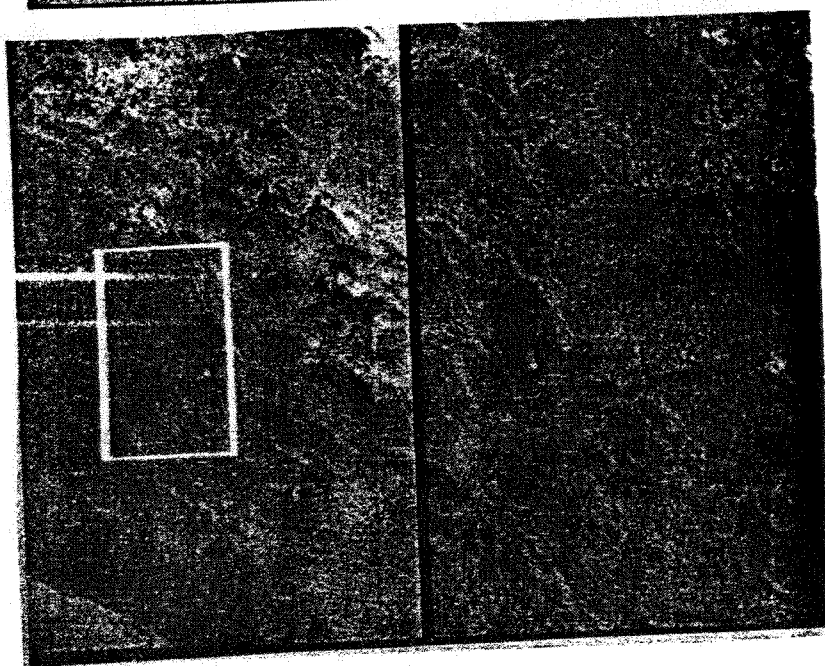
A photograph showing intergranular cracking of the main failure is in Figure 15. This fracture is a result of high temperature exposure coupled with some corrosion. A higher magnification view is in Figure 16 and definitely indicates that corrosion is part of the failure mechanism within the inner diameter area. A higher magnification view is in Figure 17 and reveals the corrosion mechanism to be intergranular in nature. Also noted is edge of grain boundaries. The photograph showing intergranular fracture from rupture is in Figure 18. This photograph was taken midway between the inner diameter and outer diameter. The failure mechanism is definitely intergranular in nature.

Photograph Figure 15
Magnification 75-225X
Showing intergranular cracking
at inner diameter surface.

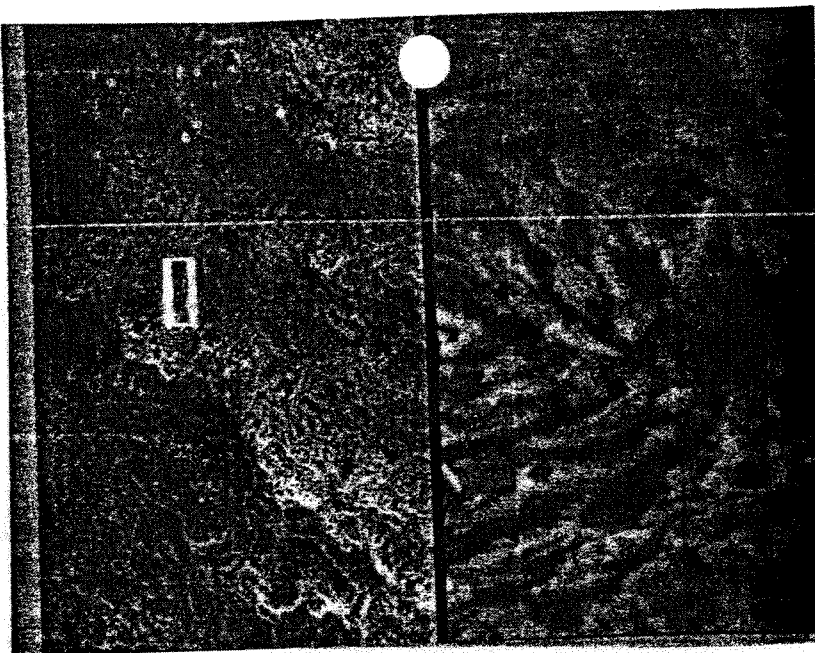
Photograph Figure 16
Magnification 350-3500X
Showing intergranular fracture
of inner diameter area.

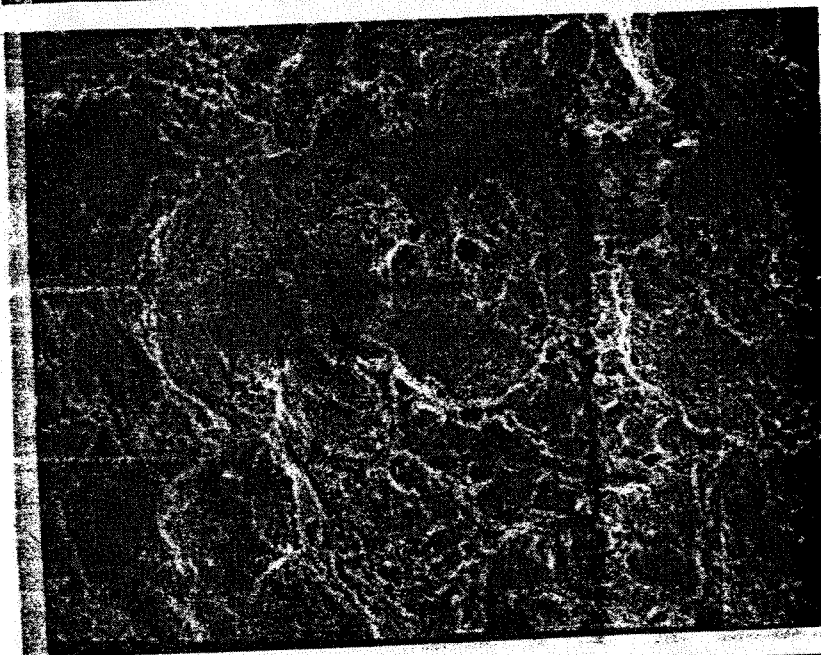
Photograph Figure 17
Magnification - 350X
Showing intergranular rupture
failure at mid section.

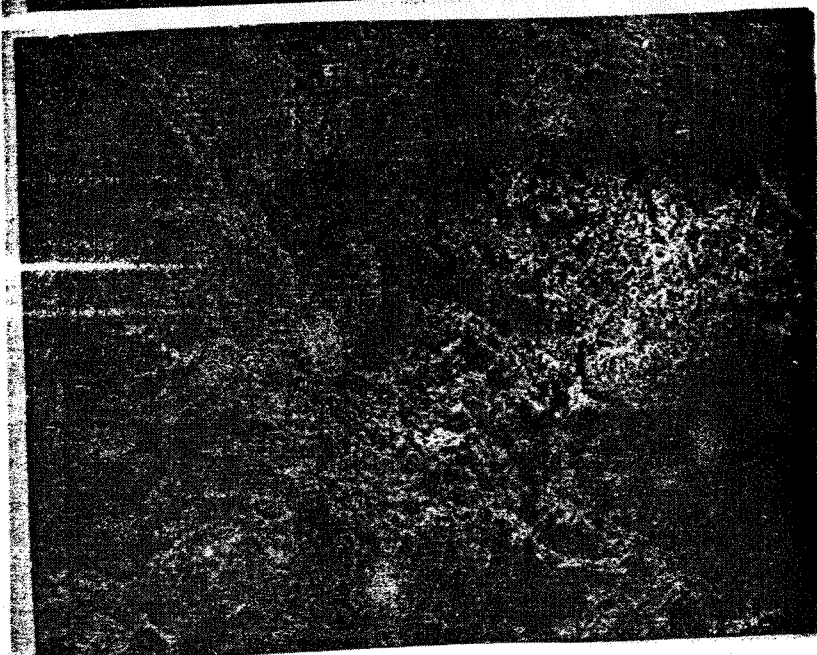
Photograph Figure 18
Magnification - 200X
Showing outside diameter failure
to be intergranular in nature.

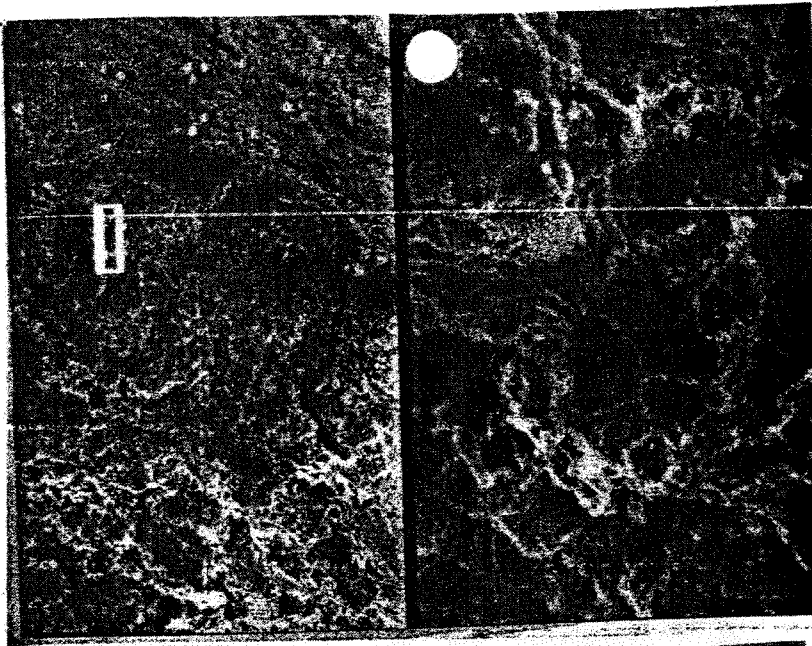
A photograph showing intergranular cracking at the outside diameter section is in Figure 19. This indicates the fracture mechanism is rupture in nature. A second photograph taken in this area is again intergranular in nature. This indicates the primary fatigue mechanism is rupture in nature.

Photograph Figure 19
Magnification 100-1000X
Showing intergranular cracking
at the outside diameter. This
is rupture in nature.

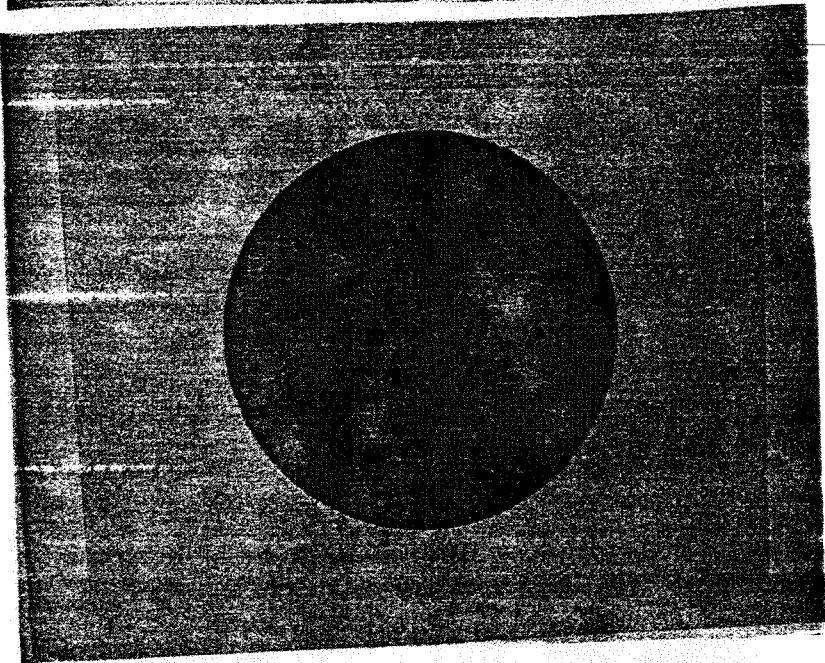
A macrograph showing etching for seamless tubing and indication of hydrogen embrittlement is in Figure 20. This photograph shows no signs of a weld or hydrogen embrittlement. The minimum outside diameter was found to be 2.422" near the thin area. This compares to the maximum of 2.862", 90° to the thin area. In terms of thickness the minimum was .177" wall and the normal .263". Samples of the main fracture and areas away from this area were then run using metallurgical and physical techniques.

Photograph Figure 20
Macro showing tubing to be
seamless and no signs of hydro
gen embrittlement.

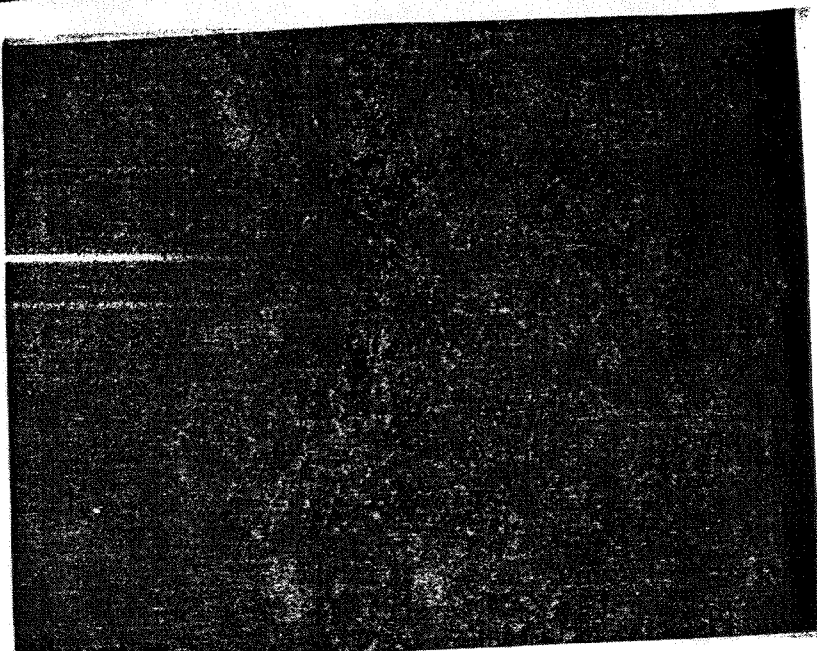
A photomicrograph showing the structure near the inner diameter of failed section is in Figure 21. Noted is this structure is martensitic. Hardness testing of this area revealed a microhardness of 355 DPH which converts to 36 Rc. A comparison with this to the outside diameter near the fracture is in Figure 22. This shows a decarburized region on the surface compared to just below it. The decarb region had a hardness of 155 DPH which converts to 80.5 Rb whereas the area just below it had a hardness of 400 DPH (41 Rc). For comparison properties, a section was made away from the failure in the thicker region.

Photograph Figure 21
Magnification - 365X
Etched in 3% Nital. Showing
inner diameter near failure to
be tempered martensite. Hard
ness is 355 DPH.

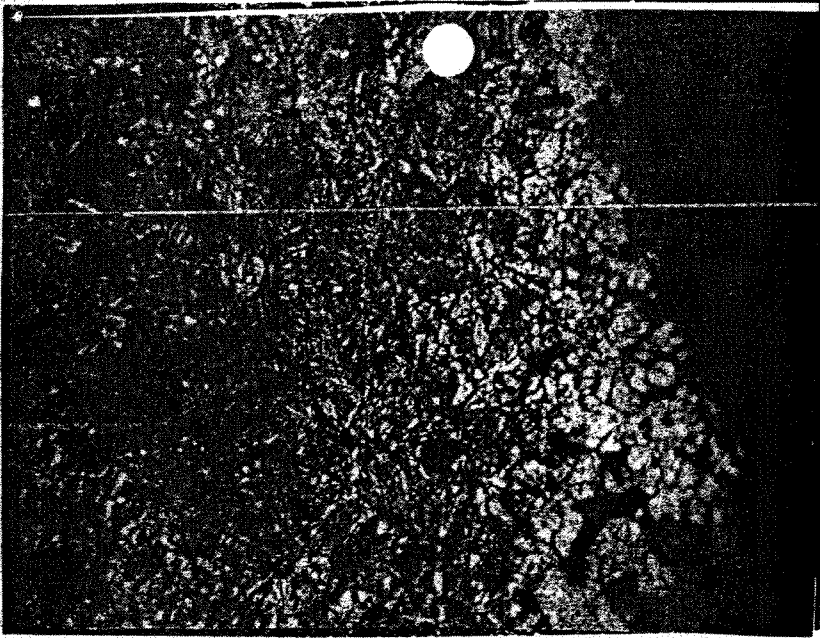
Photograph Figure 22
Magnification - 365X
Etched in 3% Nital. Showing
structure at outer diameter of
tubing to be decarb. Decarb
area has hardness of 155 DPH
compared to subsurface hard-
ness of 400 DPH.

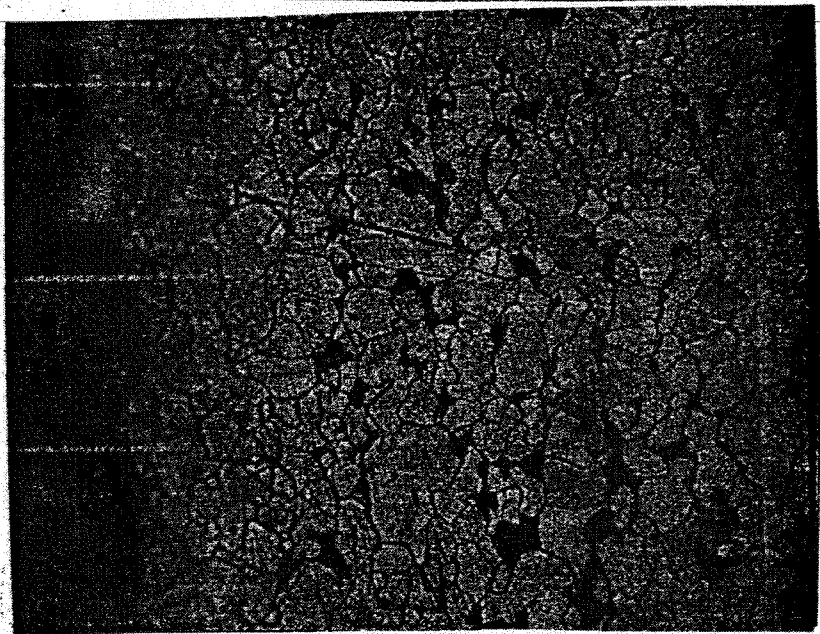
A photomicrograph showing the inner diameter of an unaffected region is in Figure 23. This shows a typical normalized steel. The hardness of this region was found to be 148 DPH (78.5 Rb). A similar photograph taken at the outside diameter of the unaffected region is in Figure 24. This again shows a typical normalized structure. Hardness of this region was found to be 160 DPH (81.5 Rb) This definitely indicates carburization at the fracture surface. Carbon analysis of the material which was unaffected revealed a content of .129%. This coupled with the EDAX analysis indicates the material is similar to a Carbon Steel. Bending testing both the affected (thin) and unaffected (thick) regions revealed the material to be ductile. These tests were performed on the inner diameter and outside diameter in tension with little difference.

Photograph Figure 23
Magnification - 365X
Etched in 3% Nital. Showing
inner diameter of unaffected
region. Structure is normalized.
Hardness is 148 DPH.

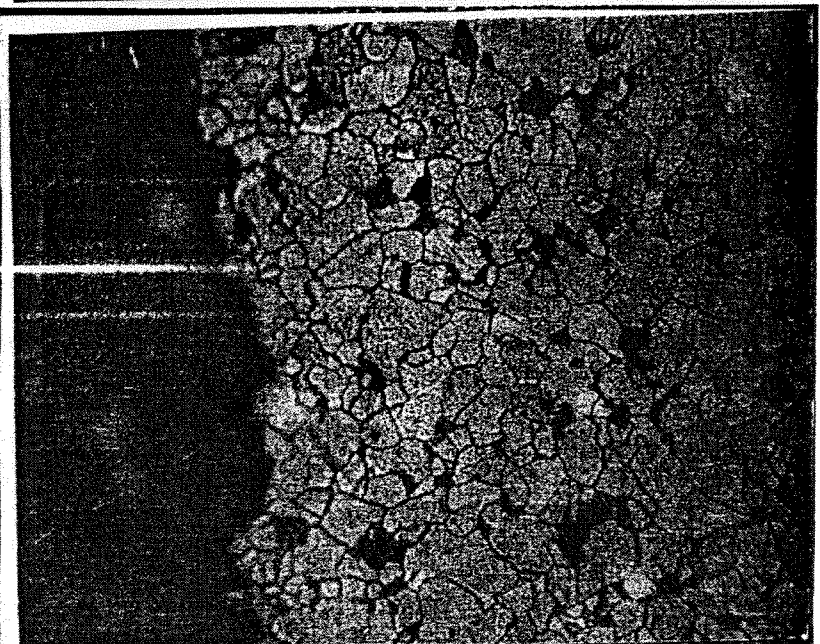
Photograph Figure 24
Magnification - 365X
Etched in 3% Nital. Showing
outer diameter of unfailed area.
Structure is normalized. Hard-
ness is 160 DPH.
