1 National Transportation Safety Board

8 Group Chairman's Factual Report  
9  
10  
11

12  
13 **Nautical Group**  
14  
15  
16  
17  
18

19 *SSEI Faro*  
20 DCA16MM001  
21

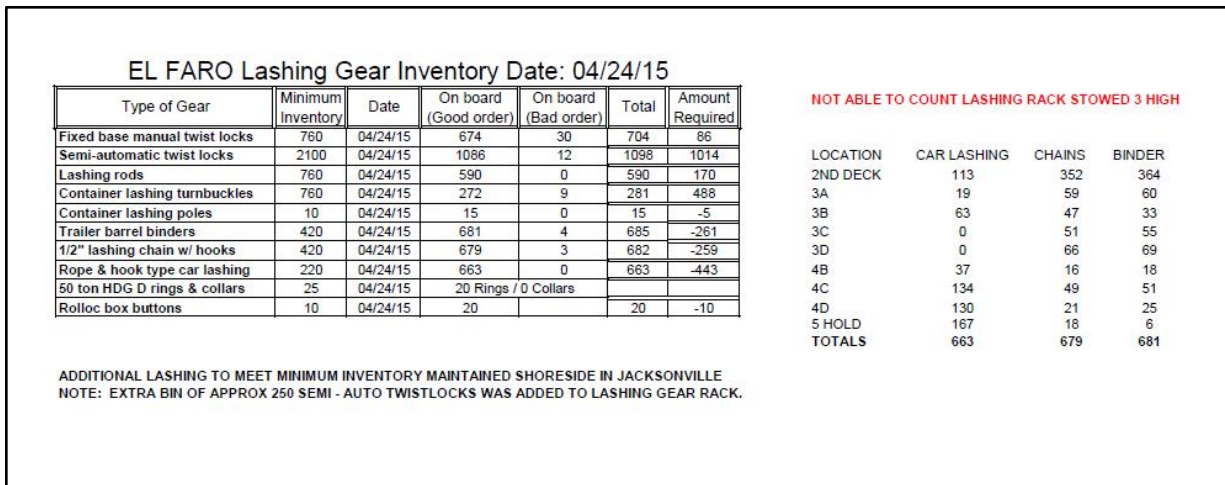
The inventory noted that the vessel was short of the following quantities required by the cargo securing manual:

- 86 fixed-base manual twistlocks.
- 1014 semiautomatic twistlocks.
- 170 lashing rods.
- 488 container-lashing turnbuckles.

Figure 19. El Faro lashing gear inventory for April 24, 2015.

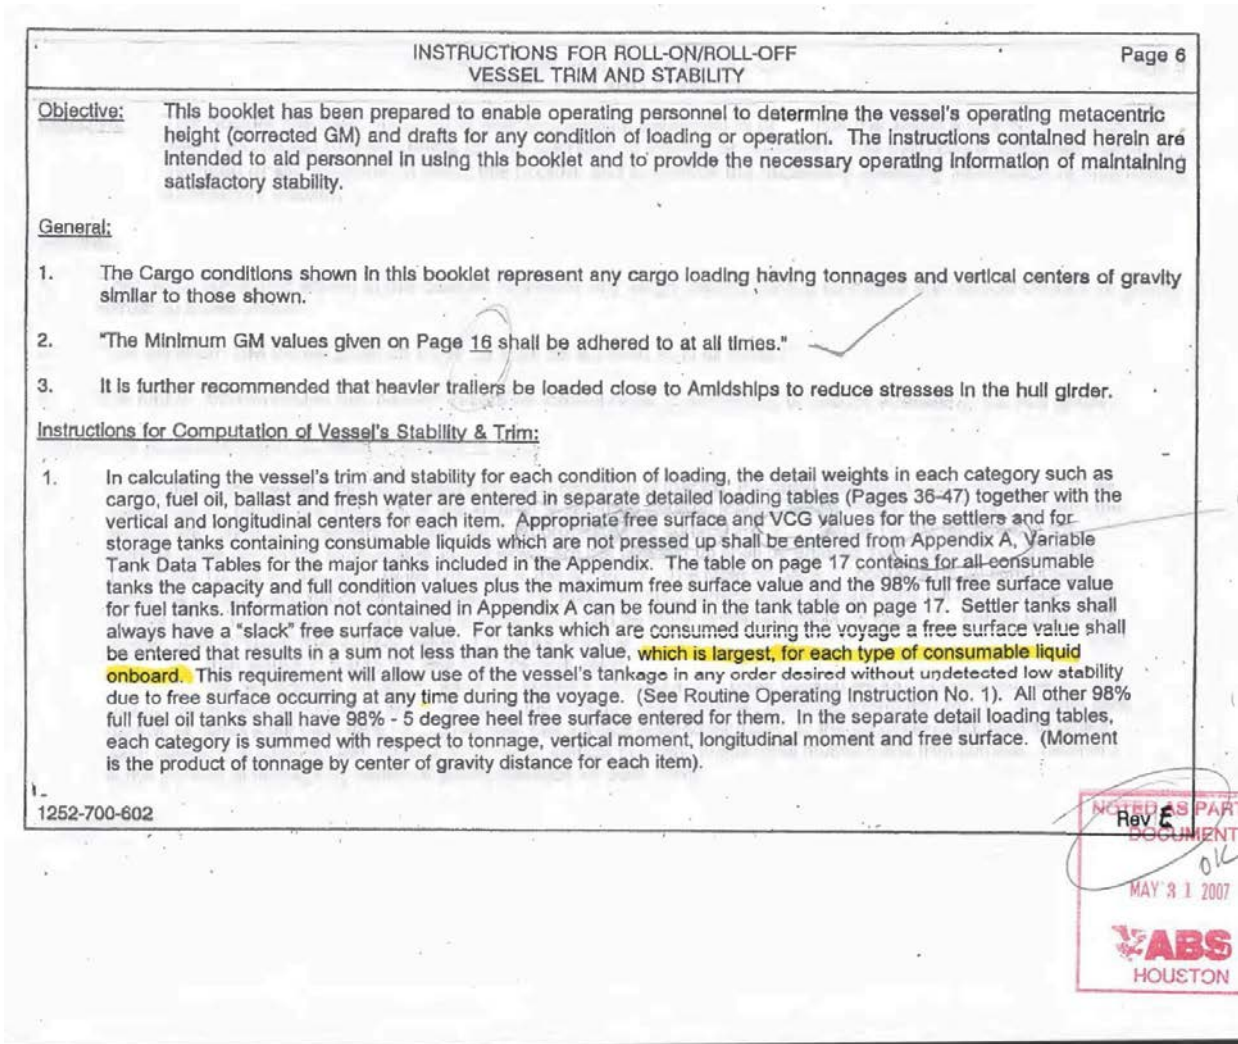
4 When asked if the load line change was noted in the vessel’s trim and stability booklet,  
 5 ABS testified: “We made sure it was documented in the booklet and the guidance for the  
 6 Master.”<sup>71</sup> Investigators reviewed the entire trim and stability book; which included the revisions  
 7 page (**figure 20**) and the “Instructions for Roll-on-Roll-off Vessel Trim and Stability” in *El Faro*’s  
 8 trim and stability booklet (**figures 21a, b, and c**); and found no mention of changes to the vessel’s  
 9 load line.

5  
 6 **Figure 21a.** Instructions in *El Faro*'s trim and stability booklet.

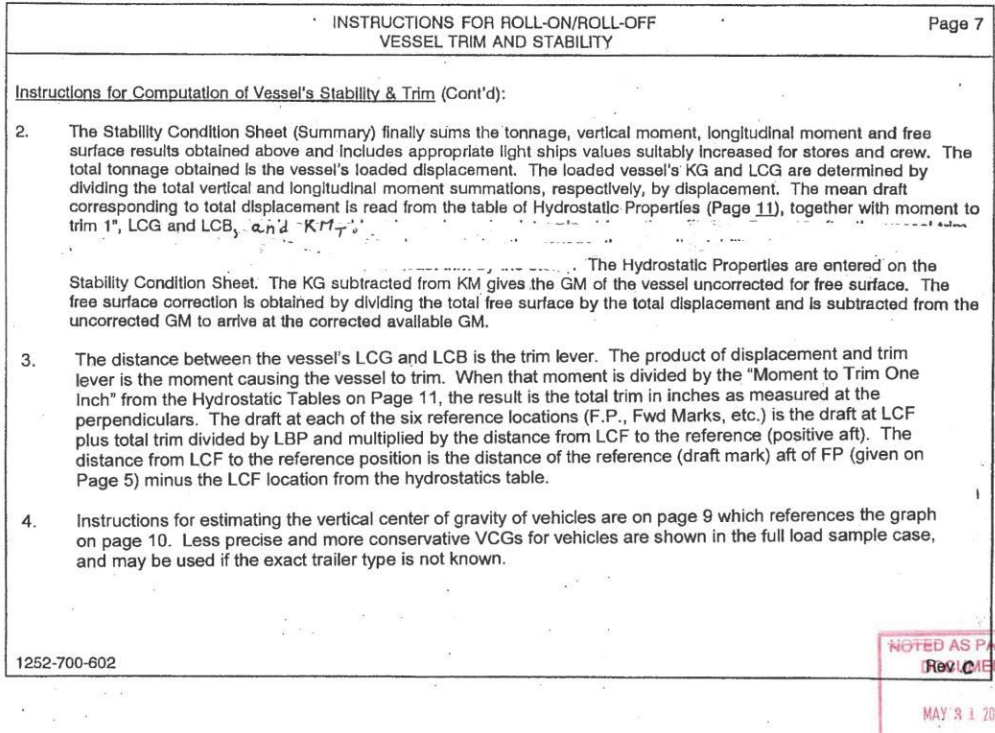
1 Investigators compared *El Faro*'s ABS approved trim and stability booklet and the specific  
 2 section on "routine operating instructions" (see **figure 21b**) to the considerations listed in Title 46  
 3 *CFR* 170.110 (d) and found that the book addressed items (1), (2), (4), (5), (6), (7), (8), (9), (10),  
 4 (12), (14), and (15).

Figure 21b. Instructions in *El Faro's* trim and stability booklet (cont).

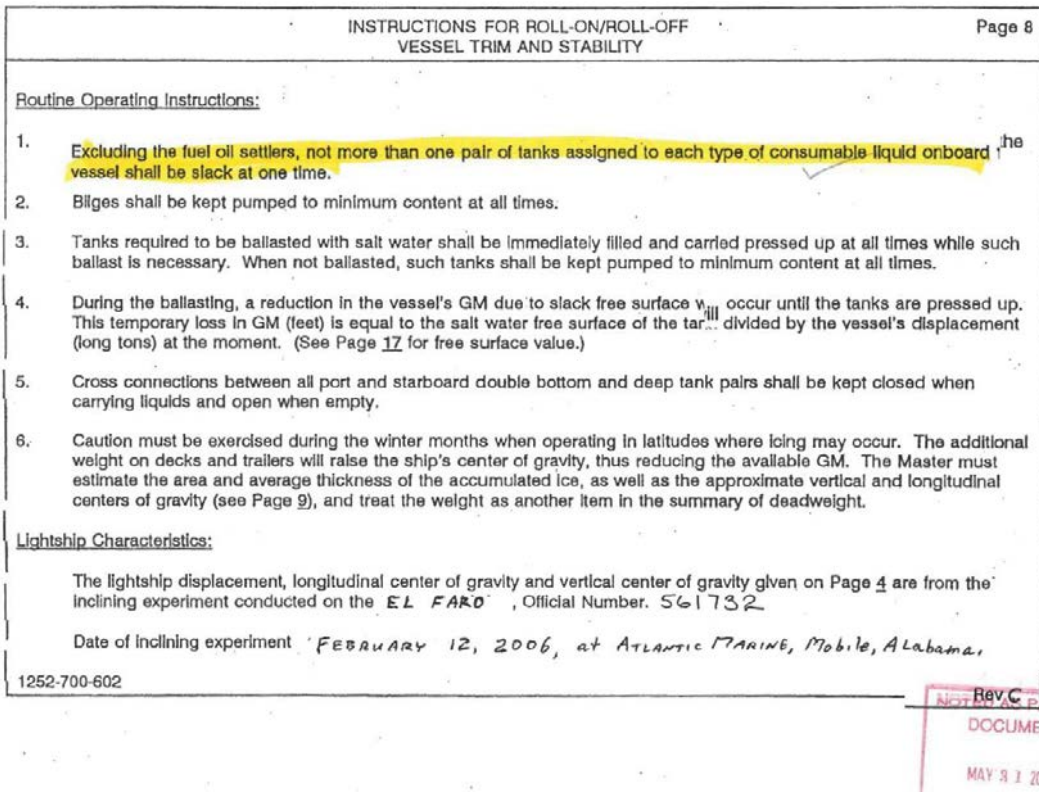
Figure 21c. Instructions in *El Faro's* trim and stability booklet (cont).
