Tote, Inc.’s Response to the National Cargo Bureau, Inc.’s “Report on Review of Cargo Securing Manual and Cargo Stowage and Securing” dated August 4, 2016

On August 9, 2016, the National Transportation Safety Board (“NTSB”) posted on Accellion a report produced by the National Cargo Bureau, Inc. (“NCB”), dated August 4, 2016, and entitled “Report on Review of Cargo Securing Manual and Cargo Stowage and Securing” (“NCB Report”).

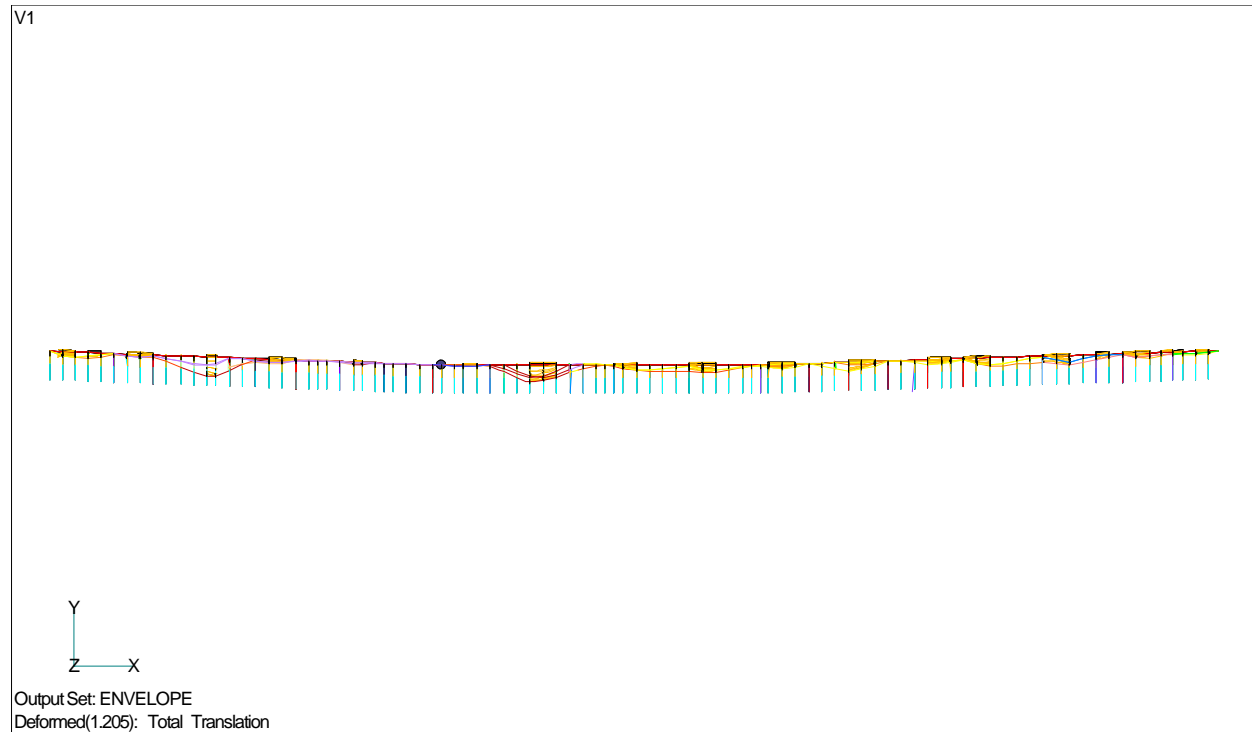
Figure 5 – Deflected model

At these locations the container supports are located between pillars, both at centerline and at the side girders, therefore allowing larger deflections than in most places where there are pillars either at or very

close to the container supports. These areas also correspond to areas in need of reinforcement as is explained later.

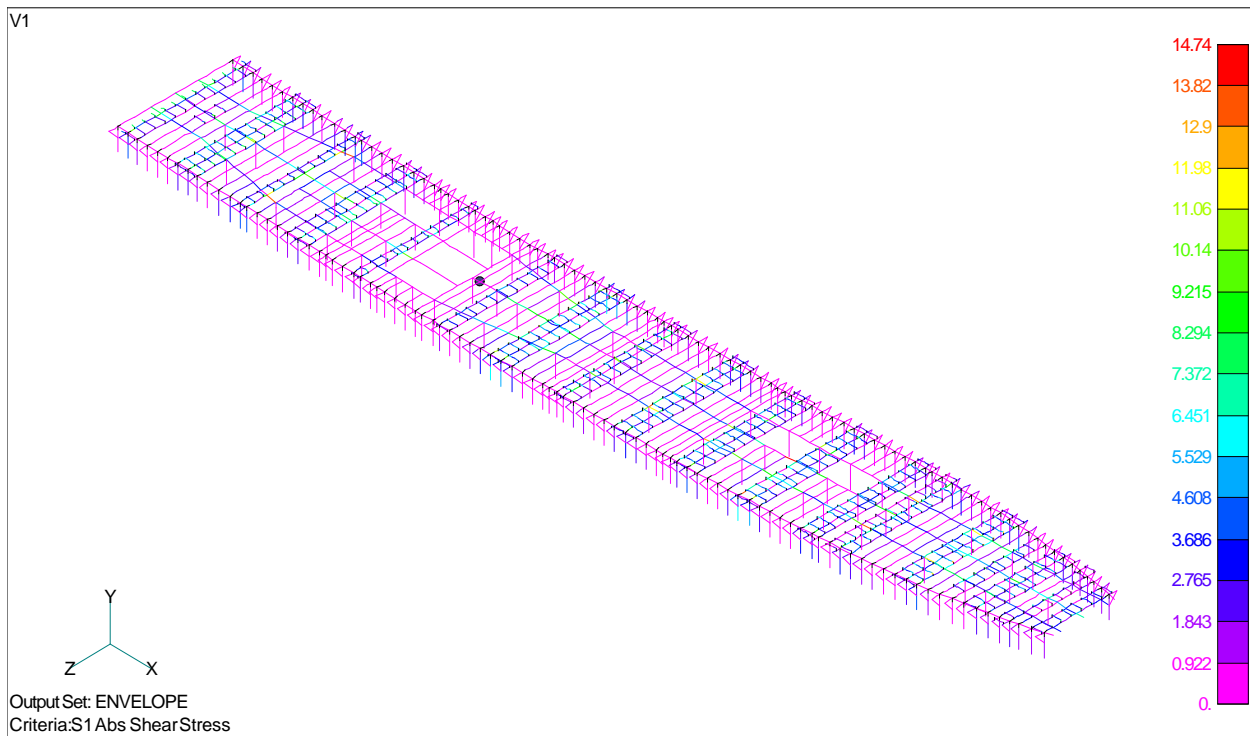
Figure 11 and Figure 12 show the maximum shear stresses from all load cases in the two primary element directions. All shear stresses are below the limit of 15 ksi.
